Performance Evaluation of Bionax SR PVCO Pipeline with Extended Bell Joints under Earthquake-Induced Ground Deformation

Cornell University
School of Civil and Environmental Engineering
Cornell University
Hollister Hall
Ithaca, NY 14853
December, 2017

This report is submitted to the IPEX Group (herein referred to as IPEX). It presents results from a testing program to investigate the performance of 6-in. (150-mm)-diameter oriented polyvinyl chloride pipeline (commercially referred to as Bionax SR) with elongated bell-and-spigot restrained joints. The purpose of the testing is to evaluate the ability of the pipeline to accommodate axial and bending deformation and assess how pipelines composed of Bionax SR pipe with extended bell-and-spigot restrained joints respond to fault rupture, which not only represents surface faulting but also the most severe ground deformation that occurs along the margins of liquefaction-induced lateral spreads and landslides. The work was undertaken in the Cornell Large-Scale Lifelines Testing Facility, which is part of the Bovay Laboratory Complex at Cornell University.

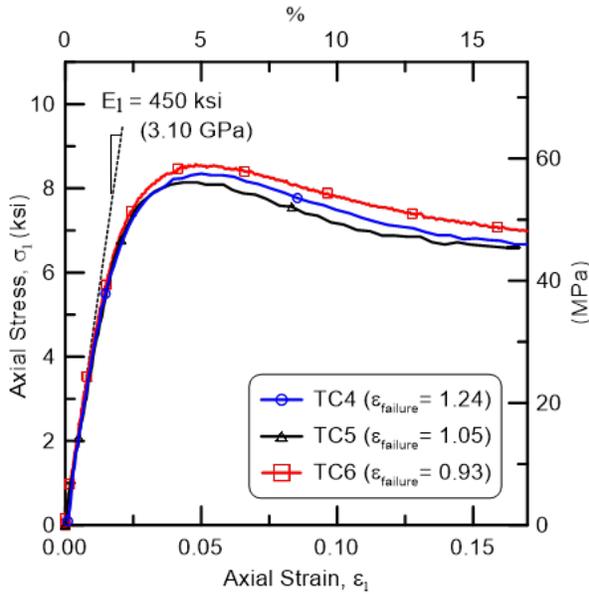
Figure 1.1. Longitudinal stress-strain results from Bionax tensile coupon specimens (Wham et al., 2017)

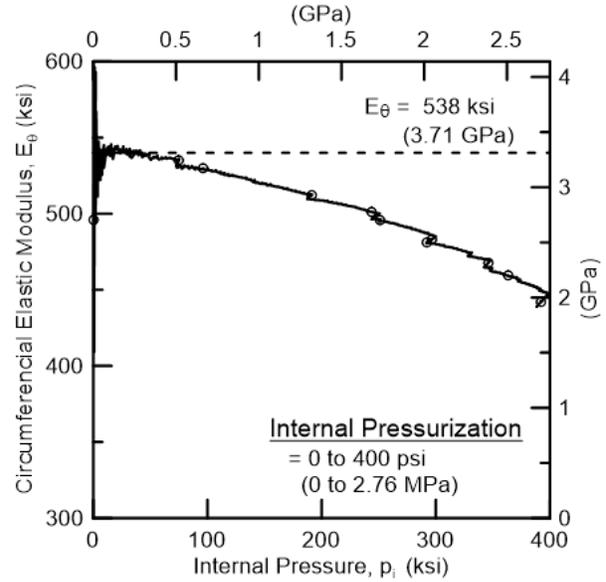
Figure 1.2. Circumferential elastic modulus variation from internal pressurization (Wham et al., 2017)

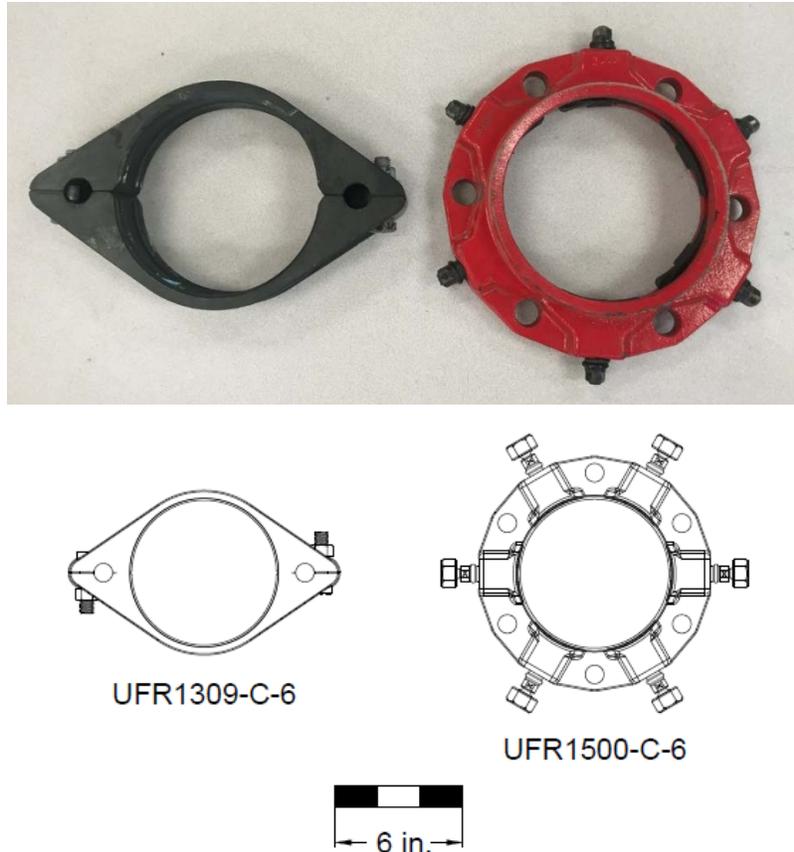
Figure 1.3. Two styles of tested joint restraints: (a) red 1559 and (b) black 1309 restraints, both produced by Ford Meter Box.

Figure 1.3 provides a comparison of the two joint restraints used in testing. Both are commercially available Uni-Flange® Pipe Restraints for AWWA C909 Pipe and manufactured by The Ford Meter Box Company, Inc. in Wabash, Indiana.

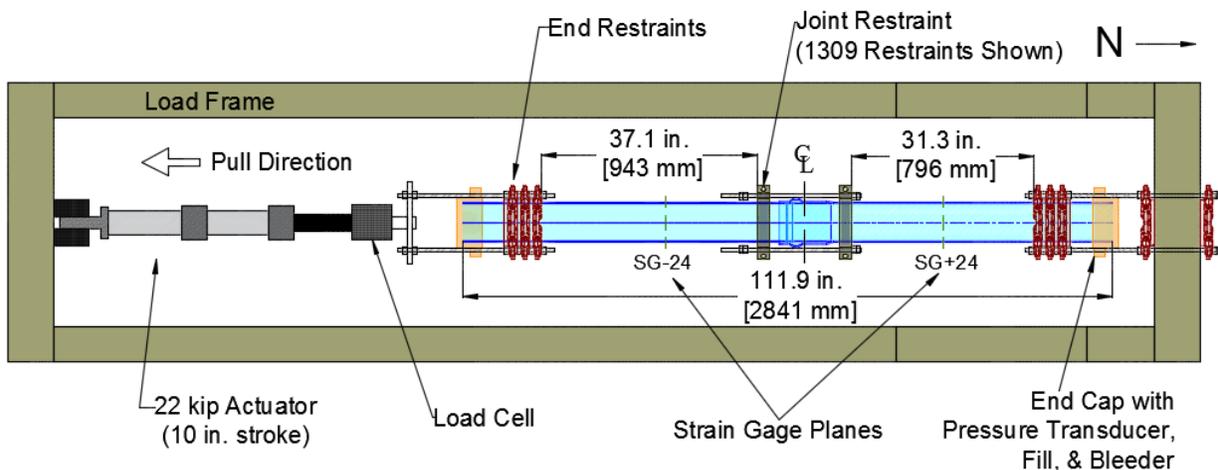
Figure 2.1. Plan view of tension test setup (TT2 with 1309 restraints shown)

The instrumentation listed in Table 2.1 was identical for each tension test. At the south end of the setup, actuator displacement was recorded internally, and axial load was provided by the load cell. Internal pressure was recorded at the north end by a pressure transducer.

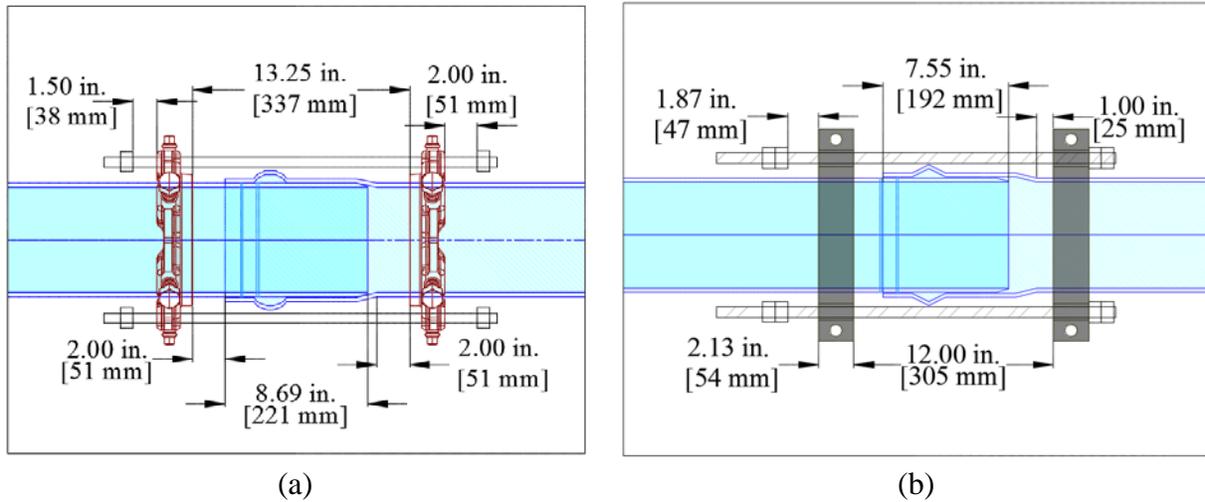
Figure 2.2. Detailed view of joint configuration for (a) TT1 (1559 Restraints) and (b) TT2 (1309 Restraints) at the start of each test

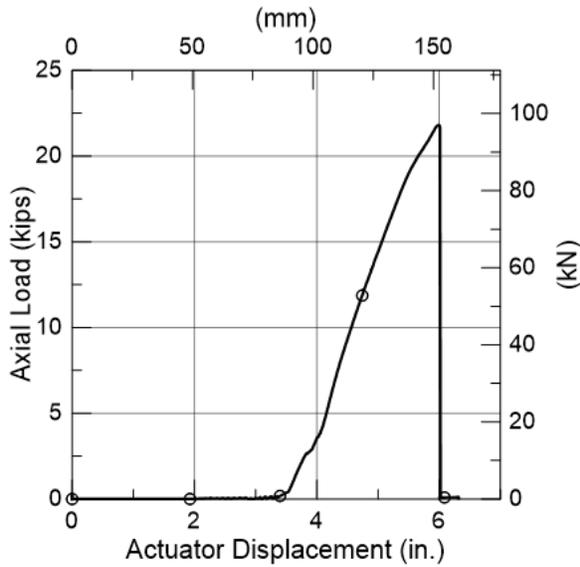
Figure 2.3. TT1 actuator load vs. displacement

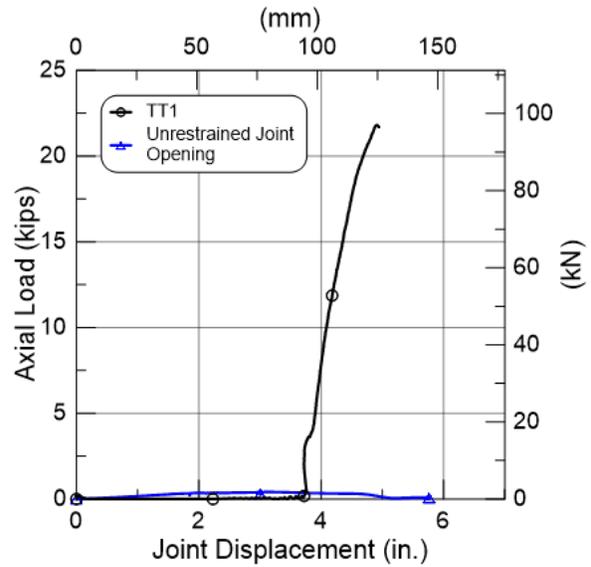
Figure 2.4. Axial load vs. joint displacement for TT1 and unrestrained joint

has 5.75 in. (146 mm) of axial displacement capacity before the end of the spigot disengages with the gasket, which leads to leakage at the joint.

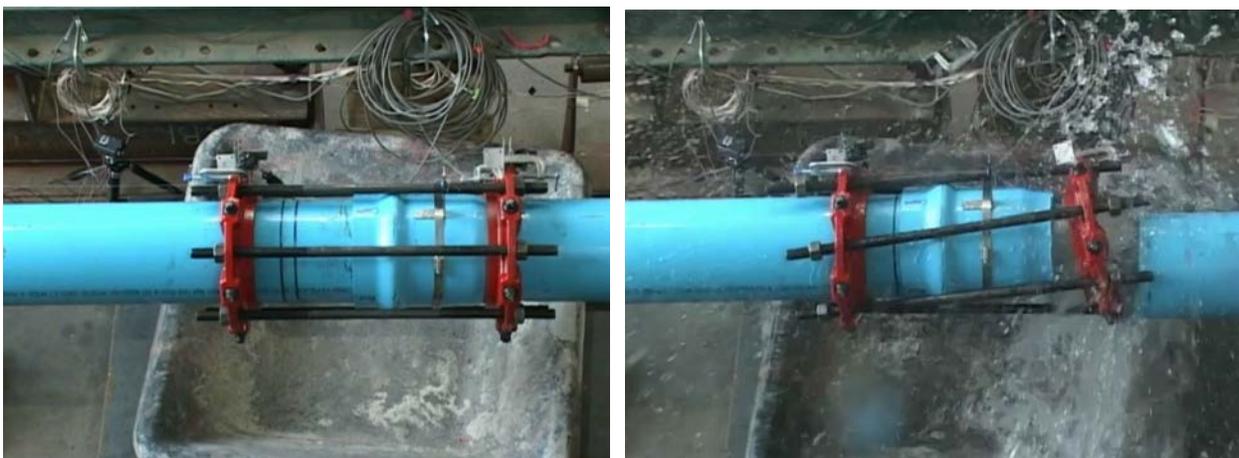
Figure 2.5. TT1 Test (a) just prior to failure and (b) after failure

At an axial load of 21.8 kips (97 kN) and a joint opening of 4.9 in. (124 mm), the specimen ruptured at the bell side (north) restraint. Figure 2.5 presents photos of the TT1 specimen just before and after failure. Post-test assessment indicates that a circumferential fracture propagated from the indentations of the restraint teeth. No leakage of the specimen was observed prior to rupture.

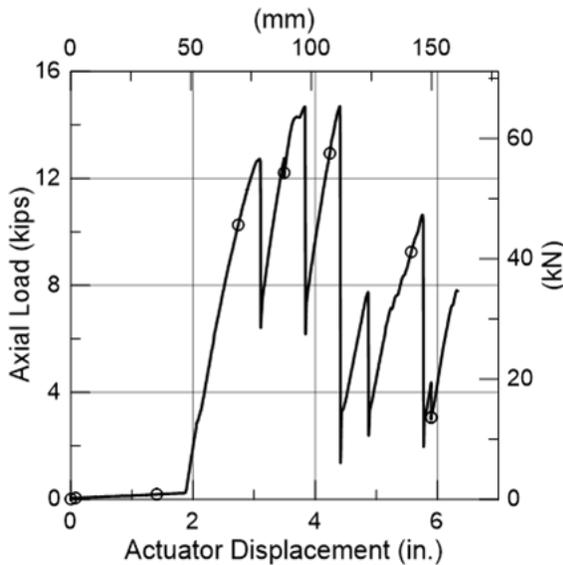
Figure 2.6. TT2 actuator load vs. displacement

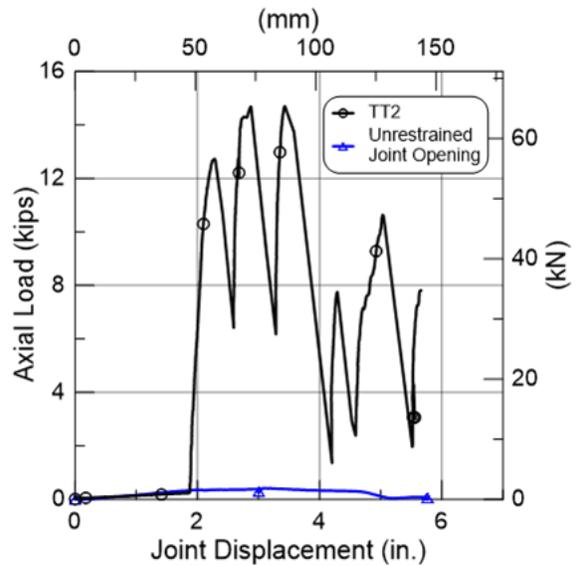
Figure 2.7. Axial load vs. joint displacement for TT2 and unrestrained joint

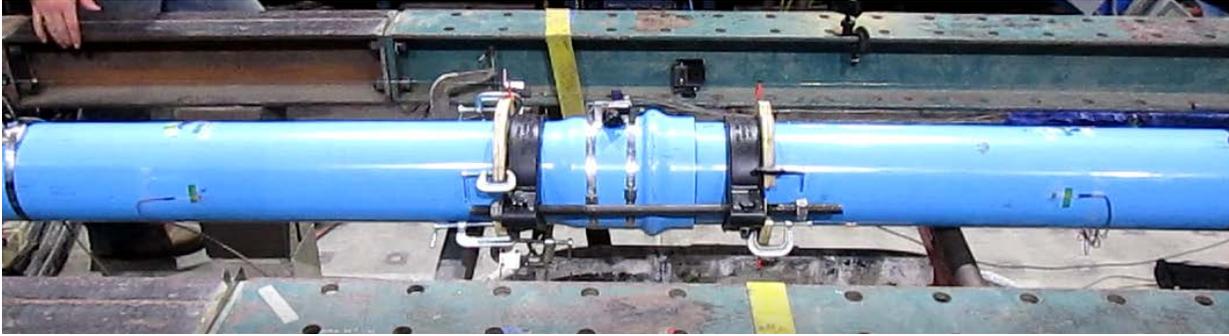
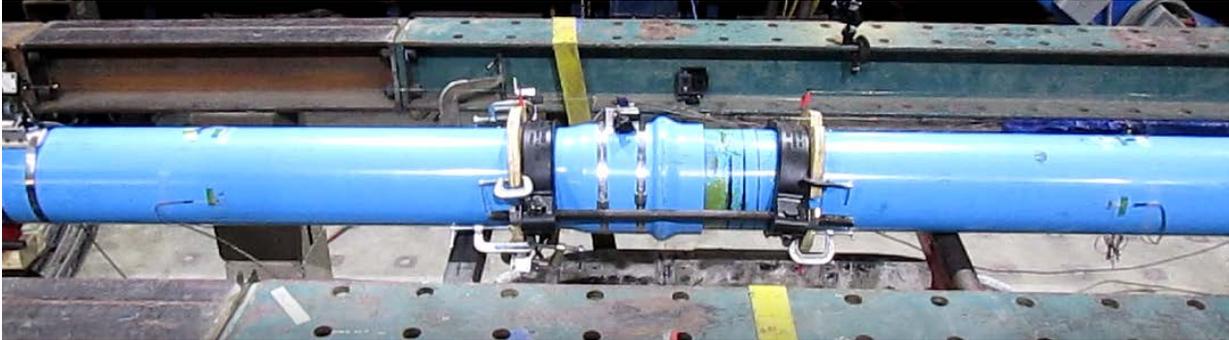
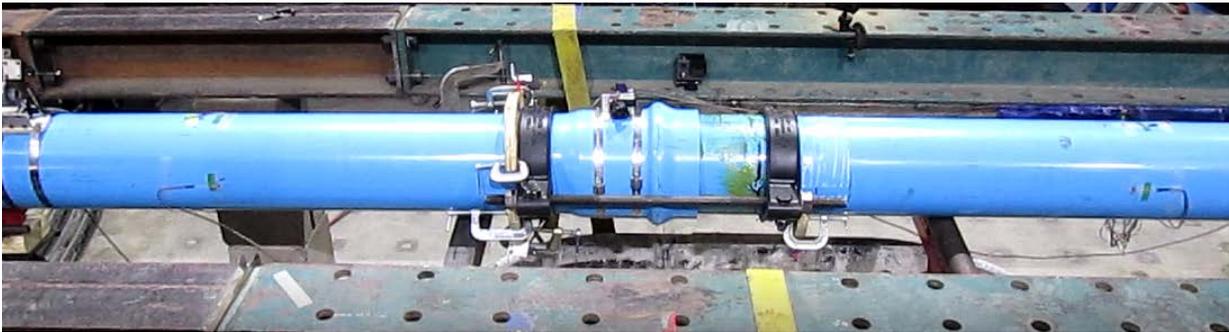
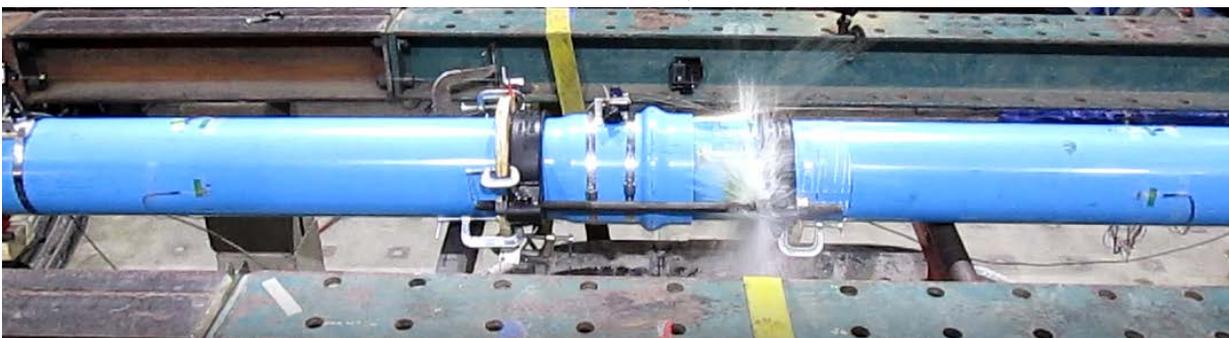
(a) Start of TT2 test (note nuts provide approx. 1.8 in. (47 mm) of pullout)

(b) Just before first ratcheting event (note bending of black restraints)

(c) After several ratcheting events, just before leakage (note scarring of pipe on the right side of the south restraint)

(d) Leakage of joint

Figure 2.8 provides a series of images captured from video of the tension test. Figure 2.8 (b) shows an image of the specimen just before the first load drop, where rotation of the restraints is evident. This rotation promoted slippage at the interface between the pipe and restraint. While indentations

of the pipe wall were visible on the right side of the south restraint, as shown in Figure 2.8(c), neither leakage nor rupture occurred until the last increment of slippage.

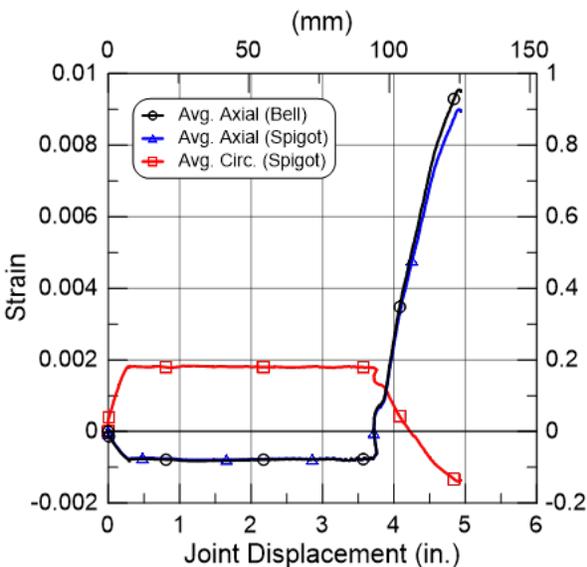
Figure 2.9. TT1 bell and spigot strains

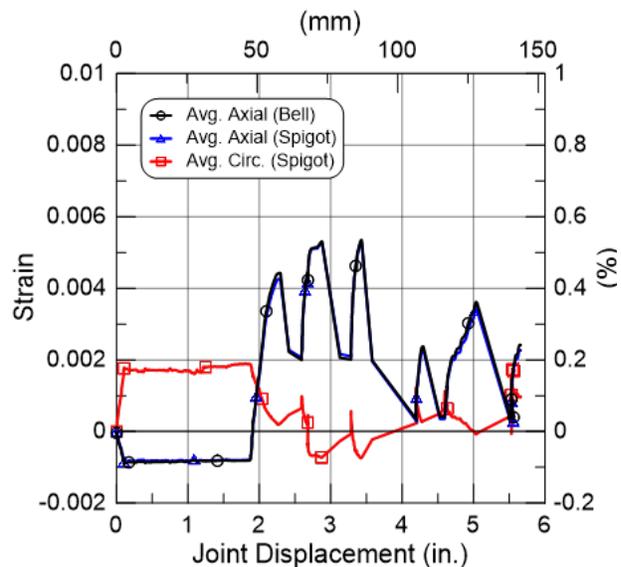
Figure 2.10. TT2 bell and spigot strains

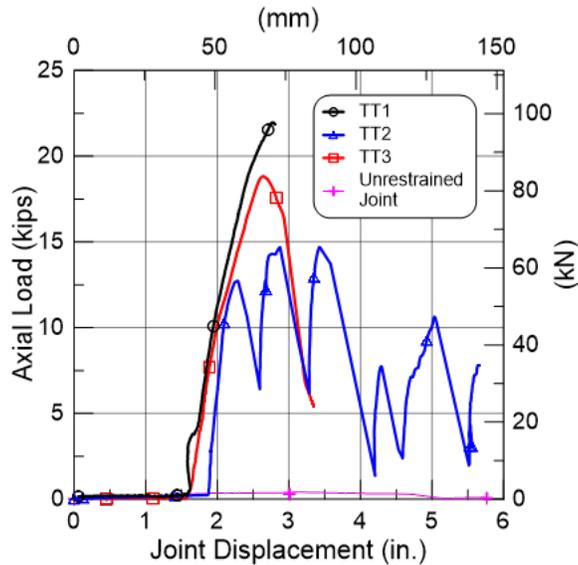
Figure 2.11. Comparison of tension tests TT1, TT2, and TT3 and unrestrained pullout

Comparisons between the two pressurized tension tests are shown in Figure 2.11. The figure also includes results from an unrestrained joint opening test and an unpressurized axial pull test (TT3) with red 1559 restraints. The unpressurized test was performed to show the axial performance of the pipe without internal water pressure. The results from the unrestrained test show the maximum

axial displacement capacity from a fully inserted position. Without a joint restraint, the previously tested Bionax joint had 3.9 in. (99 mm) of available axial displacement before leakage from pullout. Testing of the Bionax SR without joint restraint demonstrated that the joint has a maximum stroke of 5.9 in. (150 mm) before leakage from a fully inserted position.

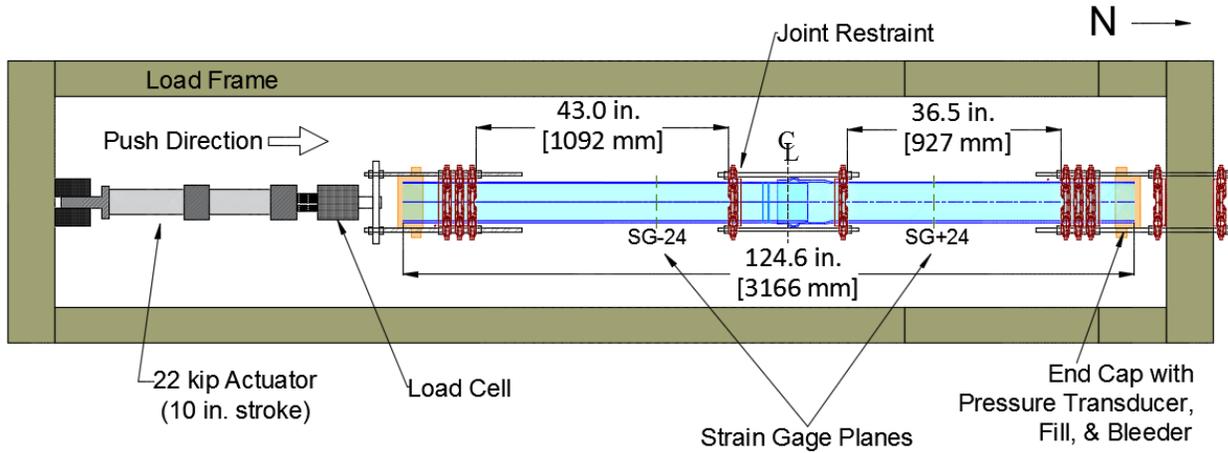
Figure 3.1. Plan view of compression test specimen

A total of 12 strain gages were fixed to the exterior of the specimen on two designated planes: SG-24 and SG+24, as shown in Figure 3.1. For each plane, the gages were located at the crown, invert, and east and west springlines. Gage plane SG+24 was positioned on the bell section of the pipe 24 in. (610 mm) north of the specimen's center, as shown in Figure 3.1. This plane included four gages oriented in the axial direction. Plane SG-24 was positioned on the spigot section of pipe 24 in. (610 mm) south of the joint center. It included four gages oriented in both the axial and circumferential directions.

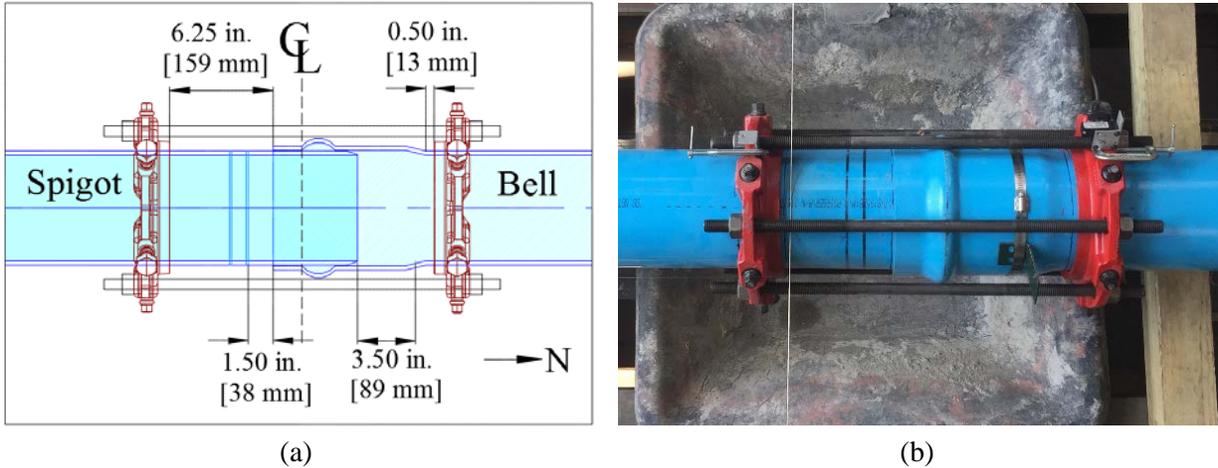
Figure 3.2. Composite of (a) plan view and (b) photo of compression test joint initial condition

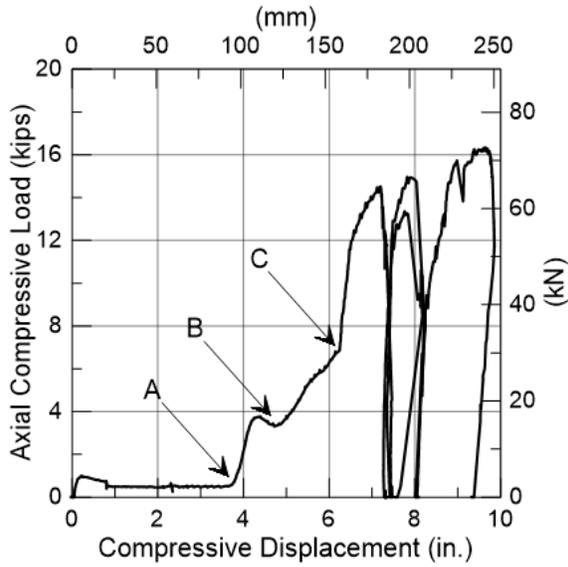
Figure 3.3. Axial compressive load vs. joint displacement for compression test

Figure 3.3 shows several changes in axial response during the first loading sequence, identified by letters A through C in the figure. At 3.5 in. (90 mm) of joint closure (point A) the spigot makes contact with the inside of the bell. At approximately 4.6 in. (115 mm) (point B) the spigot reaches the collar of the bell restraint, requiring greater axial force to displace past this location. At 6.25 in. (160 mm) (point C) the spigot restraint makes contact with the bell face (refer to Figure 3.2(a)). At this point, the spigot begins to move relative to the spigot restraint, increasing the joint closure while the restraints remain at a constant spacing. Despite some minor striations on the spigot outer wall, significant damage to the pipe did not occur as a result of this relative displacement.

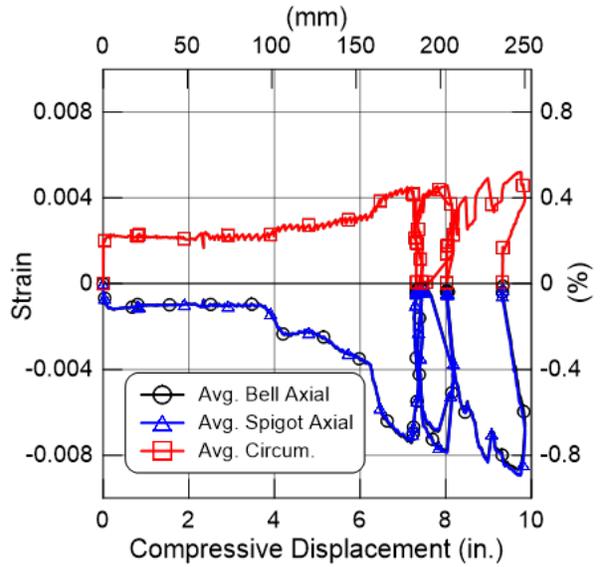
Figure 3.4. Pipe strains at north (bell) and south (spigot) gage planes

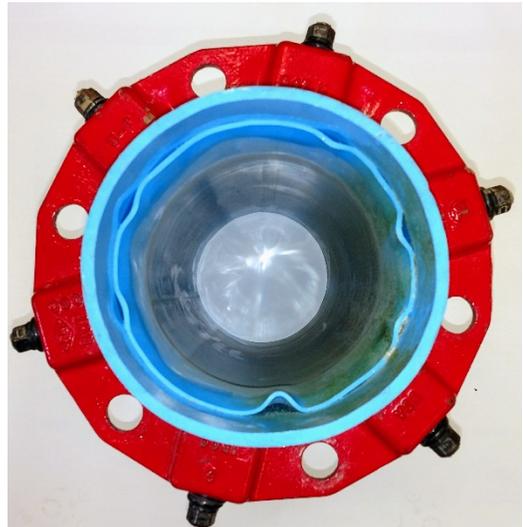
Figure 3.5. Post-test images of (a) joint profile and (b) cross-section cut of pipe showing wrinkling of spigot

Figure 3.5 provides photos of the pipe specimen after testing. A comparison between Figure 3.2(b) and Figure 3.5(a) shows that the restraining collar on the bell side of the joint remained relatively stationary. Following the test, the bell was cut to provide the cross-sectional view of the joint in Figure 3.5(b). As the spigot was pushed under compressive load past the bell side collar, wrinkling around the pipe resulted in a reduction of the spigot diameter. This reduction in diameter allowed

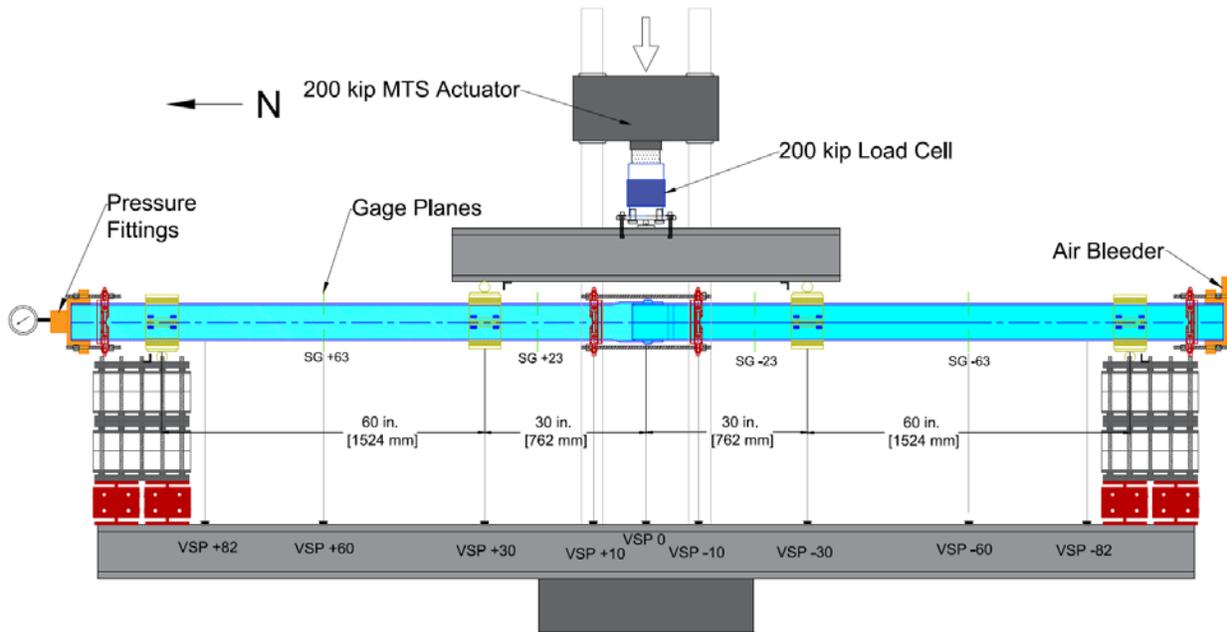
Figure 4.1. Bending test specimen showing string potentiometer locations

Also shown in Figure 4.1 are the nine string potentiometers (string pots) used to measure vertical displacements along the specimen. String pots were fixed between the frame and the invert of the specimen at equal distances of 10, 30, 60, and 82 in. (250, 760, 1520, and 2080 mm) either side of the centerline of the test setup to measure vertical displacement. Each string pot location is labeled with respect to distance; e.g., VSP-30 was located at 30 in. (760 mm) to the right of the test centerline in Figure 4.1. Two additional string pots were attached at the crown and invert horizontally spanning the joint to provide a measure of joint rotation (or deflection). The instrument locations and names are listed in Table 4.1.

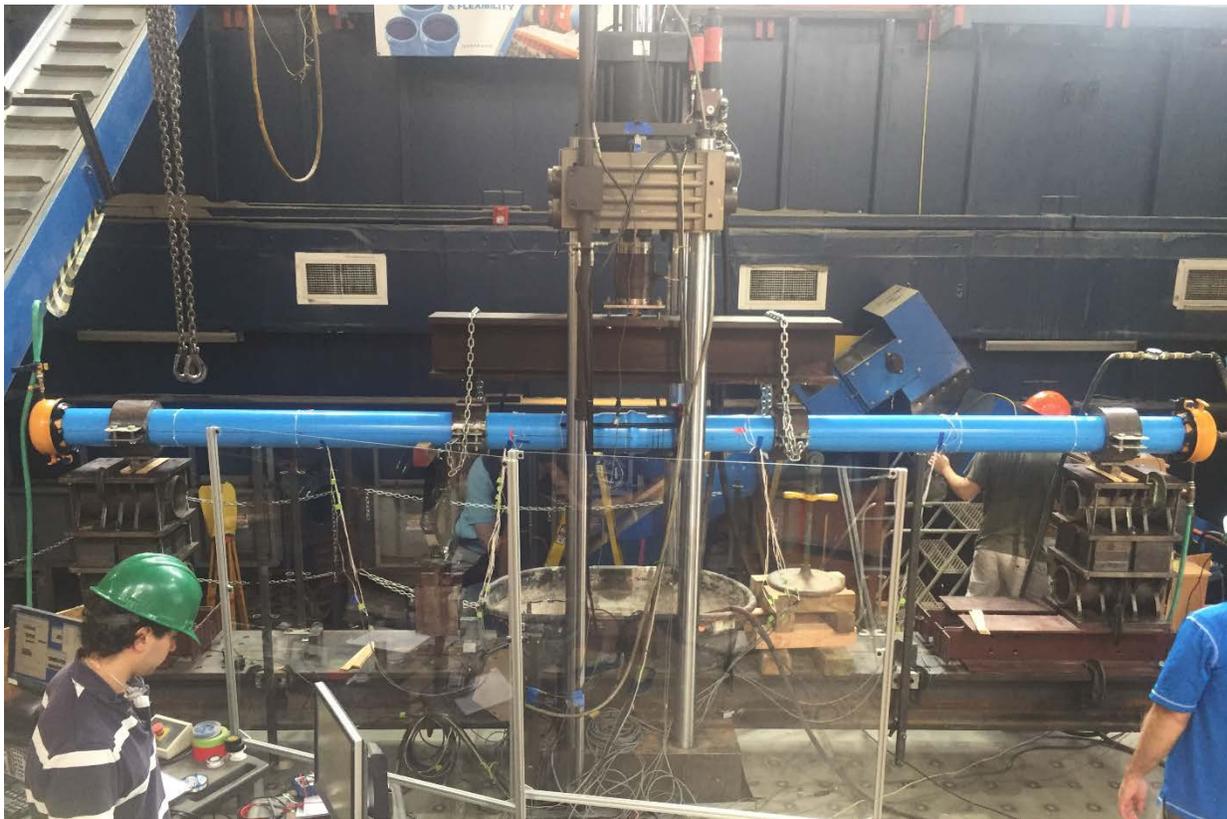
Figure 4.2. Profile view of four-point bending test

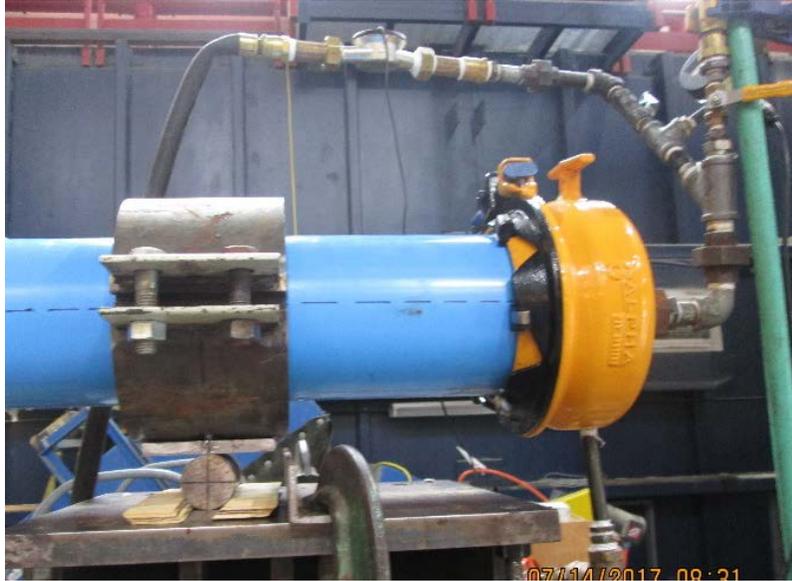
Figure 4.3. Support saddle and roller for bending tests

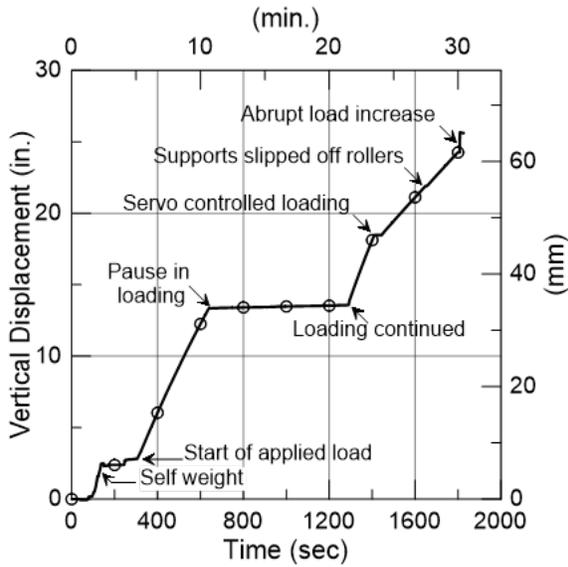
Figure 4.4. Vertical displacement at loading points vs. time

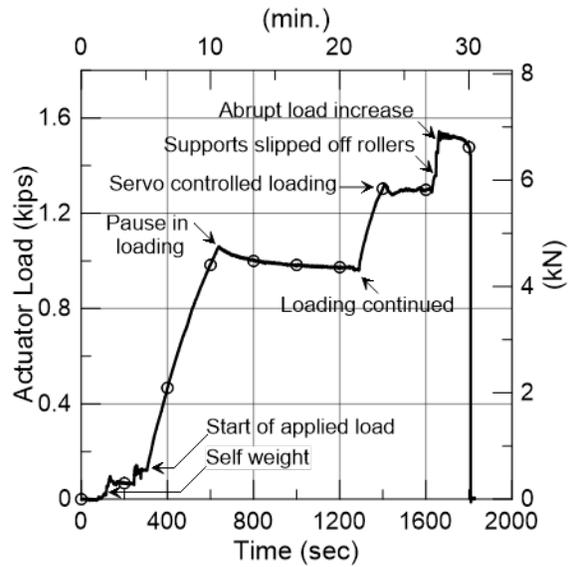
Figure 4.5. Actuator load vs. time

At $t = 1650$ seconds, an abrupt increase in actuator load from 1.3 kips (5.8 kN) to 1.5 kips (6.7 kN) is shown in Figure 4.5. This change in load occurred when the north and south support saddles slipped from their supporting rollers. The test specimen remained stable and loading was continued without pausing. It should be noted that, after this point in the test sequence [vertical displacement equal to 22 in. (560 mm)], the north and south support points were not able to move laterally, thus altering the test boundary conditions.

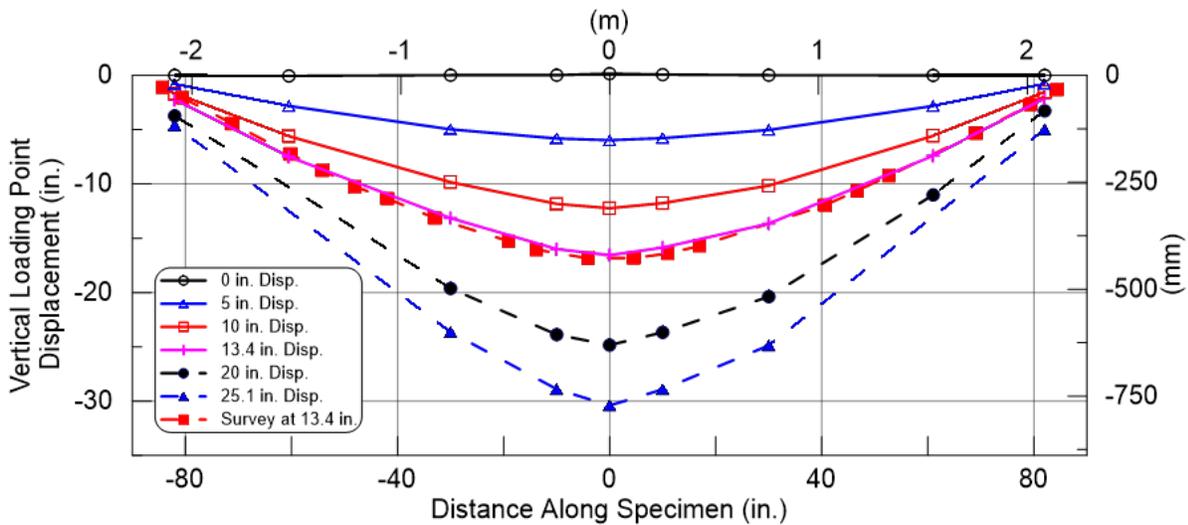
Figure 4.6. Vertical displacements along the pipe specimen for various vertical load point displacements

Figure 4.6 shows the vertical spring pot (VSP) displacements measured along the pipe at six increments of imposed displacement. The figure shows good agreement between string pots positioned at equal distances on either side of the test centerline. Note that VSP+60 and VSP-60 reached the end of their measurement strokes at about 20 in. (508 mm). Also shown in the figure are survey measurements, taken with a total station instrument, along the springline of the specimen during the pause at 13.4 in. (340 mm) of applied vertical displacement. These survey measurements are in excellent agreement with the string pot measurements.

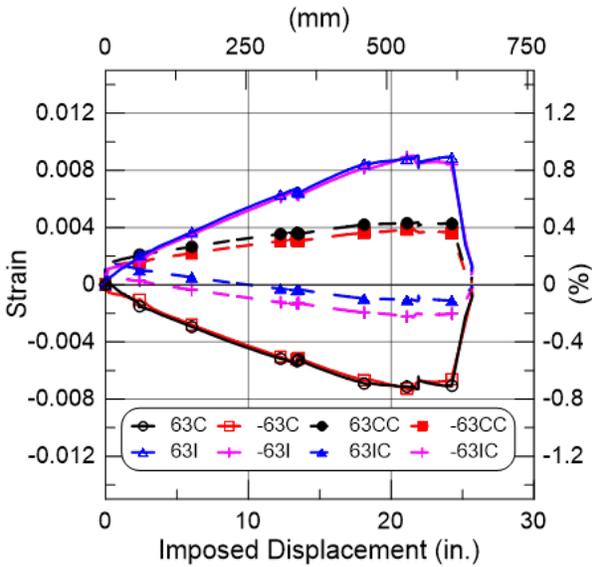
Figure 4.7. Axial and circumferential strains at the crown and invert for planes SG+63 and SG-63

Strains were measured at four planes along the bending test specimen. Figure 4.7 shows the axial and circumferential strain gages measurements at the crown and invert of the specimen for strain gage planes SG+63 and SG-63. These planes are positioned approximately halfway between the loading and support points along the barrel of the pipe, as shown in Figure 4.1. The figure demonstrates the symmetry and consistency in measurements among gages placed at equal

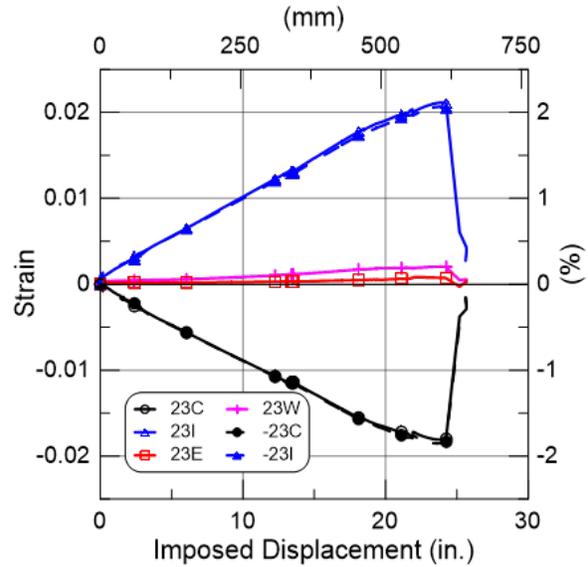
Figure 4.8. Axial strains at the specimen crown, invert, and springlines for planes SG+23 and SG-23

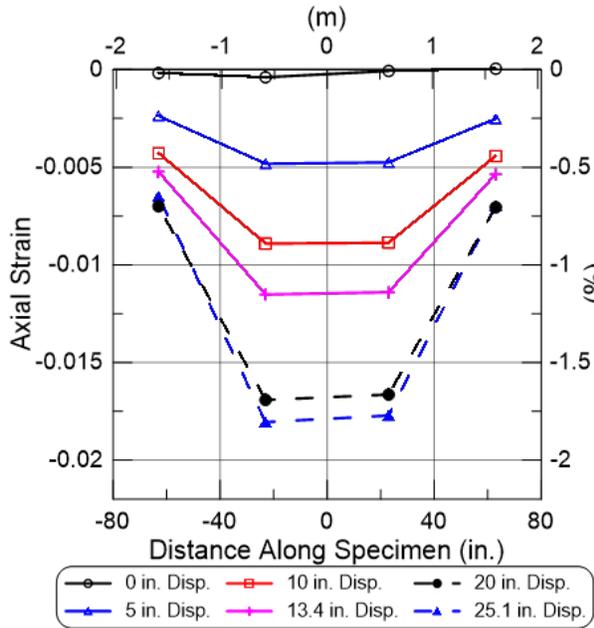
Figure 4.9. Crown strain at various levels of loading point vertical displacement

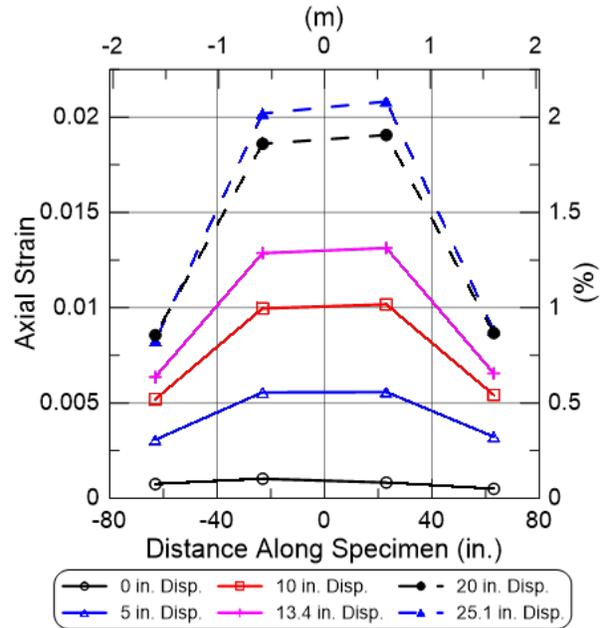
Figure 4.10. Invert strain at various levels of loading point vertical displacement

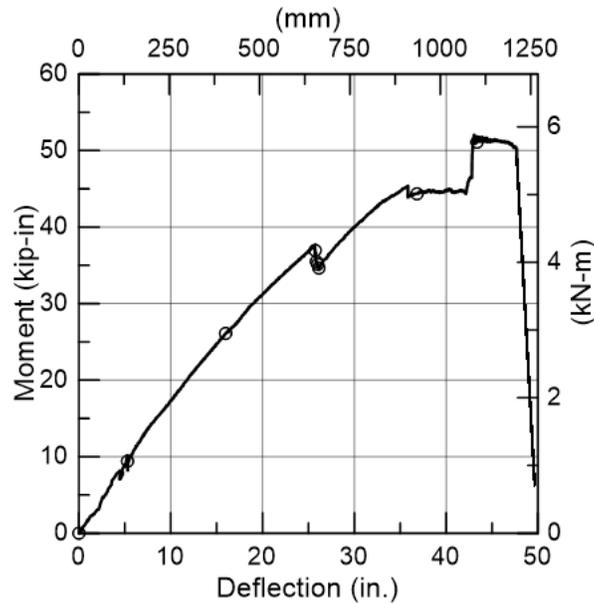
Figure 4.11. Applied moment vs. specimen deflection

The moment-rotation response of the restrained joint is provided in Figure 4.11. Rotation (or deflection) of the specimen is calculated simply as the arcsine of vertical displacement at VSP-30 or VSP+30 divided by the distance along the pipe from the end support to the vertical loading

The moment-rotation relationship in Figure 4.11 increases at an approximately linear rate until about 25 degrees. After the pause in loading at 25 degrees, the slope of the moment versus rotation plot decreases until approximately 43 degrees. At this rotation the support points slipped, as

previously discussed, disrupting the boundary conditions of the test. At 43 degrees the maximum moment spikes at 52 kip-in. (5.9 kN-m), after which failure of the bending test specimen occurred at 47.5 degrees.

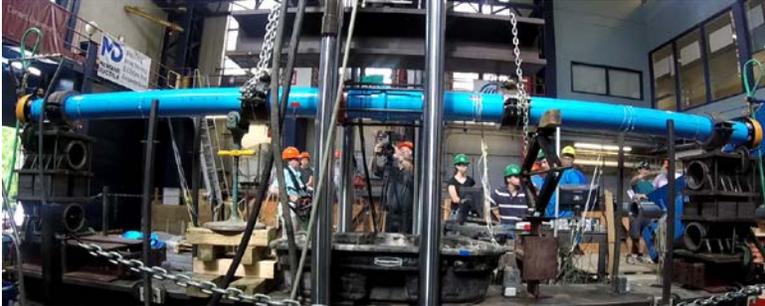
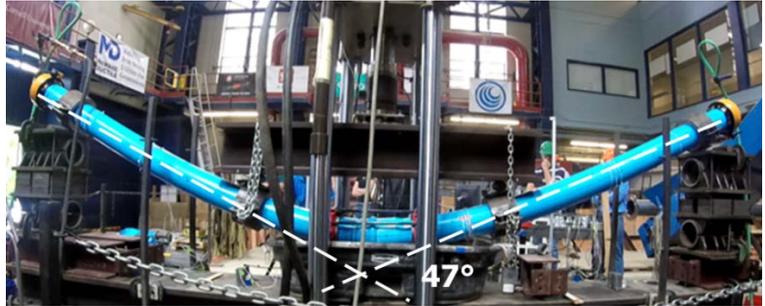
(a) Initial position

(d) 25 in. (635 mm), just before failure

Figure 4.12. Restrained joint at several levels of imposed bending deformation

Figure 4.12 shows a sequence of photos of the test specimen before, during, and following the four-point bending test, including pipeline deformation at applied vertical displacements of the pipeline centerline of 13.4 in. (340 mm), 18.5 in. (470 mm), and maximum of 25 in. (635 mm), just before pipe failure. It should be recognized that there is some distortion in the photos due to the fisheye effect of the camera lens. Nevertheless, this sequence of photos shows the remarkable degree of deflection that the pipeline was able to sustain before failure. A relative rotation of 47 degrees is shown in Figure 4.12d, consistent with the largest deformation attained by the test specimen. This photo provides an illustration of how the relative rotation, as described previously in Section 4.4.3, is defined.

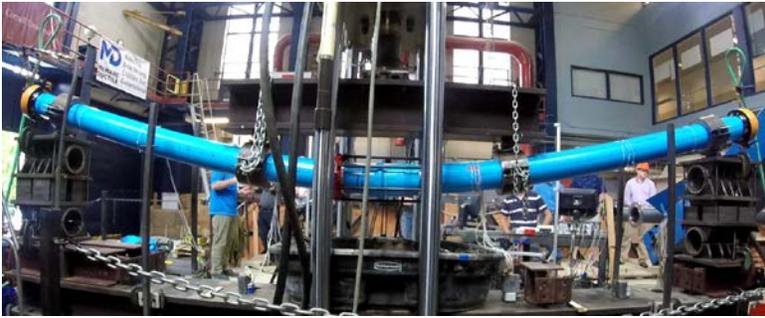
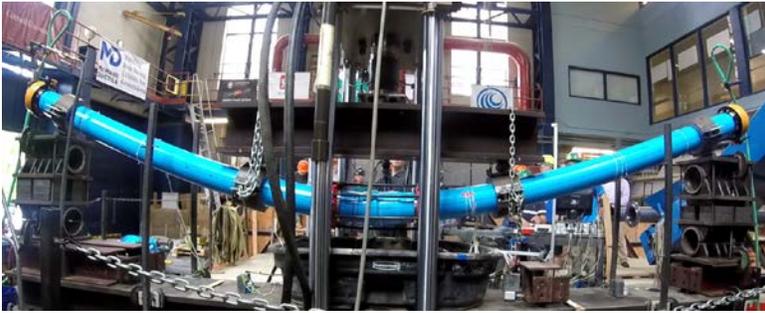
(b) 13.4 in. (340 mm) vertical displacement

(c) 18.5 in. (470 mm) vertical displacement (beginning of servo control)

Figure 4.13. Restrained joint bending test failure

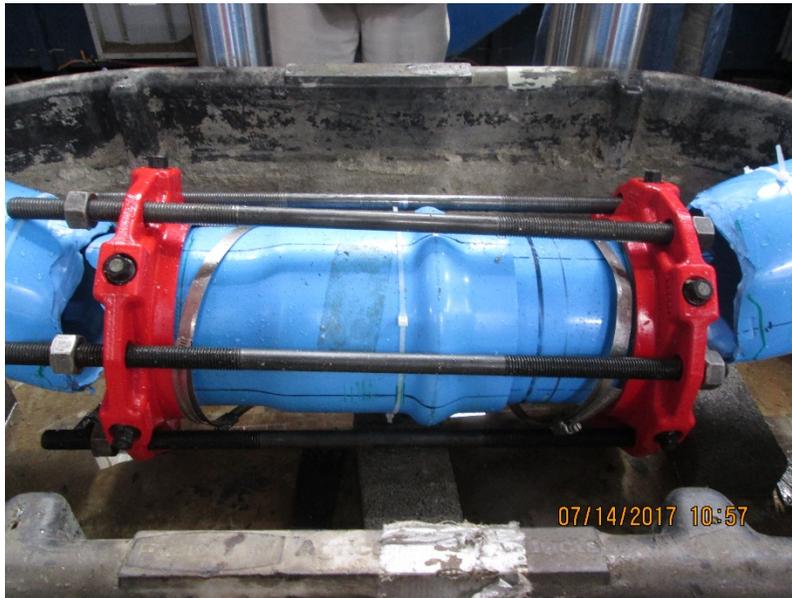
Figure 4.14. Failure of specimen at both the north and south restraints

the restraining collars. Full circumferential failures at both sides of the pipe just outside the restraints are visible in the photo.

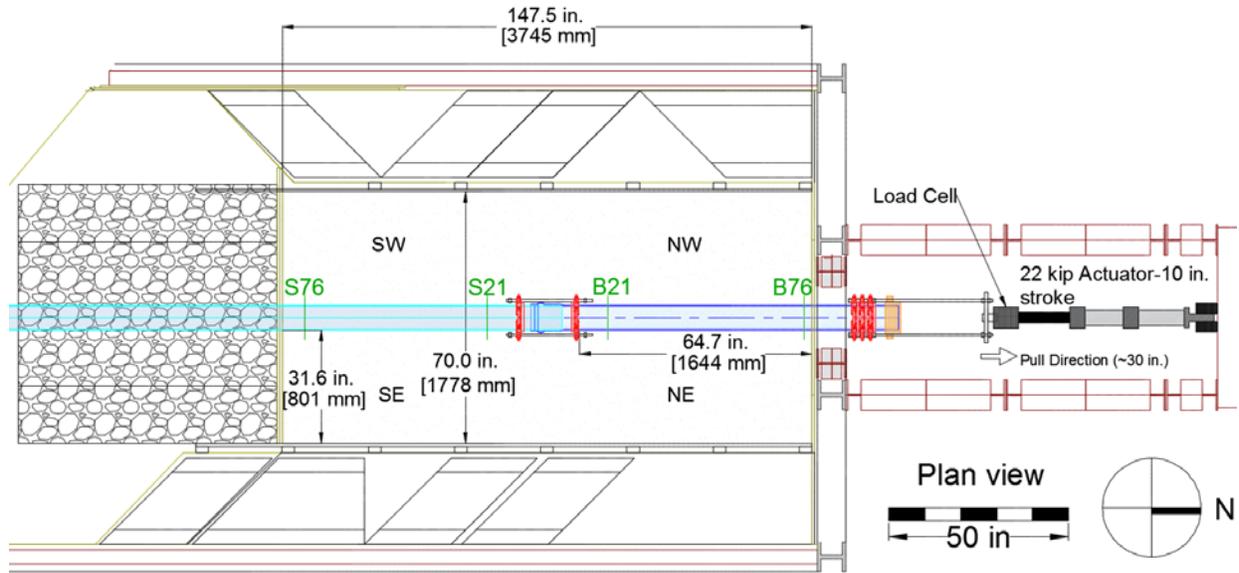
Figure 5.1 Plan view of pull through specimen including approximate locations of nuclear densitometer and moisture content measurements

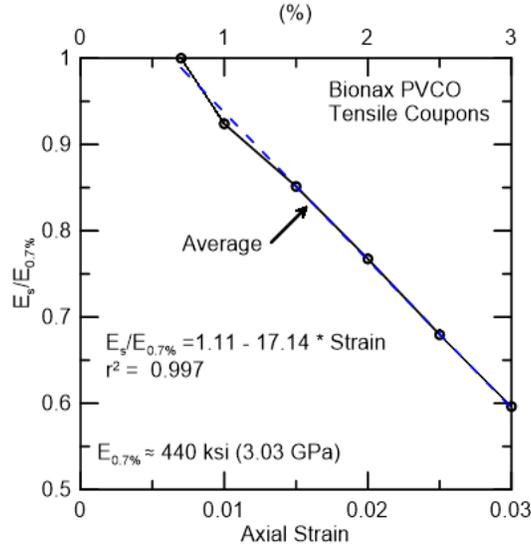
Figure 5.3. Ratio of axial secant modulus to elastic modulus vs. axial strain

The axial pull tests mobilized strains exceeding 1% in the pipe, thus deforming the PVCO into the range of nonlinear stress vs strain behavior. To determine the force in the pipe at the strain gage planes, it is necessary to use the axial secant modulus of the PVCO that is compatible with the axial strain mobilized in the pipe during the time of measurement. Using stress versus strain data from tensile coupon tests previously performed for IPEX (Stewart et al., 2013a), the ratio of axial secant modulus to initial elastic modulus is plotted as a function of axial strain in Figure 5.3. Please note that at 1% strain, or 0.01, the figure shows about a 10% decline relative to the initial modulus associated with very low levels of strain.

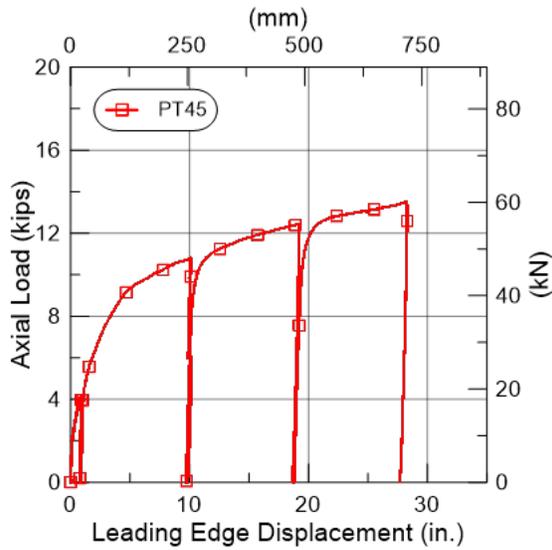
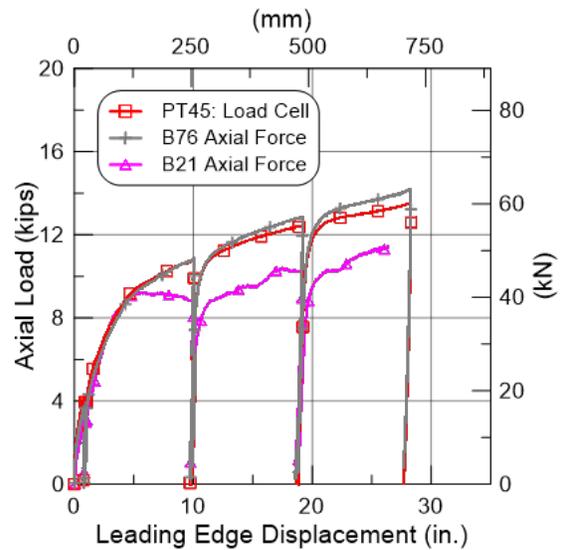
(a) Actuator load

(b) Load cell and strain gage loads

Figure 5.4. PT45 axial load vs. displacement plot for actuator, load cell, and strain gage loads

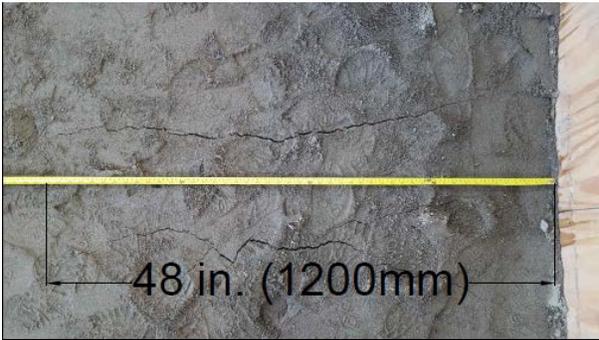
Figure 5.5. Soil surface cracking adjacent to north wall for PT45

Figure 5.5 shows a photo of the minor to moderate cracking at the ground surface during this test. Such tensile cracking indicates that some volume expansion and shear distortion were transferred to the surface as the restrained pipe joint was pulled through the soil.

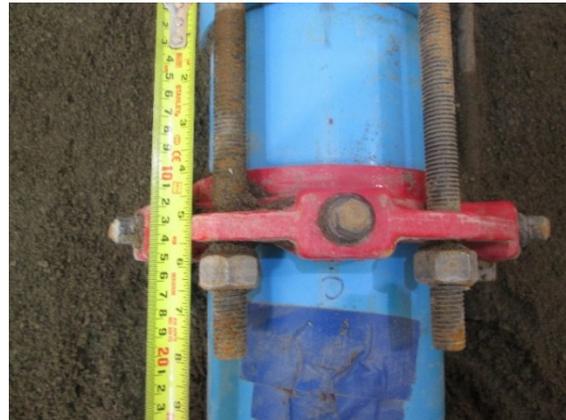
Figure 5.6. Photo of sand lodged between nuts and collar of the joint restraint

restraint collar that was exposed when soil over the pipe was excavated after the pull test. Sand had lodged between the nuts and restraining collar along the rods, thereby preventing the full 2.5 in. (64 mm) of joint opening.

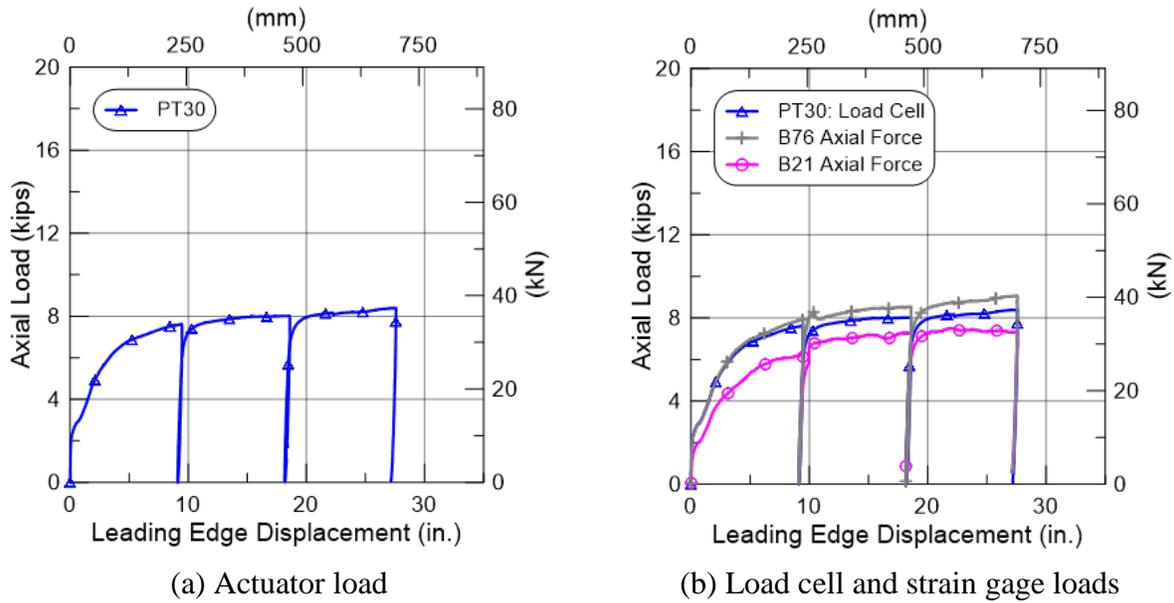
Figure 5.7. PT30 axial load vs. displacement plot for actuator, load cell, and strain gage loads
