Performance Evaluation of Bionax SR PVCO Pipeline with Extended Bell Joints under Earthquake-Induced Ground Deformation

Cornell University
School of Civil and Environmental Engineering
Cornell University
Hollister Hall
Ithaca, NY 14853
December, 2017

This report is submitted to the IPEX Group (herein referred to as IPEX). It presents results from a testing program to investigate the performance of 6-in. (150-mm)-diameter oriented polyvinyl chloride pipeline (commercially referred to as Bionax SR) with elongated bell-and-spigot restrained joints. The purpose of the testing is to evaluate the ability of the pipeline to accommodate axial and bending deformation and assess how pipelines composed of Bionax SR pipe with extended bell-and-spigot restrained joints respond to fault rupture, which not only represents surface faulting but also the most severe ground deformation that occurs along the margins of liquefaction-induced lateral spreads and landslides. The work was undertaken in the Cornell Large-Scale Lifelines Testing Facility, which is part of the Bovay Laboratory Complex at Cornell University.

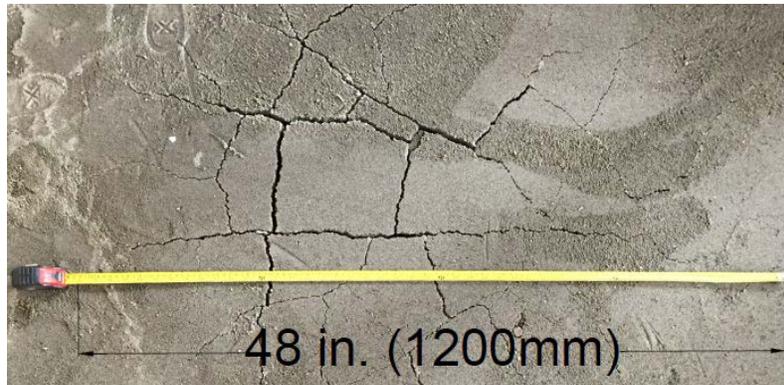
Figure 5.8. Soil surface cracking for PT30

Figure 5.8 provides a photo of the surface cracks that appeared during this test. The cracking was more severe for this test relative to Test 1 and reflects volume expansion and shear distortion that develops as the restrained pipe joint is pulled through the soil. The greater width and severity of surface cracks are related to the lower depth of cover for this test

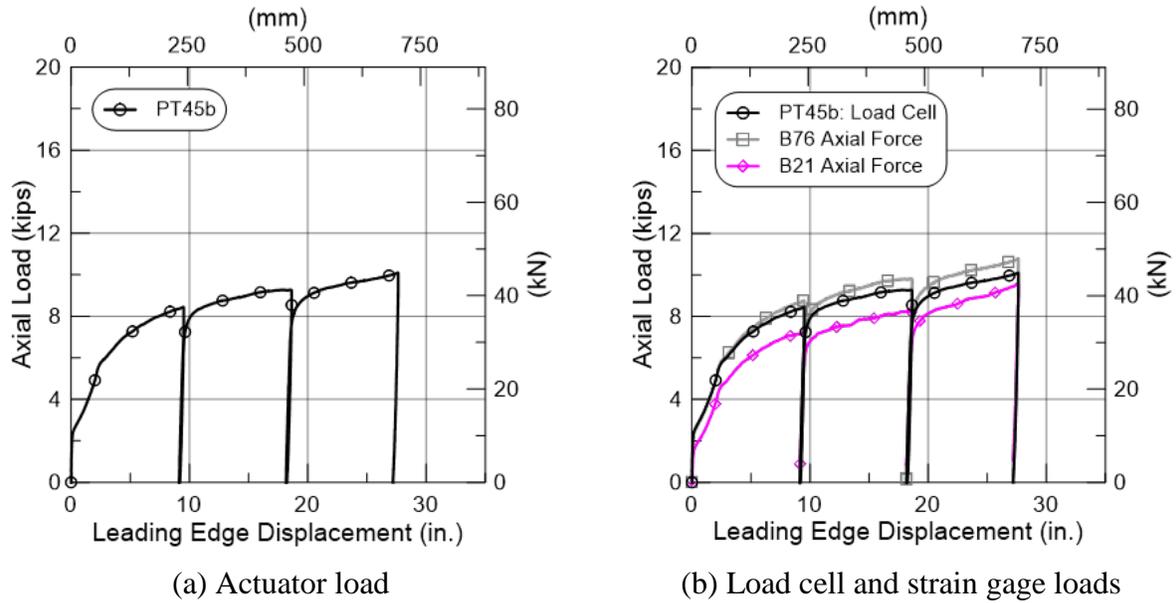
Figure 5.9. PT45b axial load vs. displacement plot for actuator, load cell, and strain gage loads

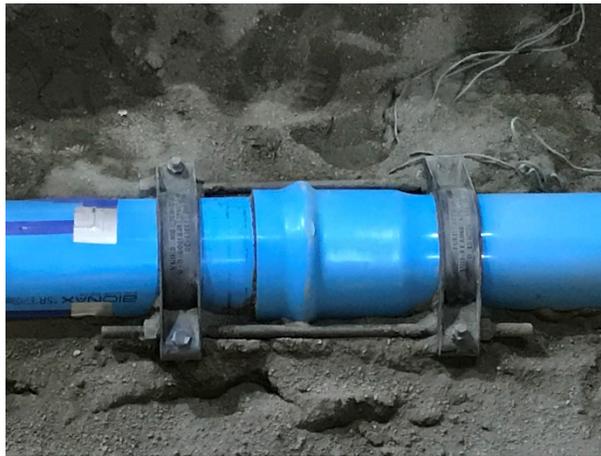
Figure 5.10. Joint opening post PT45b

The string pot measurements indicate that the joint opened a maximum distance of approximately 2.5 in. (54 mm) during the test, which compares well with the distance of 2.5 in. (64 mm) that was set at the beginning of the test. As shown in Figure 5.10, very little soil was observed between the face of the restraint and the nuts on the restraining rods. The 1309 restraint is equipped with only

two rods in comparison to the 1559 restraint with six rods. The smaller size and lower number of rods of the 1309 restraint reduces the opportunity for soil to become trapped between the nuts and restraint surface as the joint opens and the nuts make contact with the restraining collar.

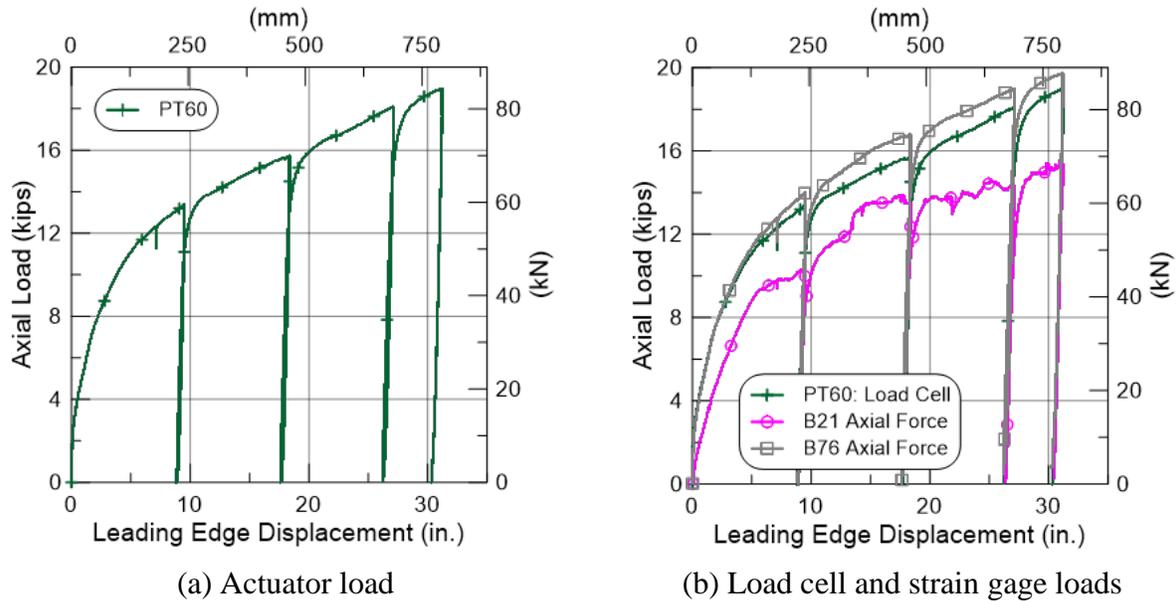
Figure 5.11. PT60 axial load vs. displacement plot for actuator, load cell, and strain gage loads

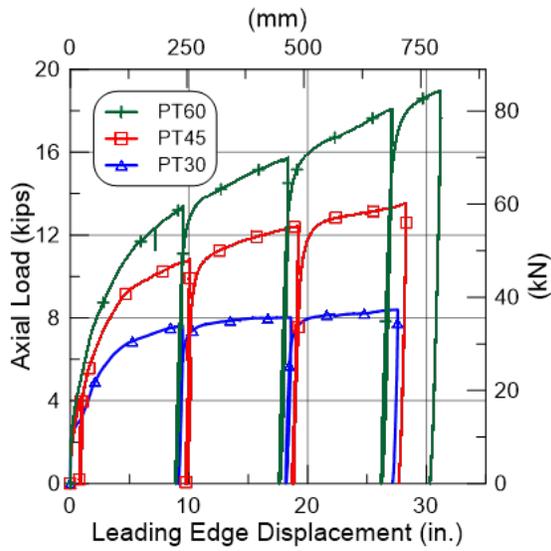
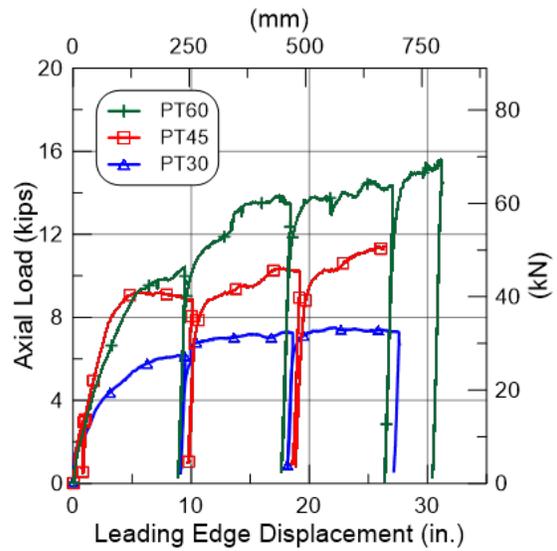
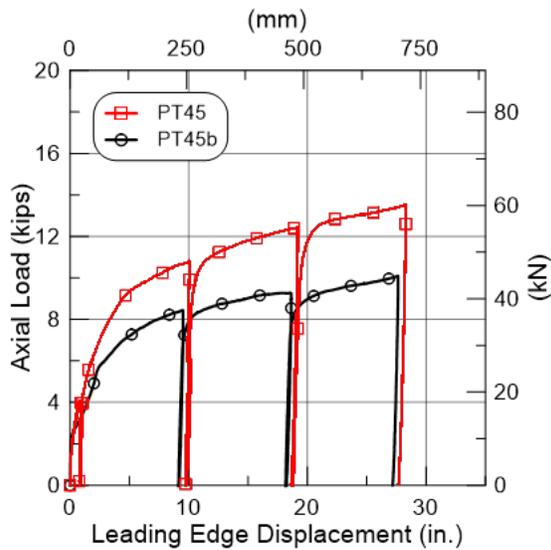
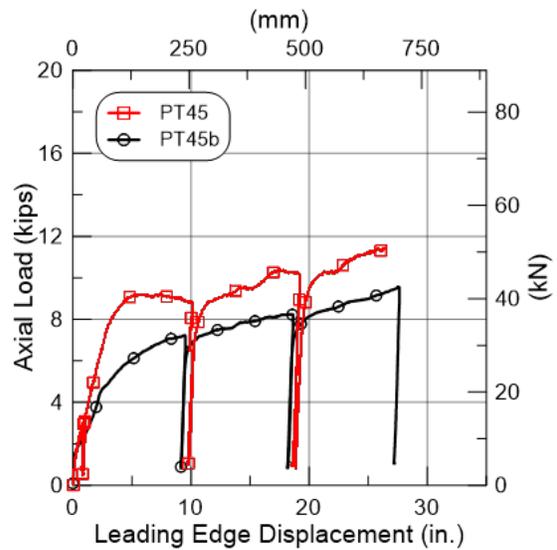
a) Actuator load vs. leading edge displacement for PT30, PT45 and PT60

b) B21 load vs. leading edge displacement for PT30, PT45 and PT60

c) Actuator load vs. leading edge displacement for PT45 and PT45b

d) B21 load vs. leading edge displacement for PT45 and PT45b

Figure 5.12. Comparison of axial load vs displacement measurements

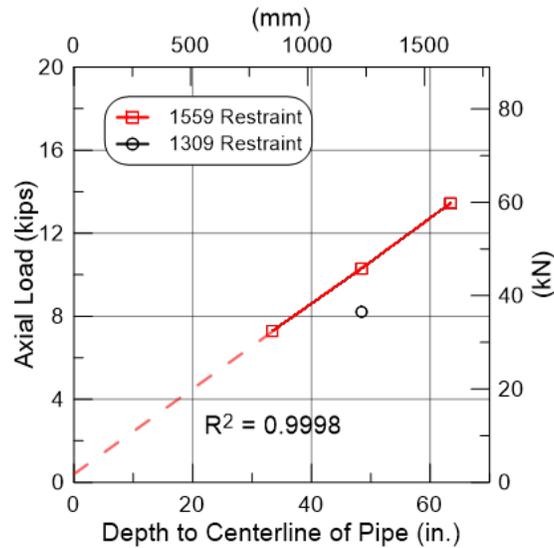
Figure 5.13. Axial load vs. depth to centerline of pipe

Figure 5.13 presents a plot of the B21 loads at 18 in. (460 mm) of displacement with respect to depth from the soil surface to centerline of pipe. These loads are approximately equal to the loads dropped across the restrained joints. A linear regression was fit to the data for pipes with the 1559 restraints at depths to pipe crown of 30, 45, and 60 in. (760, 1140, and 1520 mm). Although there are only three data points, the high coefficient of determination, $r^2 > 0.99$, provides confidence that the linear trend shown in the figure is statistically robust relative to the database. The linear regression has an intercept that is nearly zero, which is consistent with the axial resisting load mobilized by the restrained joint being directly proportional to depth, and thus the vertical confining stress provided by the soil. The single data point for the test involving the 1309 restraint is also shown on the plot. If a similar trend is inferred for the 1309 restraint, the axial resistance of pipe joints with 1309 restraints is expected to be 80% of the axial resistance of pipe joints with 1559 restraints at all depths in granular soil of similar density and strength.

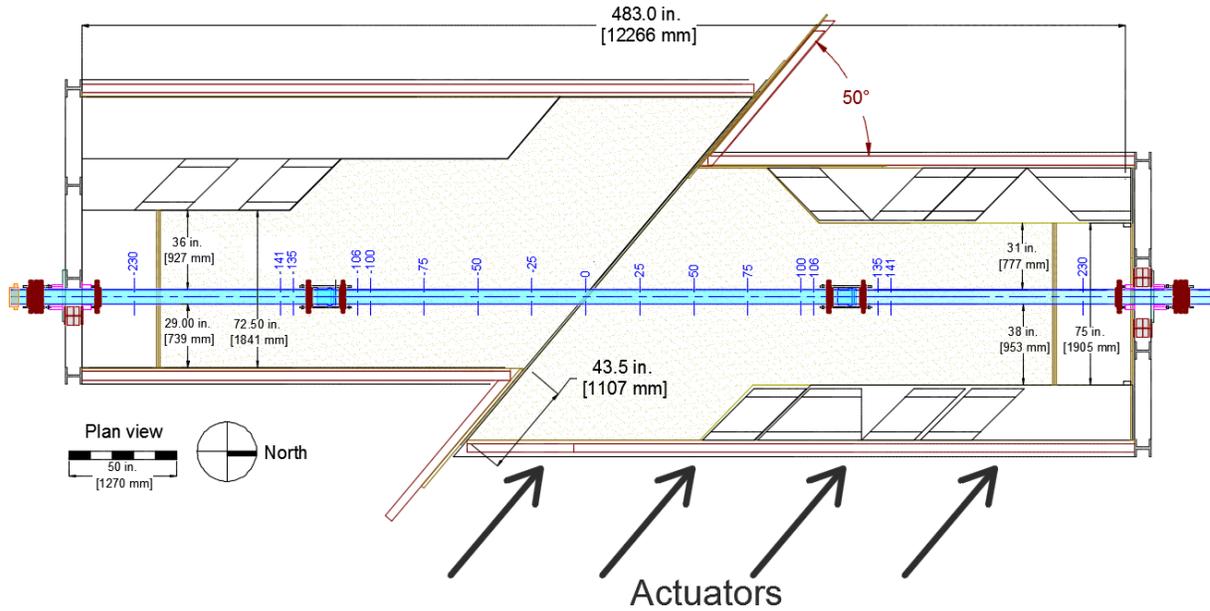
Figure 6.1. Plan view of split basin prior to fault rupture test

As presented in Figure 6.1, a total pipeline length of 34.4 ft (10.5 m) was buried in soil. The total pipeline length from the north to south inside walls of the test basin was 40.3 ft (12.3 m). The ends of the pipe were fixed to each end of the split basin to limit axial displacement or translation, representing worst-case loading conditions. Wooden retaining walls were located near the ends of the pipeline to allow access to instruments and end restraints. The pipe was pressurized with water

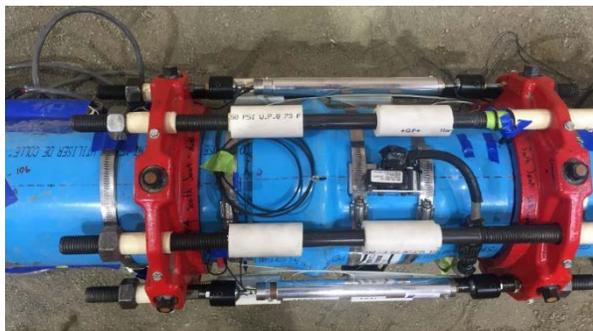
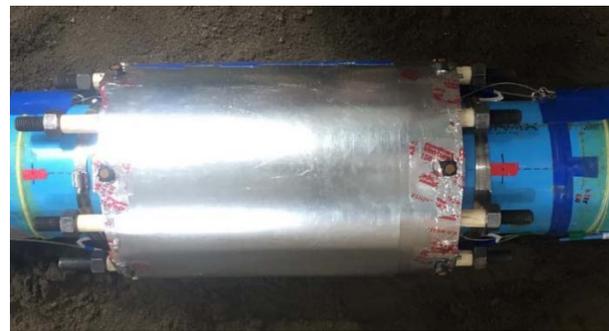
Figure 6.2. Joint instrumentation (a) before and (b) after installation of joint shield

Four calibrated load cells were positioned at each end of the test basin to measure axial load. Table 6.2 provides the locations and the labeling of the load cells. Three string potentiometers (string pots) were installed at each joint to measure pullout displacement and rotation. The string pot measurement system was protected by a joint shield composed of sheet metal that enclosed the joint. Figure 6.2 shows photos of the joint instrumentation and the protective metal enclosure.

A photo of the instrumented joint prior to burial is provided in Figure 6.2, and a drawing of the initial joint configuration is provided in Figure 6.8. The joint opening recorded by three string potentiometers located within shields at the south and north joints is shown in Figure 6.9. Excellent

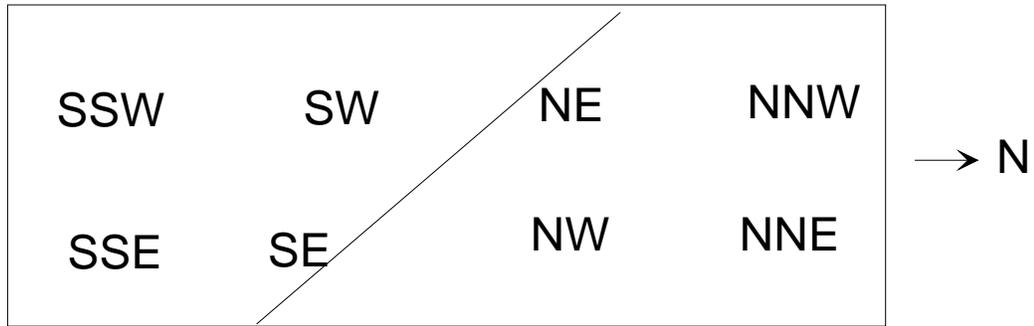
Figure 6.3. Plan view of locations for compaction measurements

Eight measurements of dry unit weight and moisture content were made for each soil lift. Figure 6.3 shows the approximate location of each measurement location. There were four measurement

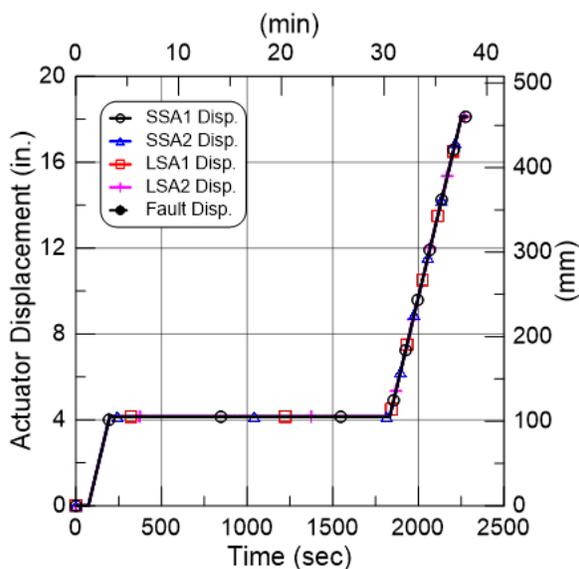
Figure 6.4. Actuator Displacement vs. Time

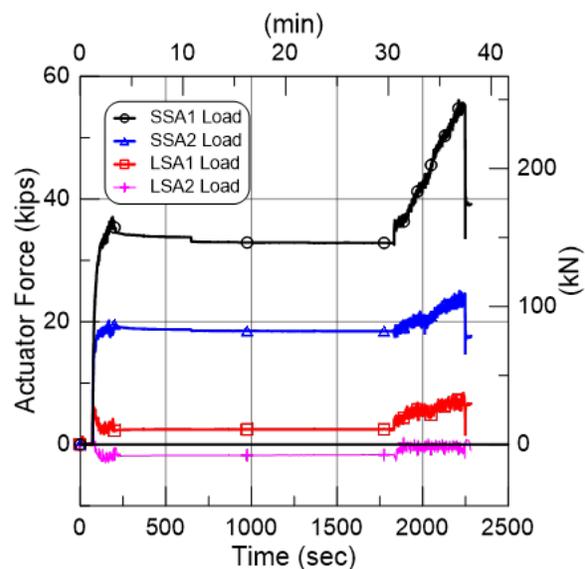
Figure 6.5. Actuator Force vs. Time

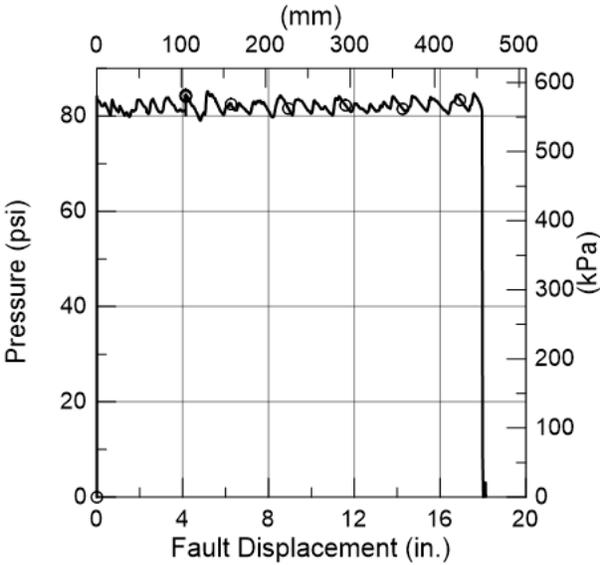
Figure 6.6. Internal water pressure vs. fault displacement

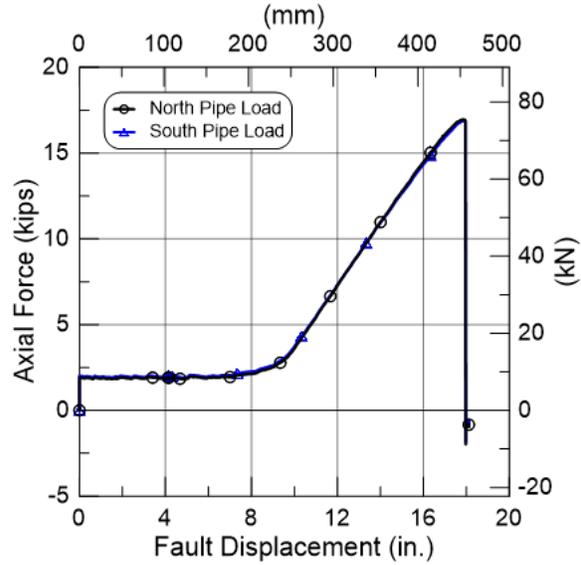
Figure 6.7. Measured north and south end axial force

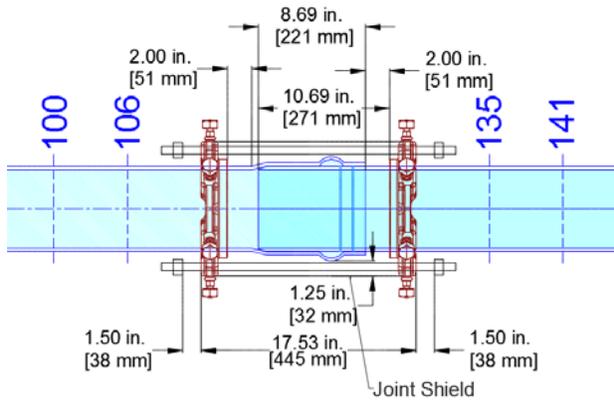
Figure 6.8. Initial conditions of restrained joint

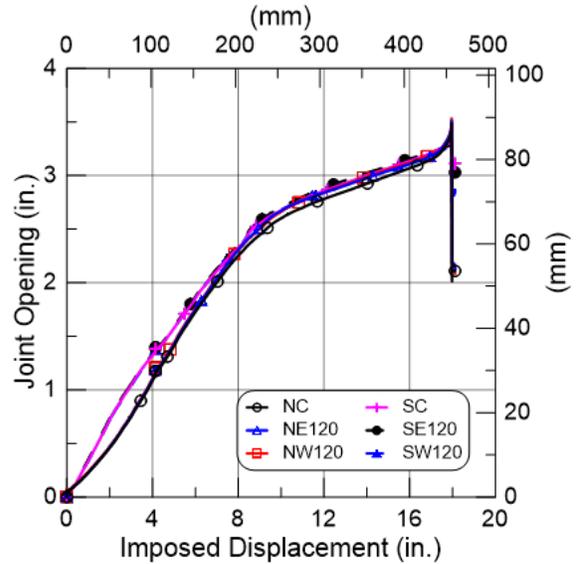
Figure 6.9. Joint opening displacement for both joints relative to fault displacement

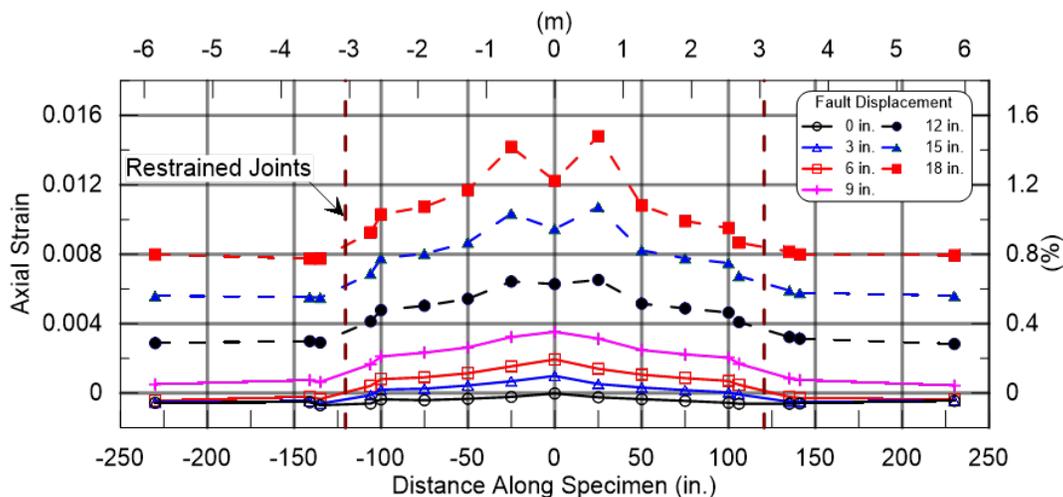
Figure 6.10. Evolution of average axial strains along pipeline at various magnitudes of fault movement

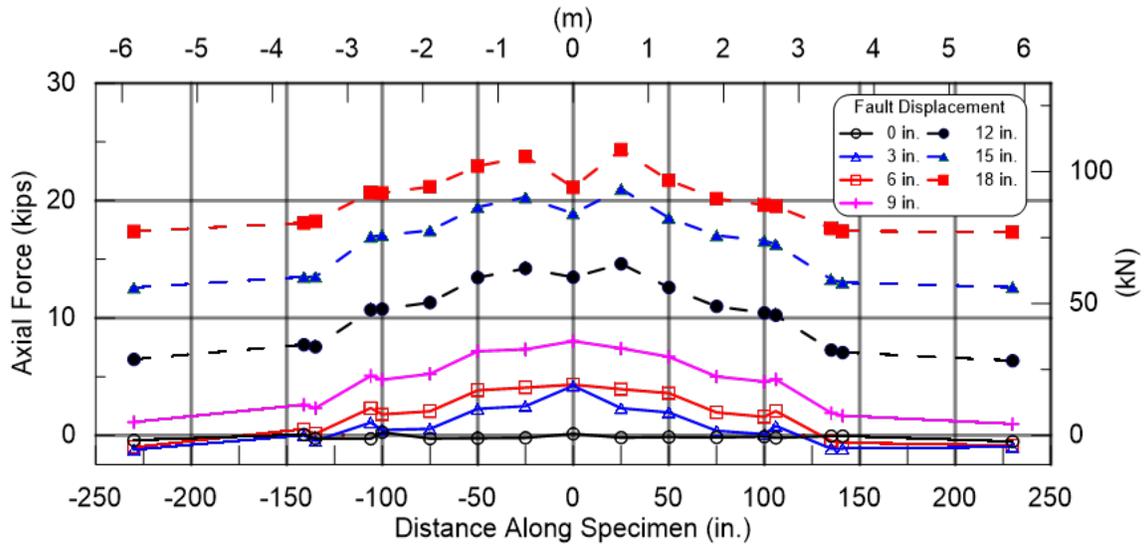
Figure 6.11. Evolution of average axial force along pipeline at various magnitudes of fault movement

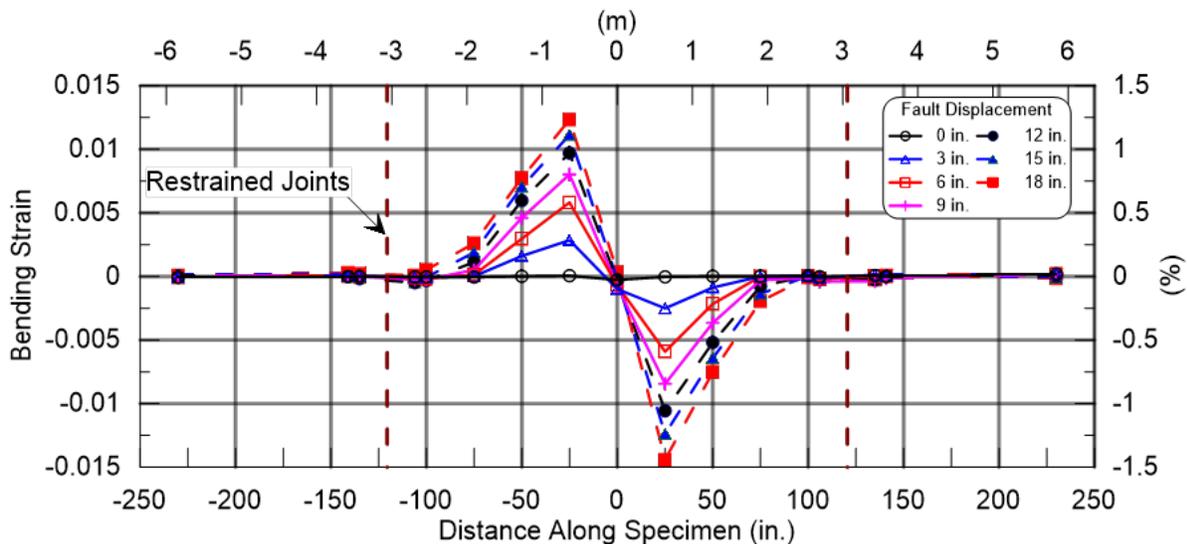
Figure 6.12. Evolution of bending strains along the specimen at various levels of fault rupture

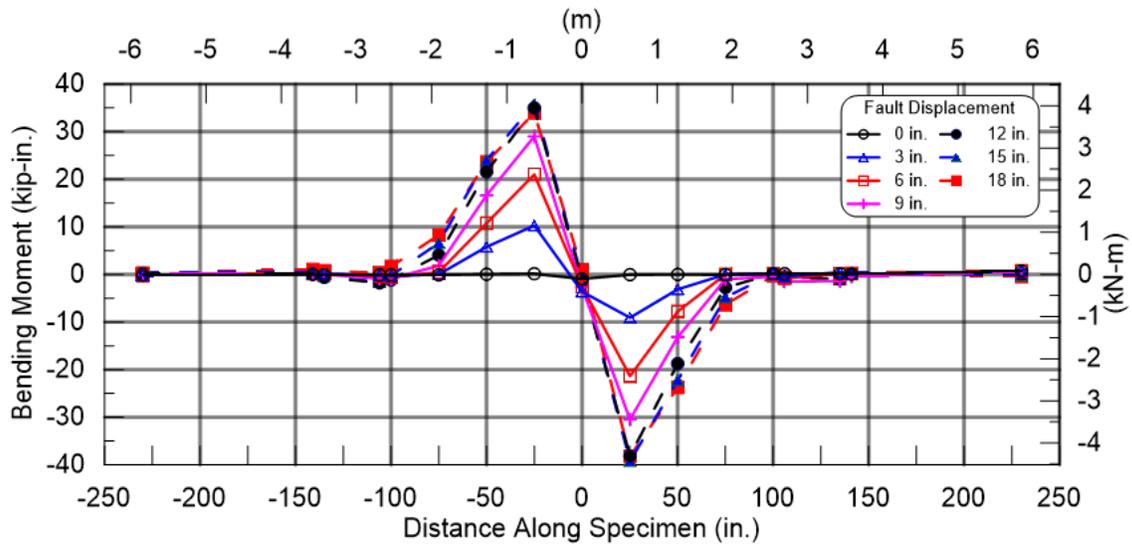
Figure 6.13. Evolution of bending moment along pipeline at various magnitudes of fault movement

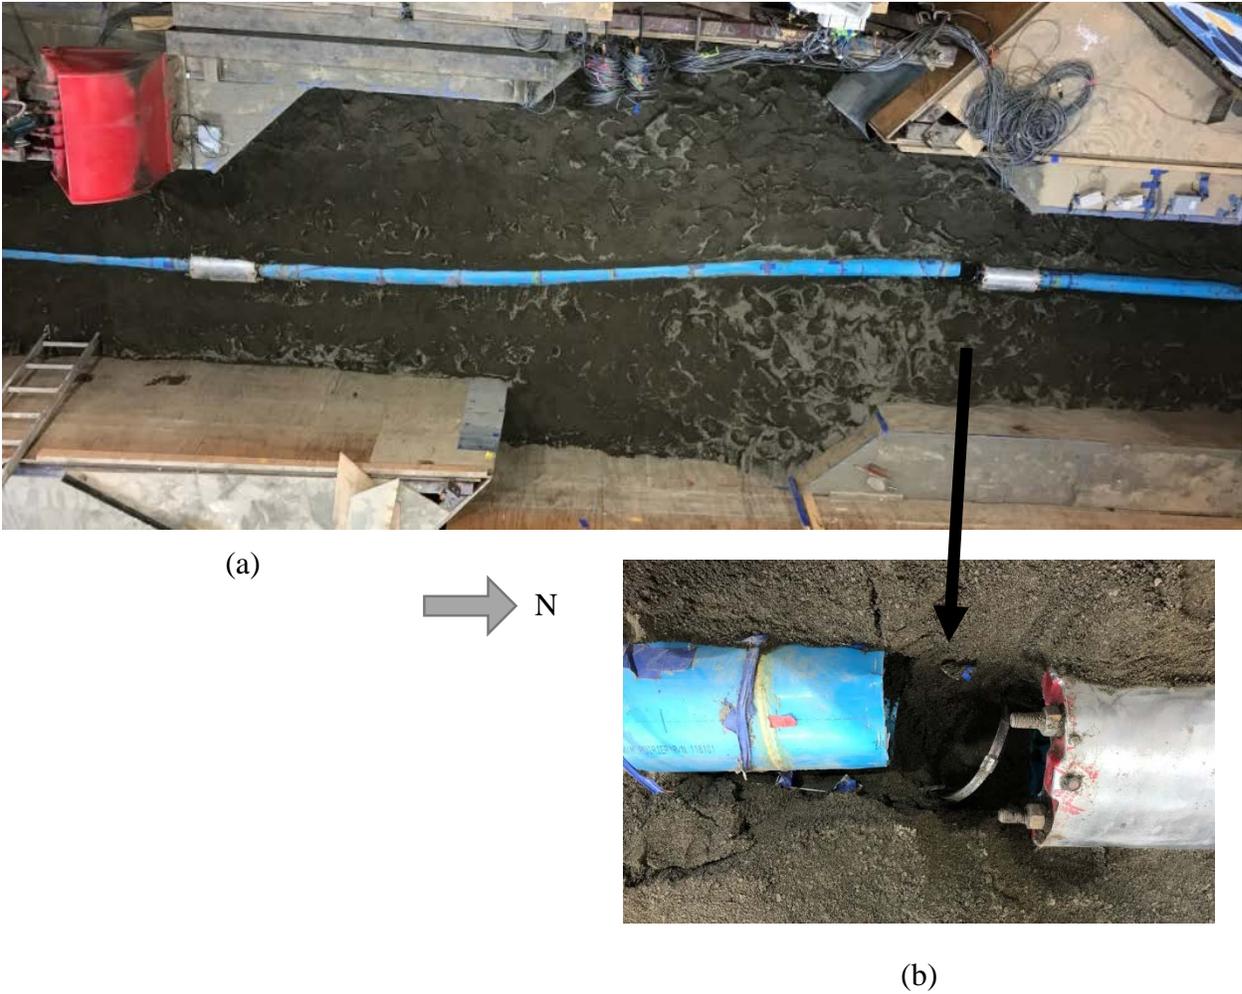
Figure 6.14. Overhead view of the (a) pipeline and (b) failed joint after excavation of the split basin test

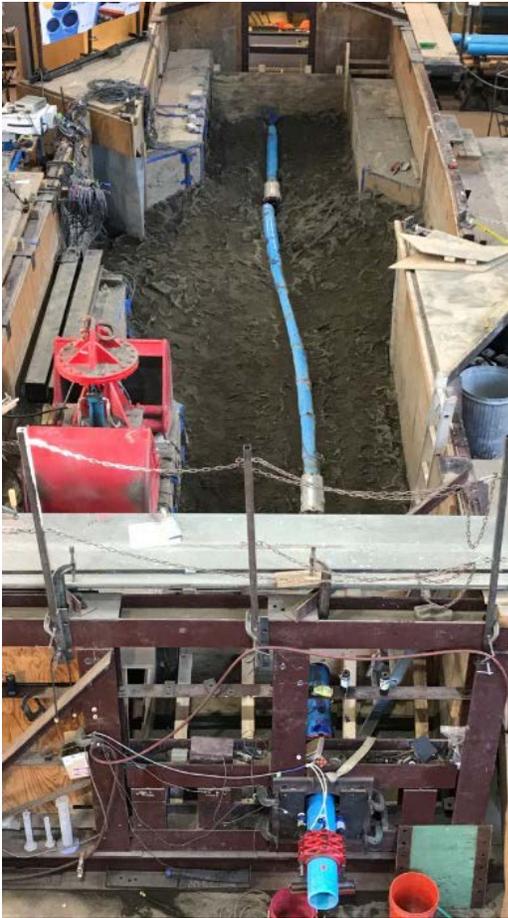
Figure 6.14. Overhead view of the (a) pipeline and (b) failed joint after excavation of the split basin test	65
Figure 6.15. View looking north of (a) failed pipeline and (b) close up of joint	66
