# Task 3 - Large-Scale Testing of Fault Rupture Effects on Bionax Pipe and Pipe Joints

School of Civil and Environmental Engineering  
Cornell University  
Hollister Hall  
Ithaca, NY 14853  
October, 2013

This report is the third in a series of three reports to IPEX Management, Inc. and describes the results of Task 3 – Large-Scale Testing of Fault Rupture Effects on Bionax Pipe and Pipe Joints. The report presents the results of a large-scale test of fault rupture effects on a Bionax pipeline with restrained bell-and-spigot joints performed in the Cornell large-scale test basin in August 2013. All testing was performed at the Cornell University Large Scale Lifelines Testing Facility. IPEX provided all pipe materials and connection fittings. The primary pipe tested was Bionax 6 in. (150mm) CIOD. The joint restraints were Model UFR1559-C-6-I restraints for C909 PVCO, manufactured by the Ford Meter Box Co., Inc.

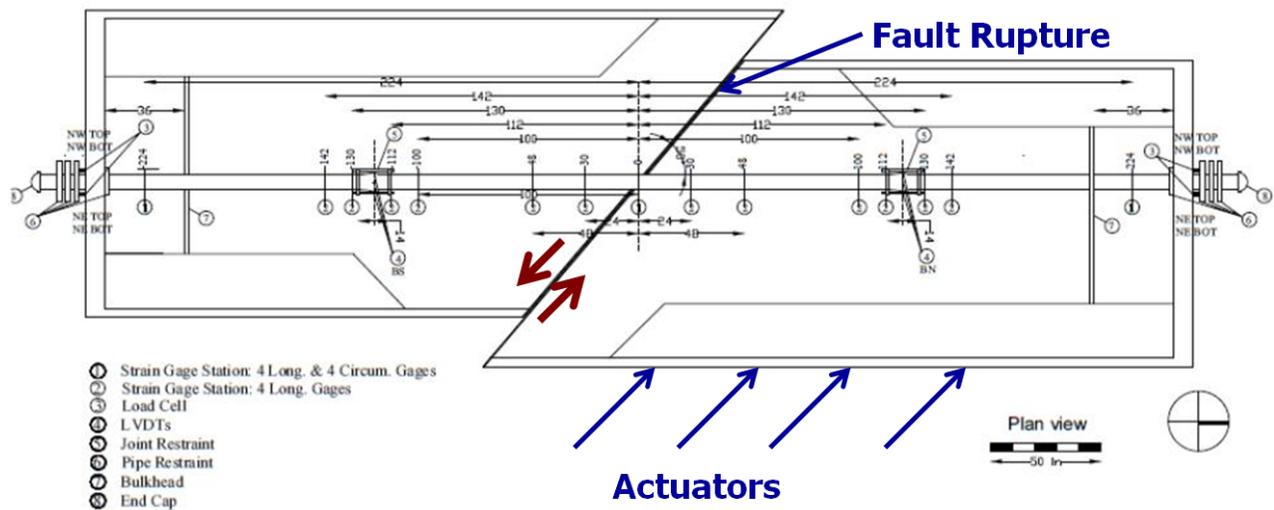
Figure 2.1 is a plan view of the test layout. The pipeline consisted of three pipe segments connected with bell-and-spigot joints and joint restraints. It was buried in the Cornell large-scale test basin in partially saturated sand that was compacted to have an average friction angle of 42°, equivalent in strength to that of a medium dense to dense granular backfill. The depth of burial to top of pipe was 2.5 ft (0.76 m). During the test, the south part of the basin remained stationary, while the north part was displaced to the north and west by large-stroke actuators to cause soil rupture and slip at the interface between the two parts of the test basin. The soil rupture is identical to left lateral strike slip fault rupture, and is also representative of the most severe ground deformation that occurs along the margins of liquefaction-induced lateral spreads and landslides.

Figure 2.1. Plan View of IPEX Bionax Pressurized Pipe Centered Specimen in Test Basin

Figure 2.1, a plan view of the test layout, shows the locations of the instruments along the test pipeline. The instrumentation consisted of strain gages at fifteen locations (gage planes) along the pipeline, load cells at the ends of the pipeline and DCDTs (Direct Current Differential Transformers) to measure joint displacements. To help correlate gage, joint, and load cell locations with the description of measurements in this report, an expanded view of Figure 2.1 is provided in Appendix A.

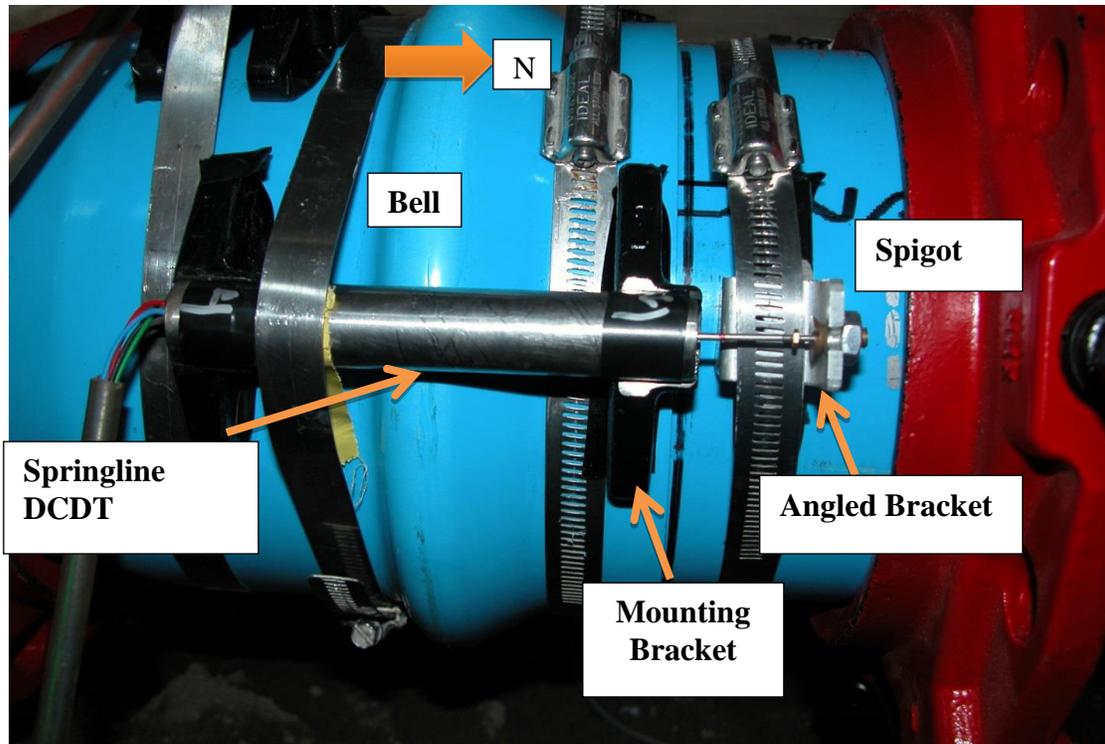
Four DCDTs were placed at each joint to measure the joint pullout and rotation, bell to bell collar relative movement, and bell-to-spigot collar movement. To measure joint pullout and rotation, two DCDTs were mounted on the east and west springlines of the bell. In Figure 3.1 arrows above depict the setup of the springline DCDT. The DCDT sits atop two curved mounting brackets and was fixed to the pipe by a single hose clamp. The DCDT's core was then attached to an angled bracket on the spigot. An identical setup was installed along the other springline of the pipe, and hence the system of DCDTs could measure pullout and rotation.

Figure 3.1. Springline DCDT

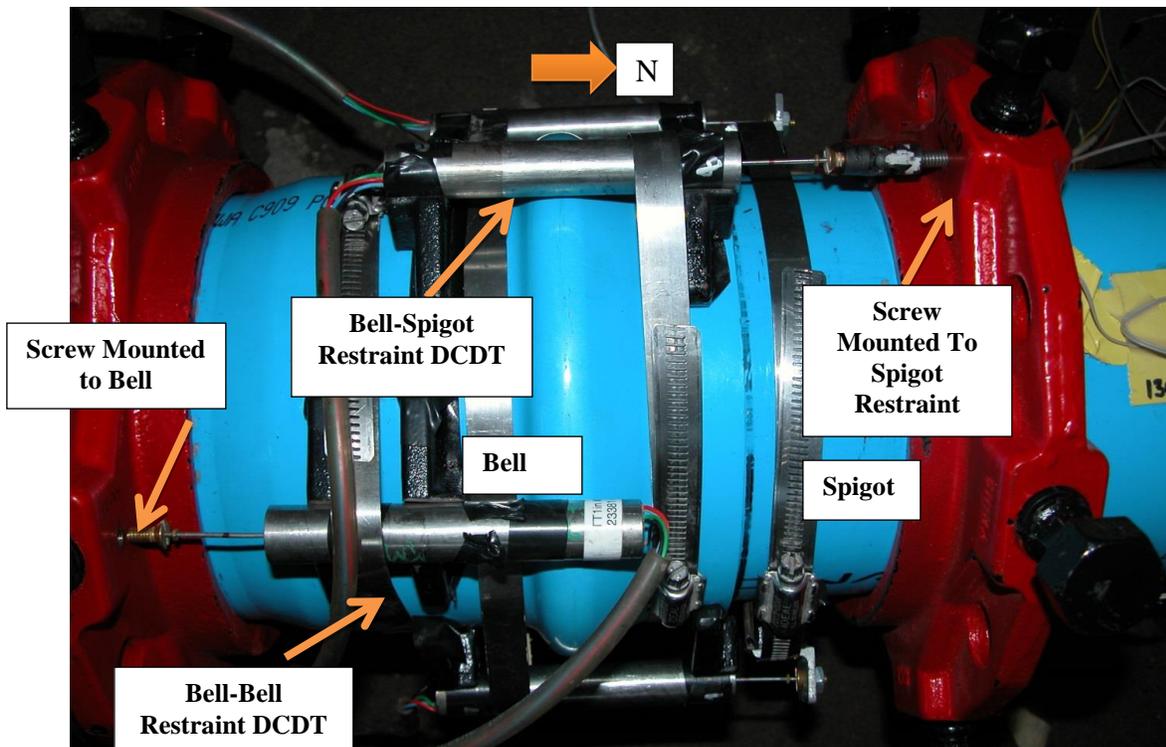
Figure 3.2 shows a DCDT mounted on the bell with screw-mounted connections to the bell end collar of the restraint to measure bell-to-clamp displacement. Similarly, the bell-to-clamp displacement at the spigot end was measured by mounting a DCDT on the bell, with screw-mounted connections to the spigot end collar of the restraint. Table 3.2 provides the locations and the labeling of the joint DCDTs. Figure 3.3 is an overview of the pipe joint with the restraint. The spigot is inserted into the bell approximately 6 in. (152 mm). After the instrumentation is installed, a protective shielding was then screwed into the restraints. Each shield was mounted to the restraint via twenty four ¼-20 screws (12 on each restraint). Figure 3.4 is an overview of the pipe joint with the protective shielding.

Figure 3.2. DCDTs to Measure the Bell-Bell Restraint and Bell-Spigot Restraint Displacements

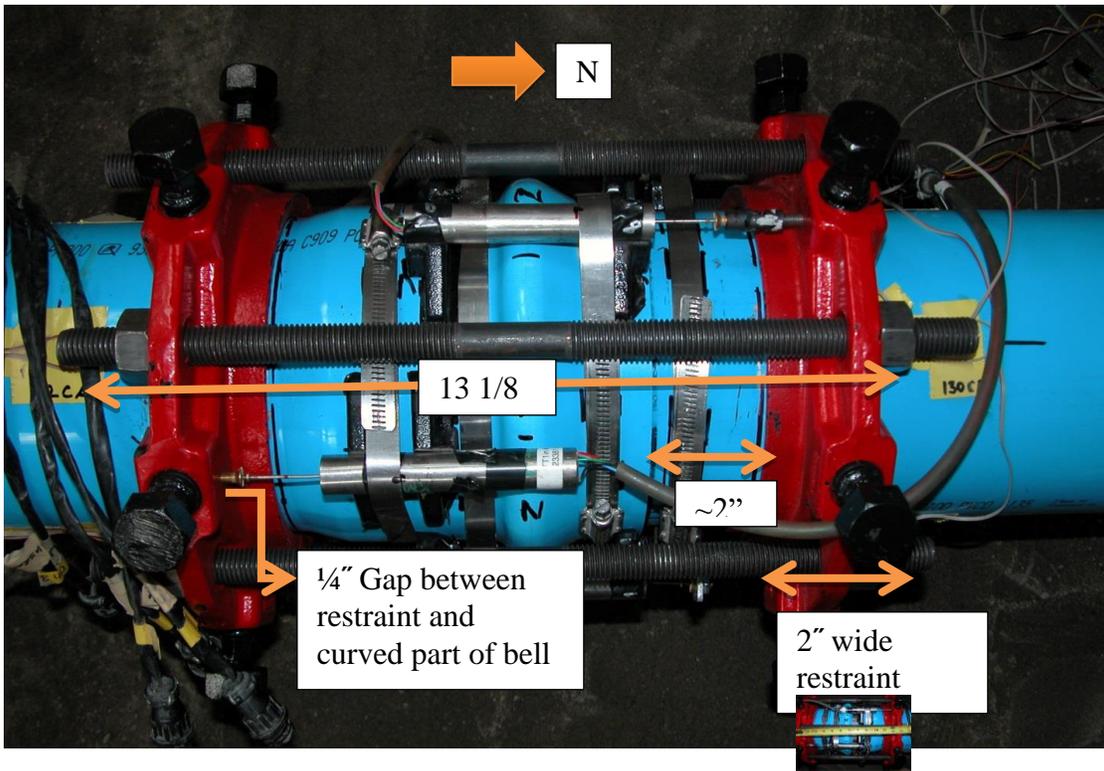
Figure 3.3. Overview of the Joint Restraint

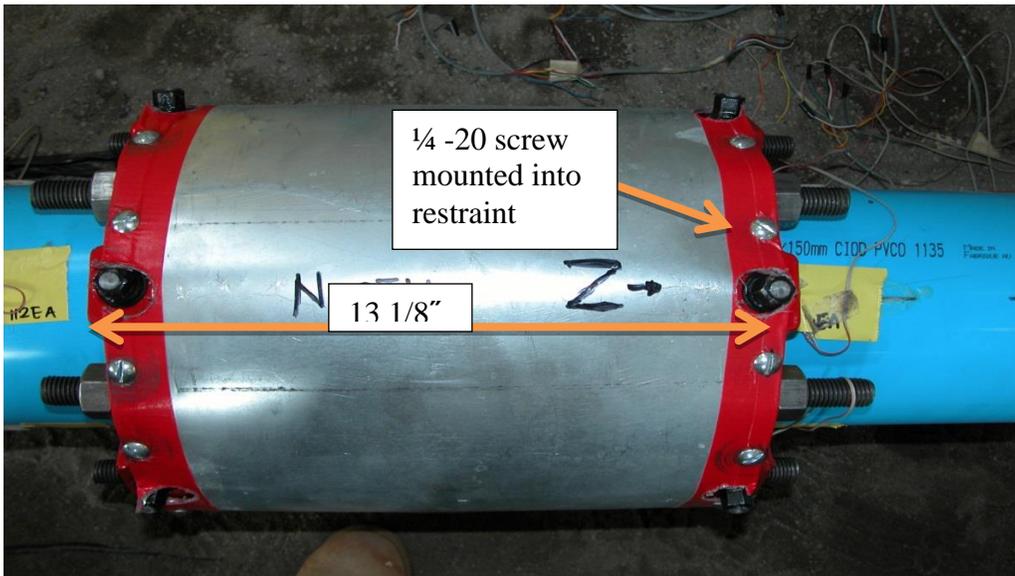
Figure 3.4. Overview of the Joint Restraint with the Protective Shielding

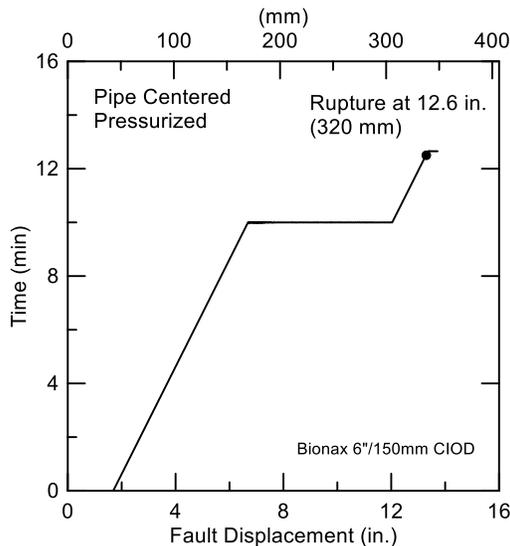
Figure 5.1 shows the displacement of long-stroke actuator 1 (LSA1) versus time. All actuators are synchronized to move at exactly the same rate and displacement, so only LSA1 is shown.

Figure 5.1 Fault Movement vs. Time

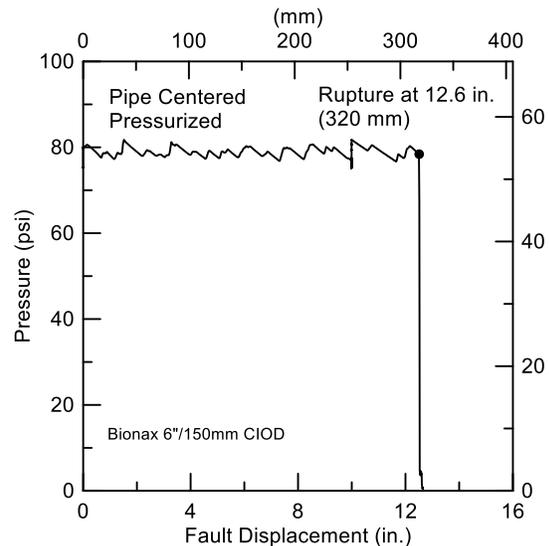
The pipe was initially pressurized to 80 psi (552 kPa) before any basin movement. Each movement of the basin caused the pipe to increase slightly in overall length, causing the pressure to fluctuate slightly (a few psi). Figure 6.1 shows the pipe internal pressure vs. fault displacement. At a fault displacement of roughly 12.6 in. (320 mm) there was a sudden loss of pressure in the pipe. At this point the test was stopped and the water drained from the pipe.

Figure 6.1. Internal Pipe Pressure vs. Fault Displacement

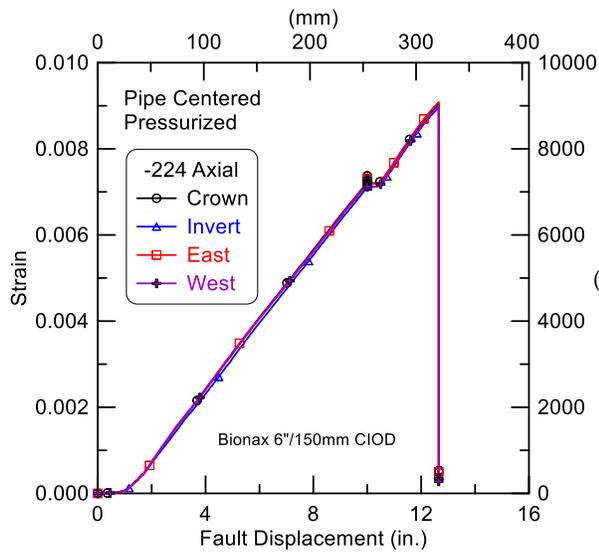
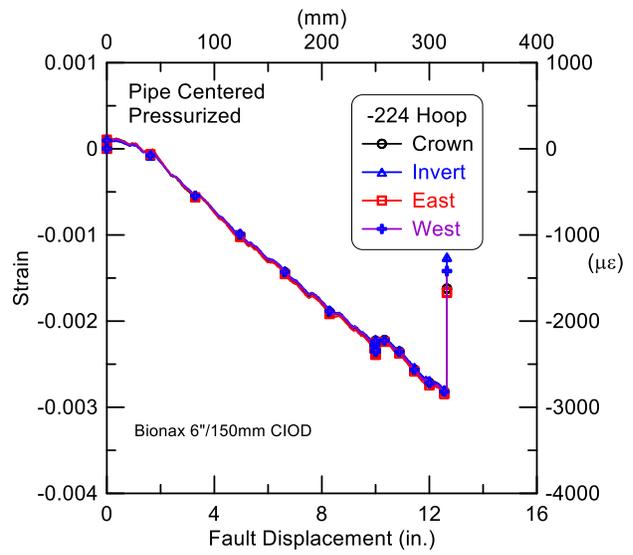
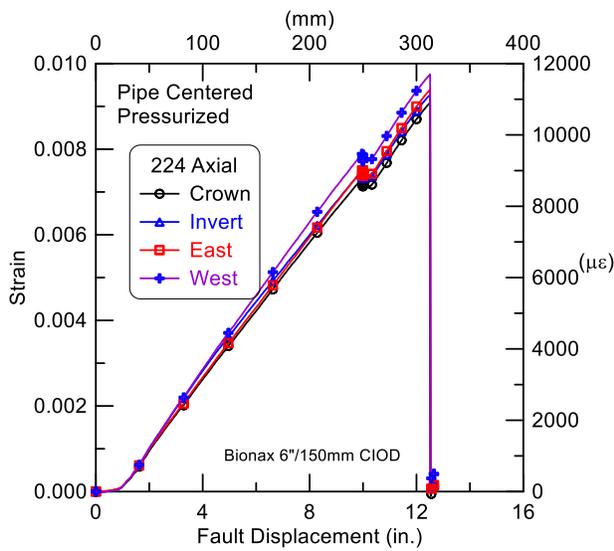
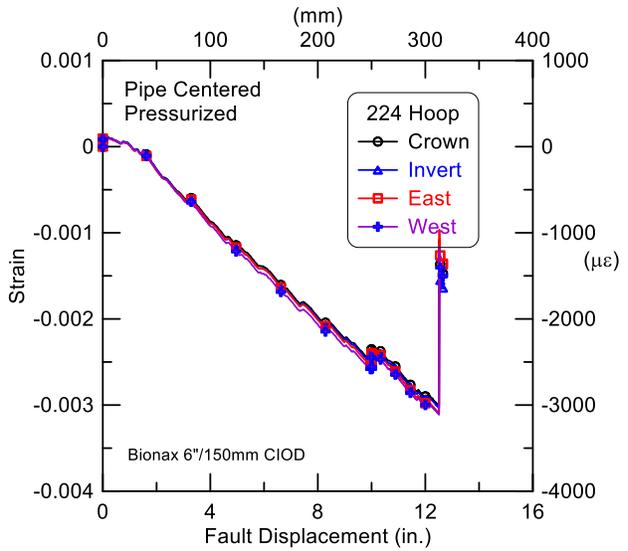
Figures 7.1 and 7.2 show the axial and hoop pipe strains, respectively, at the crown, invert, east springline, and west springline measured at the -224 in. (-569 cm) gage plane. This plane was outside the soil at the south end of the test basin. Figures 7.3 and 7.4 show the axial and hoop pipe strains, respectively, at the crown, invert, east springline, and west springline measured at the 224 in. (569 cm) gage plane. This plane was outside the soil at the north end of the test basin. The strains at both the south and north stations are in excellent agreement, and indicate symmetry at these gage planes. Neither of the gage planes indicated lateral bending at these locations outside the soil.

Figure 7.1. Axial Strain vs. Fault Displacement 224 in. (569 cm) South of Fault

Figure 7.2. Hoop Strain vs. Fault Displacement 224 in. (569 cm) South of Fault

Figure 7.3. Axial Strain vs. Fault Displacement 224 in. (569 cm) North of Fault

Figure 7.4. Hoop Strain vs. Fault Displacement 224 in. (569 cm) North of Fault

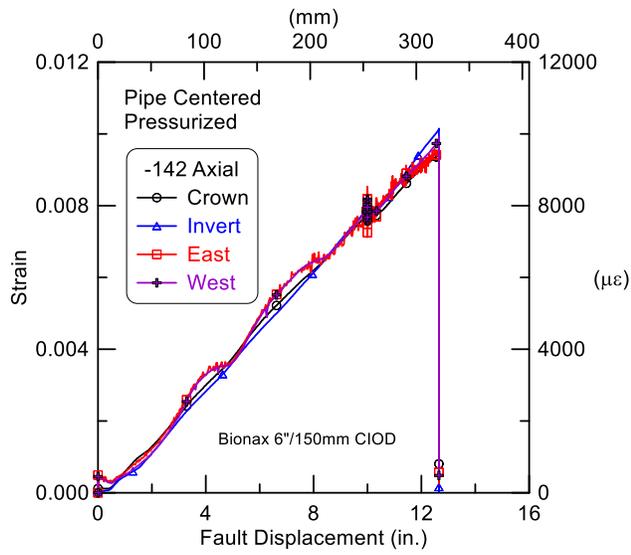
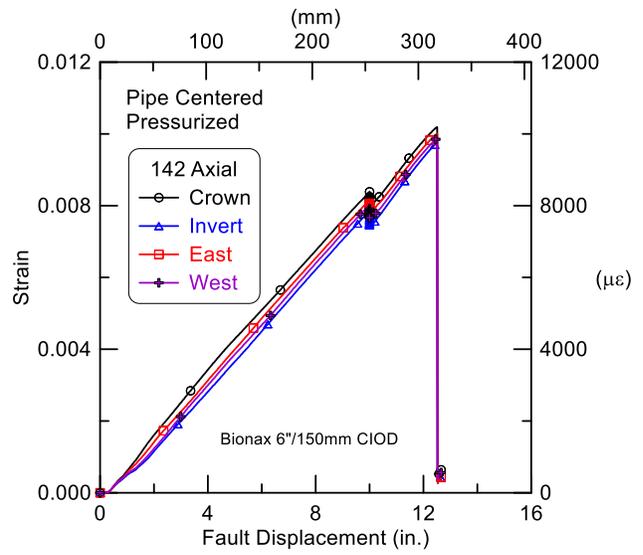
Figures 7.5 and 7.6 show the axial strains at 142 in (356 cm) south and north of the fault, respectively. The strains at the crown, invert, and east and west springlines are all in very good agreement and also indicate essentially no lateral pipe bending at these locations.

Figure 7.5. Axial Strain vs. Fault Displacement 142 in. (356 cm) South of Fault

Figure 7.6. Axial Strain vs. Fault Displacement 142 in. (356 cm) North of Fault

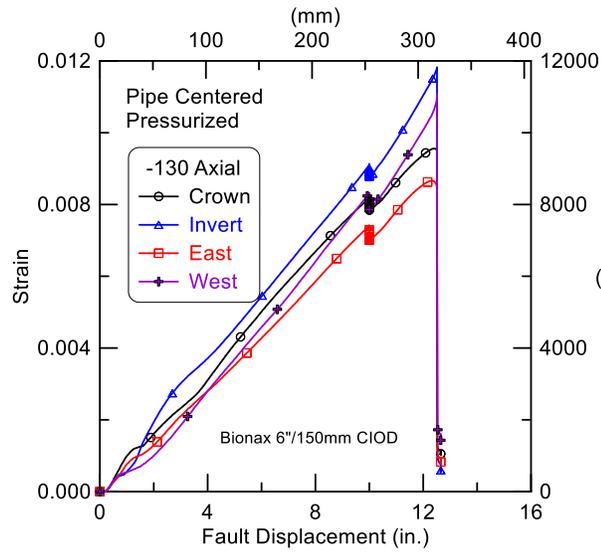
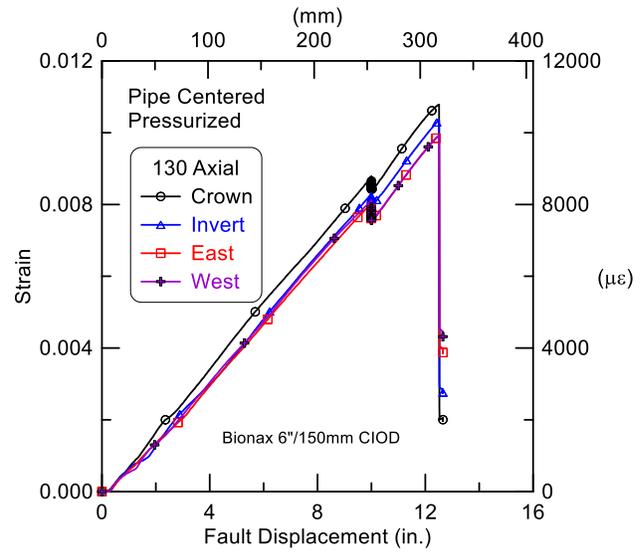
Figures 7.7 and 7.8 show the axial strains at 130 in. (330 cm) south and north of the fault, respectively. There are differences between strains at the crown, invert, and east and west springlines south of the fault that show increasing levels of bending until failure at the south joint. The strains at the gage locations 130 in. (330 cm) north of the fault are in relatively close agreement.

Figure 7.7. Axial Strain vs. Fault Displacement 130 in. (330 cm) South of Fault

Figure 7.8. Axial Strain vs. Fault Displacement 130 in. (330 cm) North of Fault

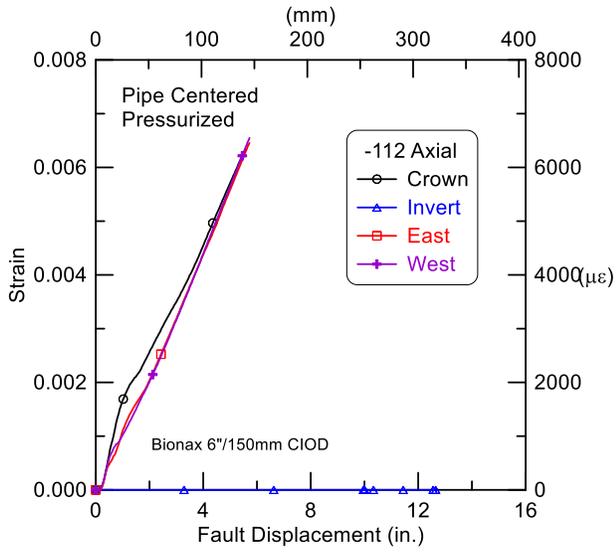
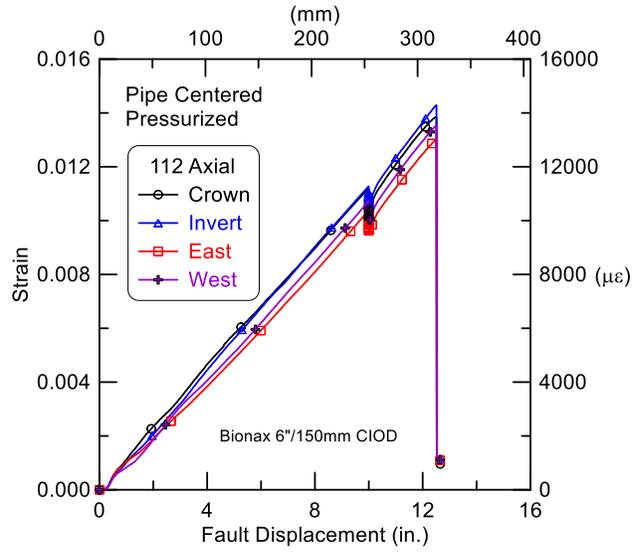
Figures 7.9 and 7.10 show the axial strains at 112 in. (284 cm) south and north of the fault, respectively. The strains at the invert and east springline at the gage plane south of the fault did not function properly. The crown and west springlines gages 112 in. (284 cm) south of the fault are in good agreement. All gages at this gage plane north of the fault agree well, and little lateral bending is indicated.

Figure 7.9. Axial Strain vs. Fault Displacement 112 in. (284 cm) South of Fault

Figure 7.10. Axial Strain vs. Fault Displacement 112 in. (284 cm) North of Fault

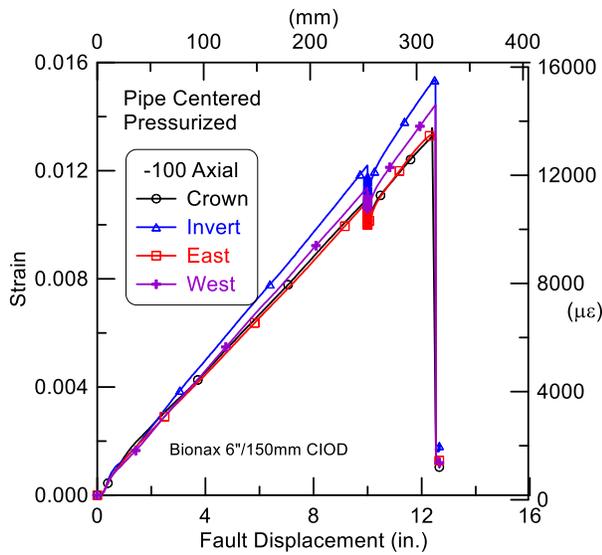
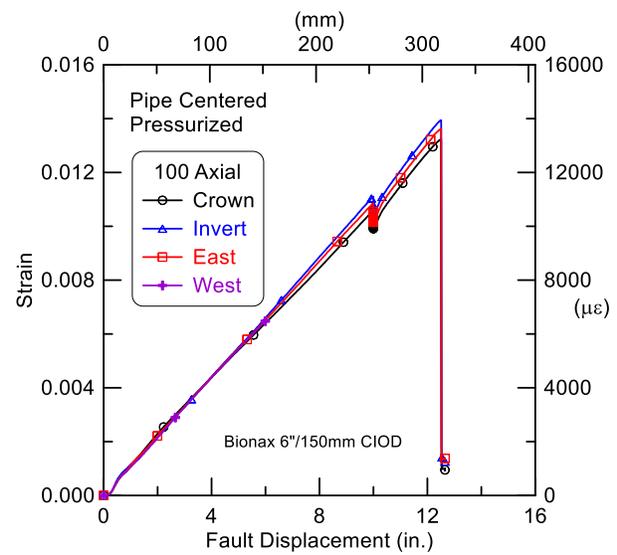
Figures 7.11 and 7.12 show the axial strains at 100 in. (254 cm) south and north of the fault, respectively. The strains at these gage planes both south and north of the fault are all quite similar. There is little to no bending strain at these gage planes.

Figure 7.11. Axial Strain vs. Fault Displacement 100 in. (254 cm) South of Fault

Figure 7.12. Axial Strain vs. Fault Displacement 100 in. (254 cm) North of Fault

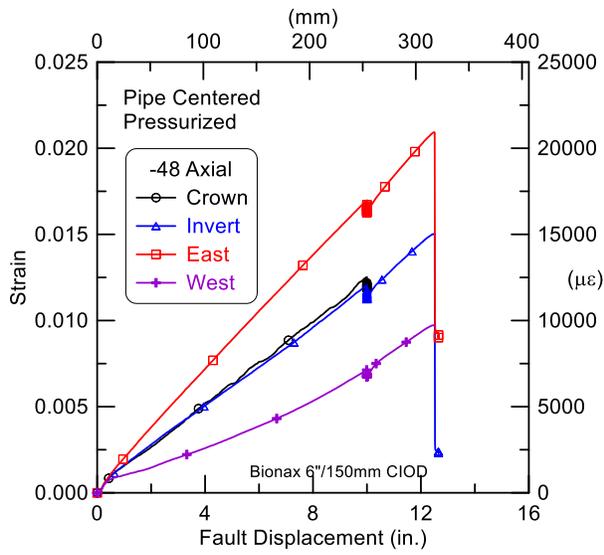
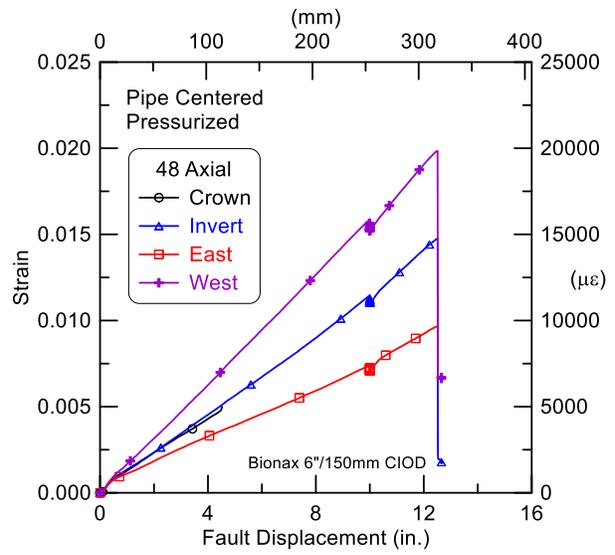
Figures 7.13 and 7.14 show the measured axial strains at a distance of 48 in. (122 cm) south and north of the fault, respectively. At these locations relatively large bending strains were measured. Note that in Figure 7.13 the east springline strains are much larger than the west springline strains south of the fault, whereas in Figure 7.14 the west springlines strains are much larger than the east springline strains north of the fault. The sign convention for bending strains is such that positive strains reflect how the pipe would be expected to deform. This indicates that the direction of lateral bending is positive (if using a negative right-hand rule) to the west on the north side of the fault. This is consistent with the north portion of the test basin being pushed to the west.

Figure 7.13. Axial Strain vs. Fault Displacement 48 in. (122 cm) South of Fault

Figure 7.14. Axial Strain vs. Fault Displacement 48 in. (122 cm) North of Fault

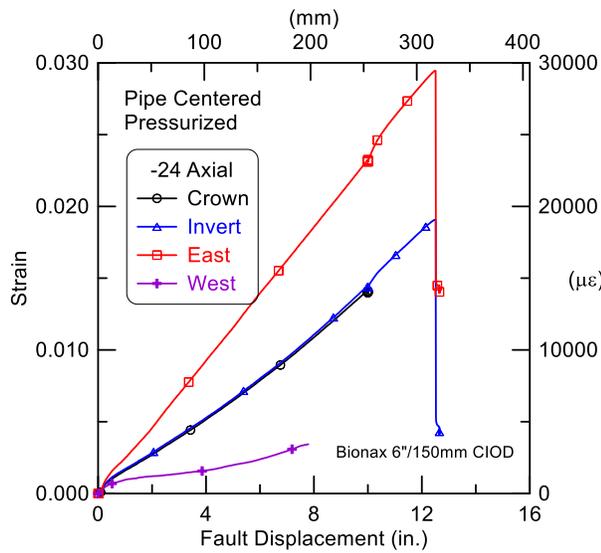
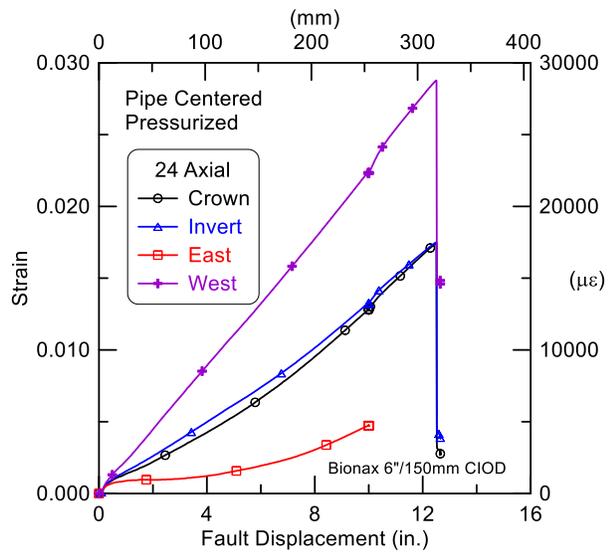
At a distance of 24 in. (61 cm) south and north of the fault, bending strains clearly are present. This is shown in Figures 7.15 and 7.16, south and north of the fault, respectively. Again, Figure 7.15 the east springline strains are much larger than the west springline strains south of the fault, whereas in Figure 7.16 the west springlines strains are much larger than the east springline strains north of the fault.

Figure 7.15. Axial Strain vs. Fault Displacement 24 in. (61 cm) South of Fault

Figure 7.16. Axial Strain vs. Fault Displacement 24 in. (61 cm) North of Fault

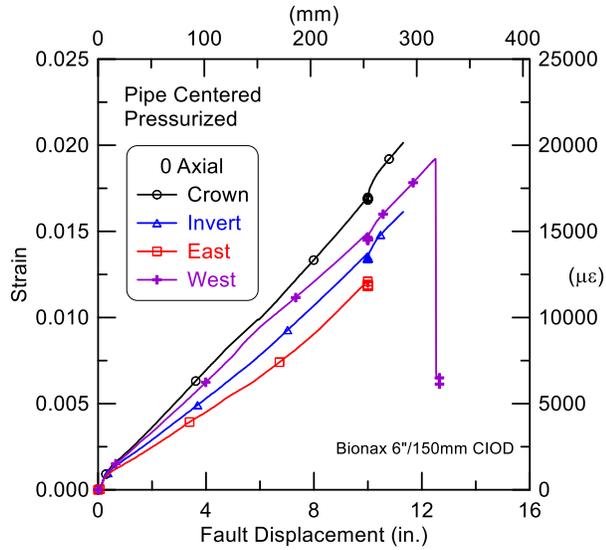
Figure 7.17 shows the measured axial strains at the fault. Here, there are bending strains but they are considerably smaller than those at 24 and 48 in. (122 and 61 cm) south and north of the fault.

Figure 7.17. Axial Strain vs. Fault Displacement at Fault

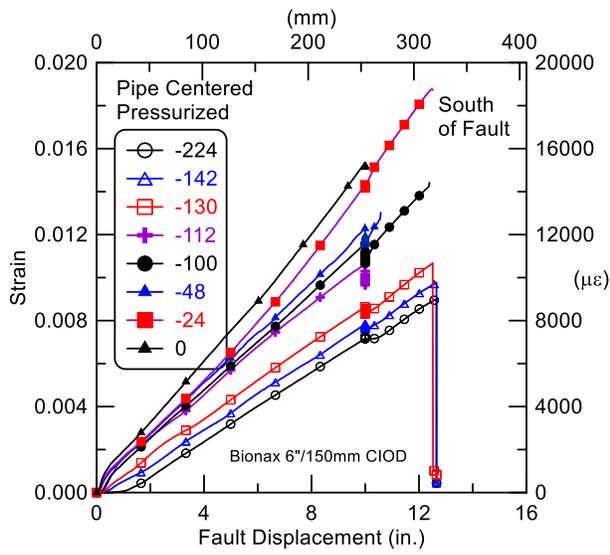
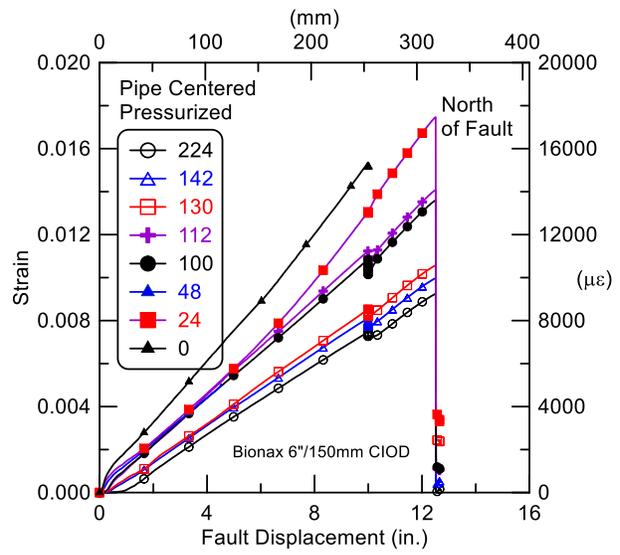
The average crown and invert axial strains at all gage locations, both south and north of the fault, are shown in Figures 7.18 and 7.19. The east and west springlines were not included in the averages because in a few cases the east or west springline gage was not functioning and then using only three gages would not represent the axial strains accurately. The progression of strains from far away from the fault increasing to the maximum at the fault is shown clearly in the average axial strain data. The average axial strains are plotted vs. distance from the fault in Figure 7.20. The strains are very symmetric about the fault, and increase as fault displacement increases.

Figure 7.18. Average Crown and Invert Axial Strain vs. Fault Displacement South of Fault

Figure 7.19. Average Crown and Invert Axial Strain vs. Fault Displacement North of Fault

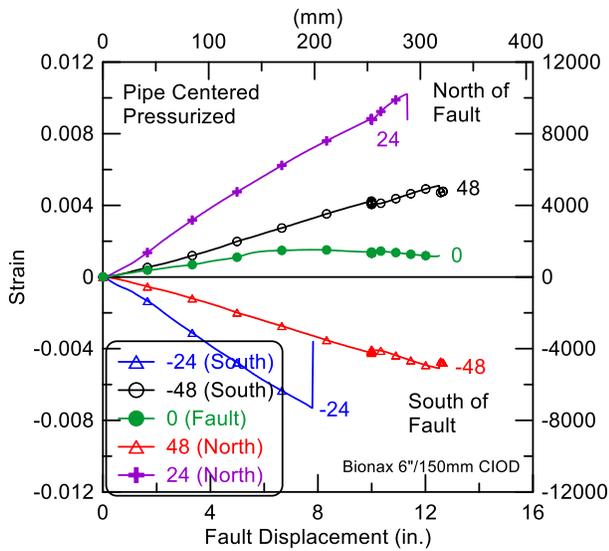
Figure 7.21. Bending Strain vs. Fault Displacement at Fault, 24 in. (61 cm) 48 in. (122 cm) South and North of Fault

Figure 7.21 shows the bending strains at the fault (0), 24 in (61 cm) and 48 in. (122 cm) south and north of the fault calculated using Eq. 1. The bending strains are quite symmetric. The bending strain at the fault is relatively small, since this represents the inflection point of the pipe in bending. As previously stated, 100 in. (254 cm) south and north of the fault, the bending strains were near zero. Figure 7.22 shows the distribution of bending strain along the pipeline vs. distance from the fault. The symmetry of the bending strains is quite clear, indicating a symmetric deformed shape with the inflection point at the fault.

The bending strain,  $\epsilon_b$ , is calculated as:

$$\epsilon_b = \frac{\epsilon_W - \epsilon_E}{2} \quad (1)$$

Where  $\epsilon_E$  is the measured strain at the gage mounted in the axial direction on the east springline and  $\epsilon_W$  is the measured strain at the gage mounted in the axial direction on the west springline. Whether it is (W-E) or (E-W) is somewhat arbitrary. If using this sign convention the direct axial strain on the east side is  $\epsilon_{AE} = \epsilon_E + \epsilon_b$  the direct axial strain on the west side is  $\epsilon_{AW} = \epsilon_W - \epsilon_b$ .

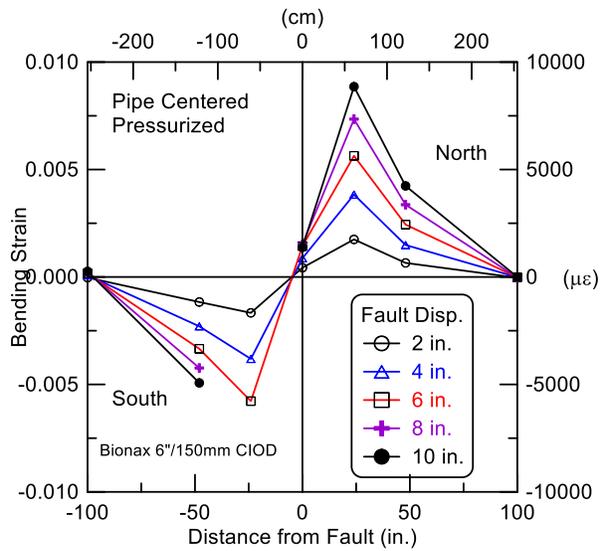
Figure 7.22. Bending Strain vs. Distance from Fault

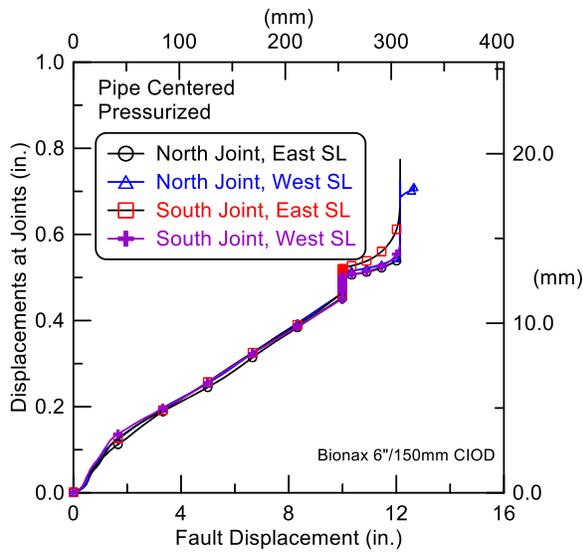
The joint movements on the east and west springlines of both the south and north joints are presented in Figure 8.1. The joint movements at the springlines are nearly identical. From roughly 2 in. (51 mm) of fault movement through 10 in. (254 mm) there is a steady increase in the joint openings. At 10 in. (254 mm) the test was paused and the joints still continued to creep open slightly. At a fault displacement of approximately 12.6 in. (320 mm) the pipe near the south joint failed. All joint movements show an abrupt jump in displacement when failure occurred. The joint openings were about 0.6 in. (15.2 mm) at that time. Since there was practically no differential opening on the east and west springlines at both joints, there was no joint rotation at either joint. The absence of joint rotation is consistent with the resistance to rotation provided by the joint restraints.

Figure 8.1. Displacements at South and North Joints, East and West Springlines

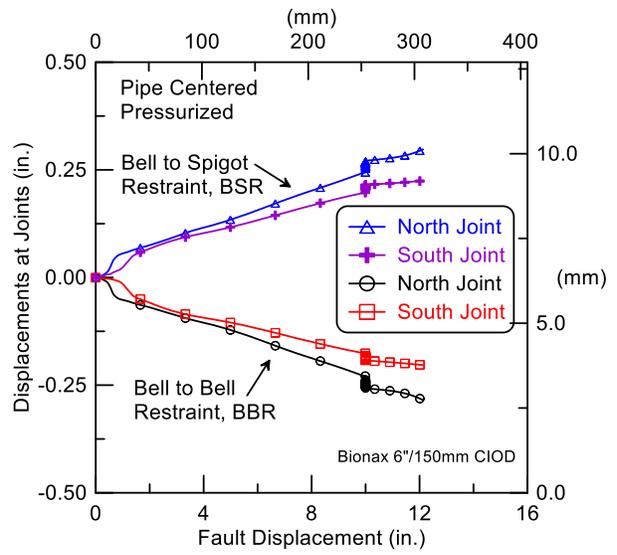
Figure 8.2 shows the DCDT measurements from the bell side of the joint to the bell side clamp of the restraint and from the bell side to the spigot side clamp of the restraint. In the test pipe, each joint had the bell on the south portion of the joint. So, the bells were facing to the north. The “Bell to Spigot Restraint” (BSR) measurements show that the spigot restraint was being pulled north, consistent with the movement of the test basin to the north along the 50° fault. The “Bell to Bell Restraint” (BBR) measurements indicate that spacing between the bell and bell side restraint decreased. At each joint, the distance between the bell and spigot side restraint increased and the distance between the same location on the bell and the bell side restraint decreased by the nearly the same amount. The small increase in restraint spacing is shown in Figure 8.3. The separation of the clamps increased roughly 0.022 in. (0.56 mm) and 0.015 in. (0.38 mm) across the south and north restraints, respectively, at a fault movement of 12 in. (305 mm).

Figure 8.2. DCDT Measurements from Bell End to Bell Restraint and to Spigot Restraint, South and North Joints

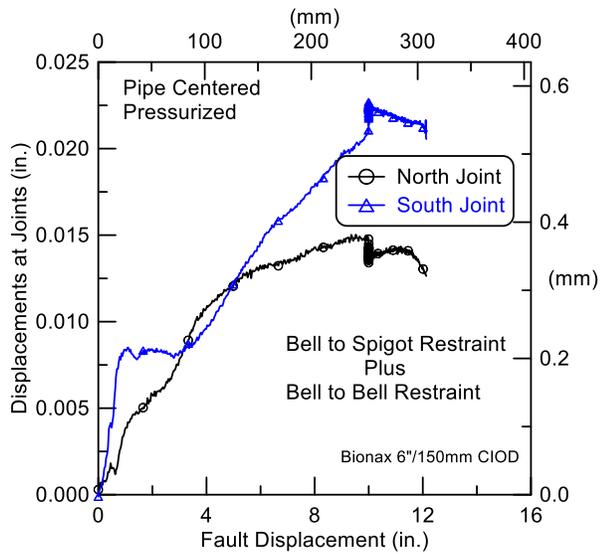
Figure 8.3. Change in Restraint Spacing, South and North Joint

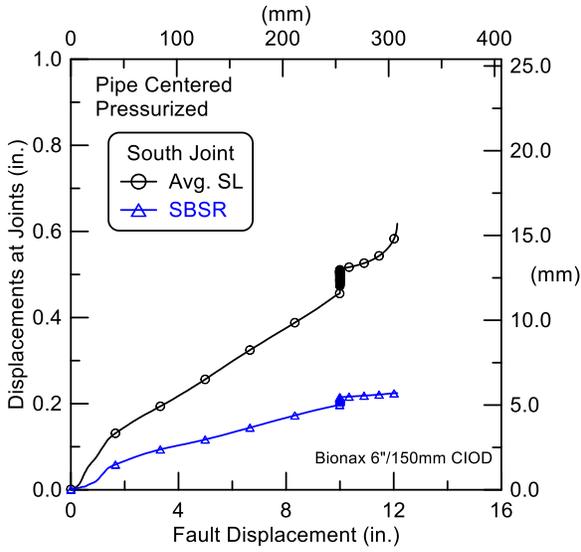
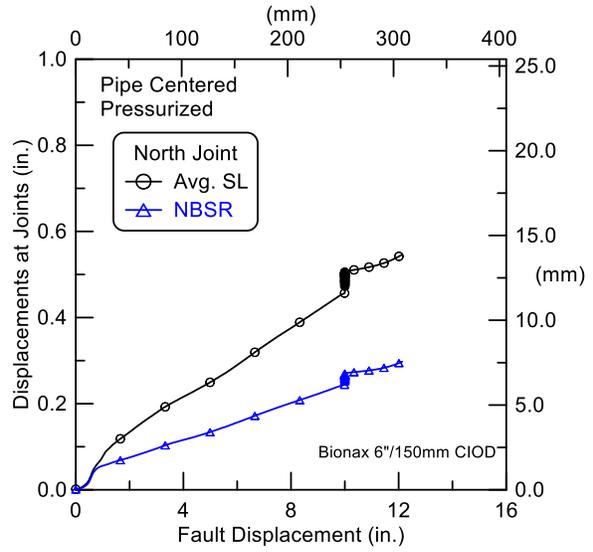
Figures 8.4 and 8.5 show the average springline movements and the bell to spigot displacements at the south and north joint, respectively. As indicated above, the movements at each joint are nearly the same. In Figures 8.4 and 8.5 the south and north “Bell to Spigot Restraint” (SBSR and NBSR, respectively) are plotted relative to the springline movement (pullout) of the joint. These movements are larger than the SBSR and NBSR movements, indicating that the spigot was pulled through the spigot side clamp at each joint. This pullout was approximately 0.3 in. (7.6 mm) and 0.2 in. (5 mm) for the south and north joint, respectively.

Figure 8.4. South Joint, Average Springline and Bell to Spigot Restraint Displacements

Figure 8.5. North Joint, Average Springline and Bell to Spigot Restraint Displacements

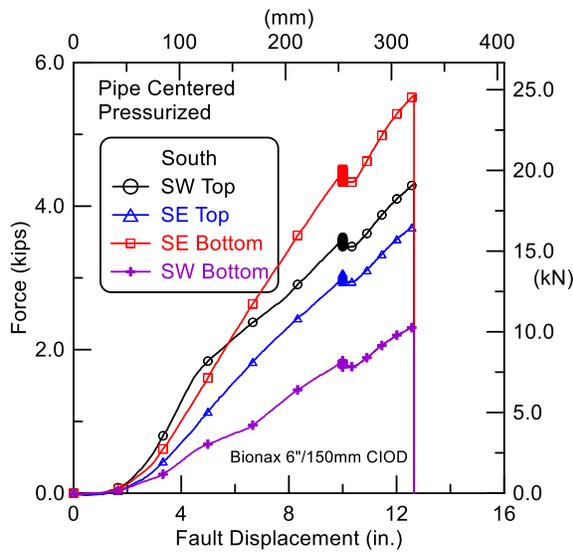
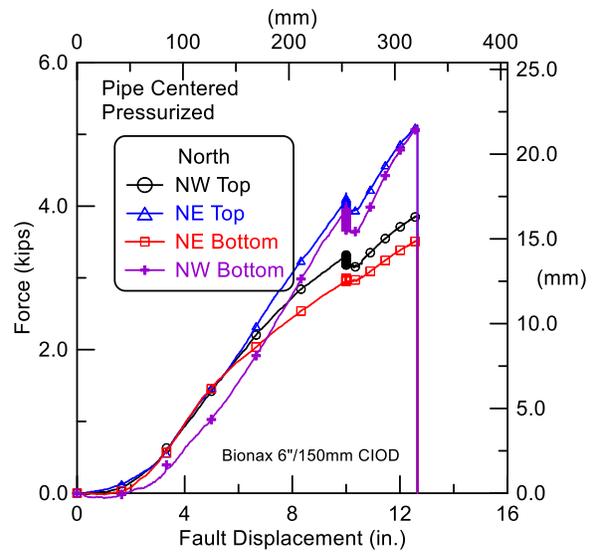
Load cells were placed at the south and north ends of the test basin, outside the ends of the pipe. The load cells measured the forces at four locations between the pipe and structural members of the test basin. Figures 9.1 and 9.2 show the four load cell measurements at the south and north ends, respectively, of the test basin. The greatest variation in load cell measurement was registered at the south end. Figure 9.3 shows the summation of all four load cells at each end of the test basin. The total loads at the ends are in reasonable agreement, in the range of 16 to 18 kips (71 to 80 kN).

Figure 9.1. South End Load Cells

Figure 9.2. North End Load Cells

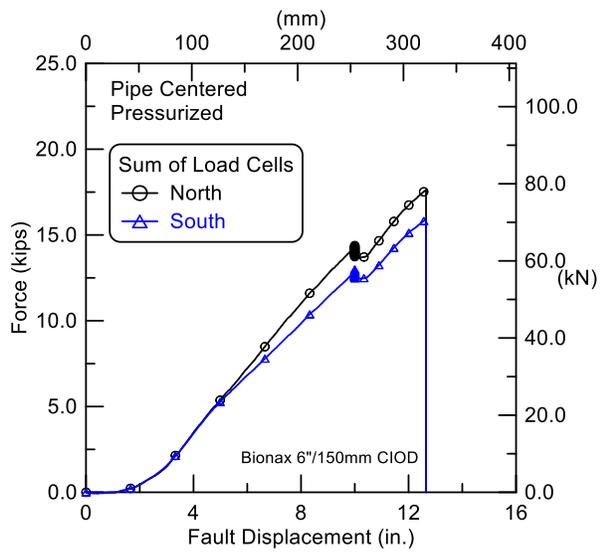
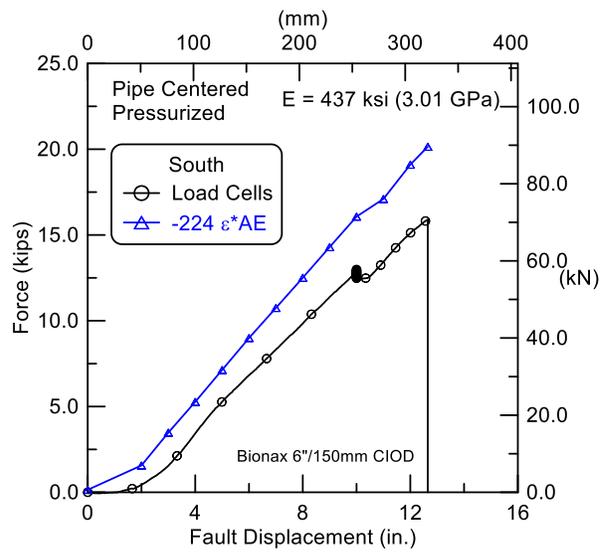
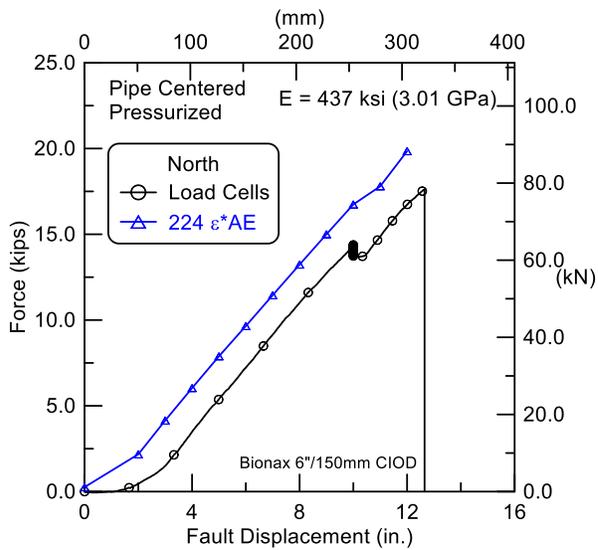
The strain gages at plane -224 on the south end and 224 on the north end are outside the soil, and 18 in. (45.7 cm) from the inside end of the test basin. The outside diameter of the pipe was OD = 6.9 in. (175.3 mm) and the average measured wall thickness of  $t_w = 0.245$  in. (6.22 mm). This gives a pipe wall cross-sectional area of  $A = 5.12$  in.<sup>2</sup> (3304.7 mm<sup>2</sup>). The average Young's modulus of the Bionax in the linear range of the stress vs. strain relationship is  $E = 437$  ksi (3.01 GPa). This was determined from several tensile coupon tests, and previously reported to IPEX ("Task 1 - Material Testing of Bionax Pipe and Joints," Cornell University, Sep. 2013). Using the average crown and invert strains at these two gage planes and multiplying the strain times  $AE$  gives the force in the pipe. Figures 9.4 and 9.5 show the forces in the south and north pipe sections at the -224 and 224 gage planes, respectively, calculated using the pipe strains with the force measured by the four load cells at each end. The linear strain-based forces are consistently higher than the summation of the four load cells at both the south and north ends. If the effects of initial load cell adjustments, thrust from internal pressure on the test pipe end caps, and nonlinear stress vs strain effects are accounted for, the forces calculated from the strain gages at the time of pipe failure are in agreement with the load cell measurements.

Figure 9.3. Sum of All Load Cells, South and North Ends

Figure 9.4. South Load Cells and Strain Gage Force vs. Fault Displacement

Figure 9.5. North Load Cells and Strain Gage Force vs. Fault Displacement

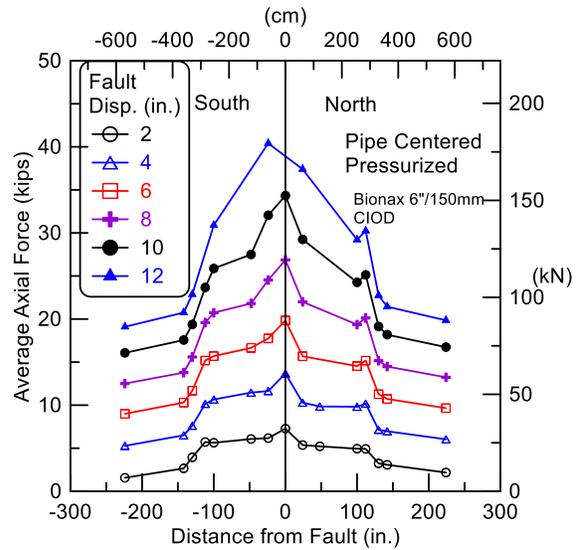
The distribution of axial force along the pipe, again calculated for a linear relationship between stress vs. strain as axial force,  $F = \epsilon AE$ , is shown in Figure 9.6. There is increasing axial force with larger fault displacement, resulting in a maximum force of 40 kips (180 kN) at the fault crossing (0 distance). If a nonlinear analysis for the relationship between stress vs. strain is used, the maximum axial force at the fault crossing is approximately 33 kips. The reduction in force occurs because the axial strains at the fault crossing require less strain for mobilization when nonlinear stress response is accounted for.

Figure 9.6. Axial Force in Pipe vs. Distance from Fault

The end forces at the south and north end of the test basing were on the order of 16 to 18 kips (71 to 80 kN). The axial force in the pipe, as determined from the strain gage readings for an assumed linear relationship between stress vs. strain, was largest at the fault crossing, and would be roughly 40 kips (180 kN). If the nonlinear relationship between stress vs. strain is used, the maximum axial force at the fault crossing is approximately 33 kips.

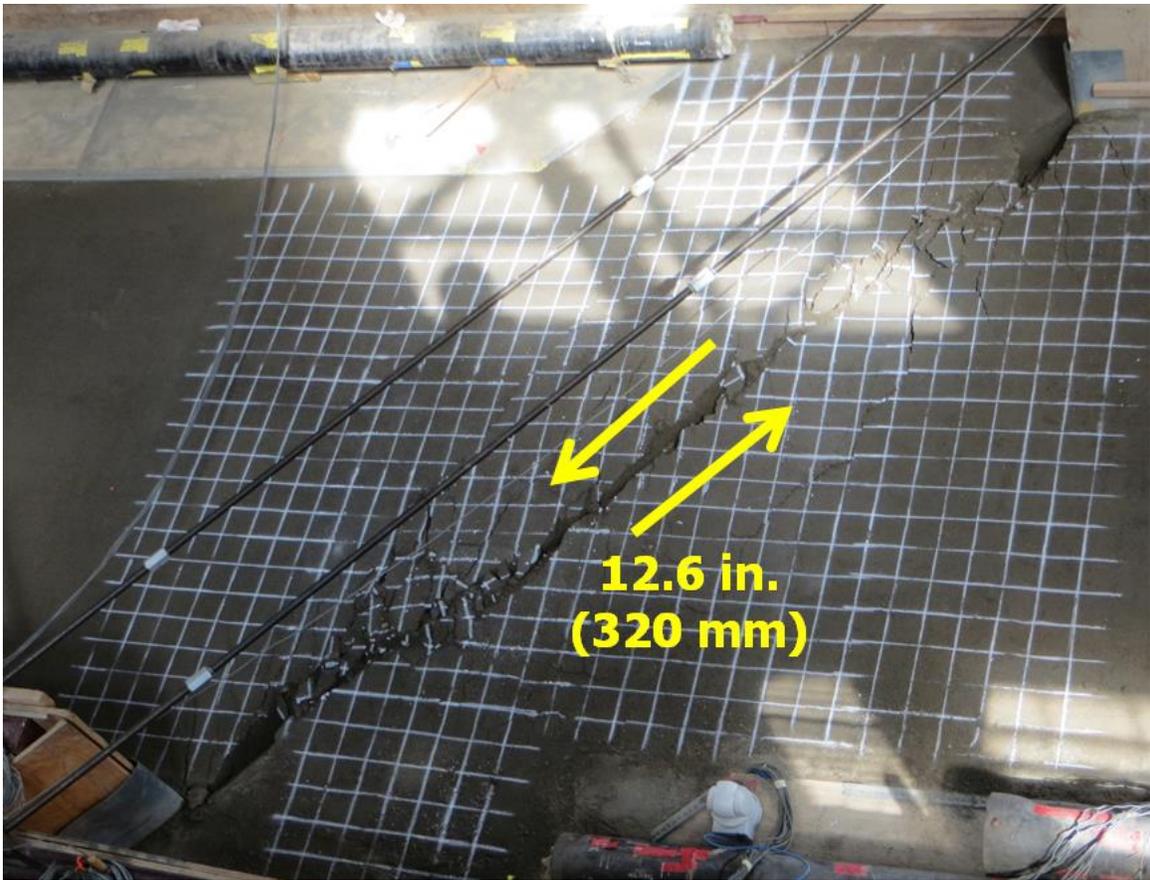
Figure 10.1 shows the fault rupture at pipe failure. Figure 10.2 shows the deformed pipe partially excavated following the test along with the rupture at the south joint. Figure 10.3 is a close-up photo of the south joint along with the protective DCDT covering, and the ruptured pipe.

Figure 10.1. Fault Rupture at Pipe Failure

The pipe was placed on a bed of compacted sand, aligned, instruments checked, and then backfilled with compacted sand to a depth of cover of 30 in. (762 mm) above the pipe crown. The test basin's north section was displaced along a 50° fault at a rate of 2 in. (51 mm) per minute. The basin was displaced roughly 10 in. (254 mm), paused, and then put in motion again. At a fault displacement of roughly 12.6 in. (320 mm) there was an audible “pop,” the pipe lost pressure, and the test was stopped. The 12.6 in. (320 mm) fault displacement corresponds to 8.1 in. (206 mm) of axial extension of the test basin and pipe. Following excavation, a full circumferential fracture of the pipe was observed just beyond the northern most restraint at the south joint.
