# Task 3 - Large-Scale Testing of Fault Rupture Effects on Bionax Pipe and Pipe Joints

School of Civil and Environmental Engineering  
Cornell University  
Hollister Hall  
Ithaca, NY 14853  
October, 2013

This report is the third in a series of three reports to IPEX Management, Inc. and describes the results of Task 3 – Large-Scale Testing of Fault Rupture Effects on Bionax Pipe and Pipe Joints. The report presents the results of a large-scale test of fault rupture effects on a Bionax pipeline with restrained bell-and-spigot joints performed in the Cornell large-scale test basin in August 2013. All testing was performed at the Cornell University Large Scale Lifelines Testing Facility. IPEX provided all pipe materials and connection fittings. The primary pipe tested was Bionax 6 in. (150mm) CIOD. The joint restraints were Model UFR1559-C-6-I restraints for C909 PVCO, manufactured by the Ford Meter Box Co., Inc.

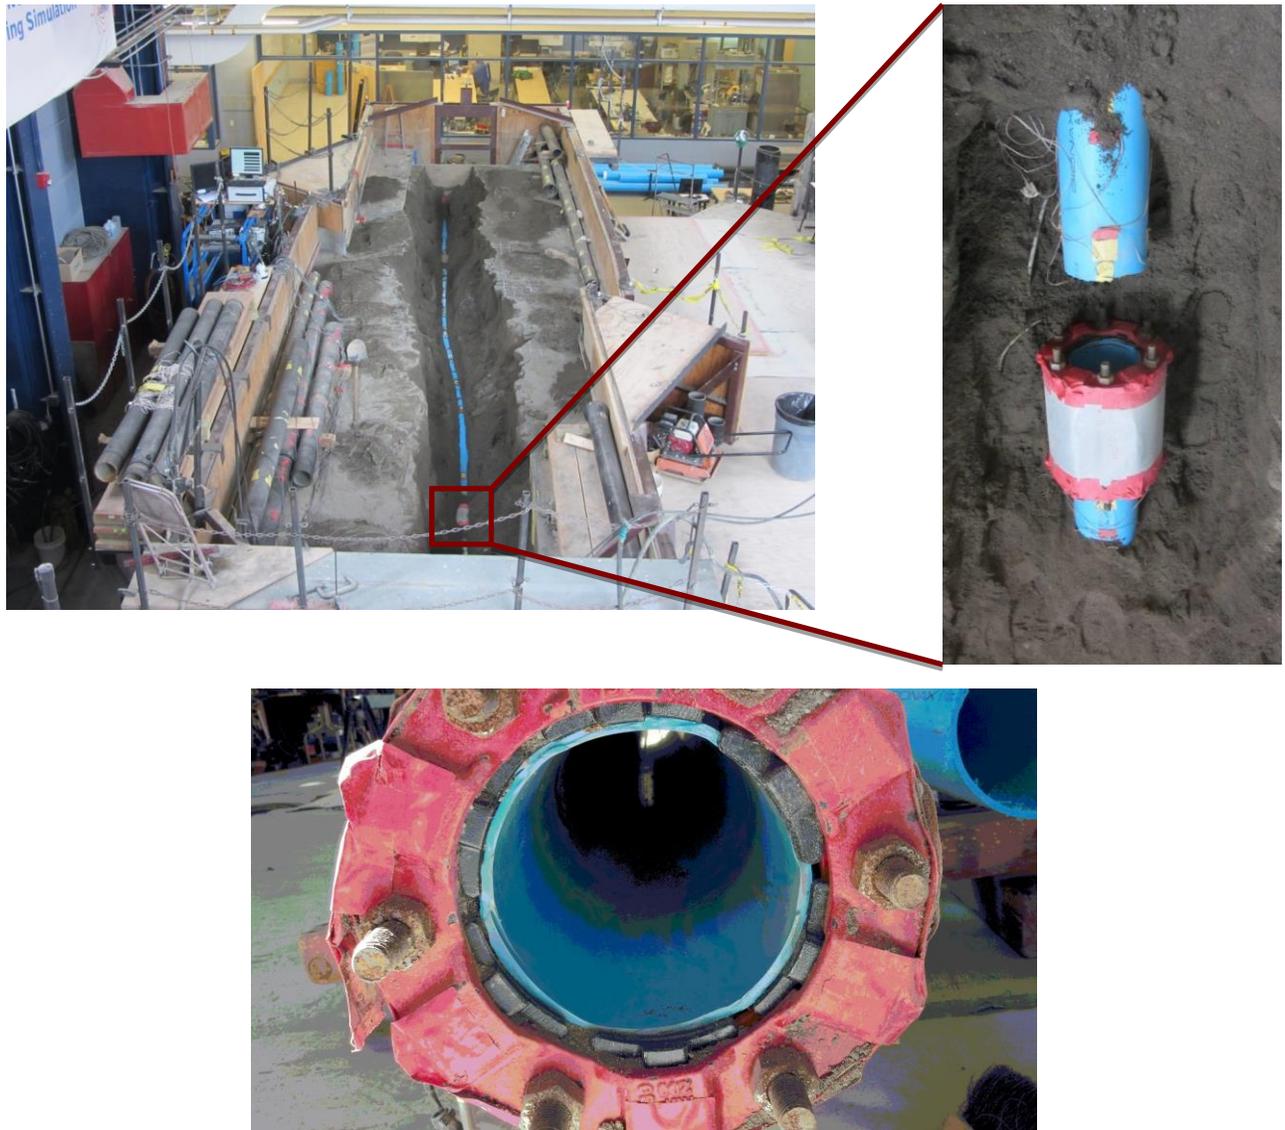
Figure 10.1 shows the fault rupture at pipe failure. Figure 10.2 shows the deformed pipe partially excavated following the test along with the rupture at the south joint. Figure 10.3 is a close-up photo of the south joint along with the protective DCDT covering, and the ruptured pipe.

Figure 10.3. South Joint after Excavation

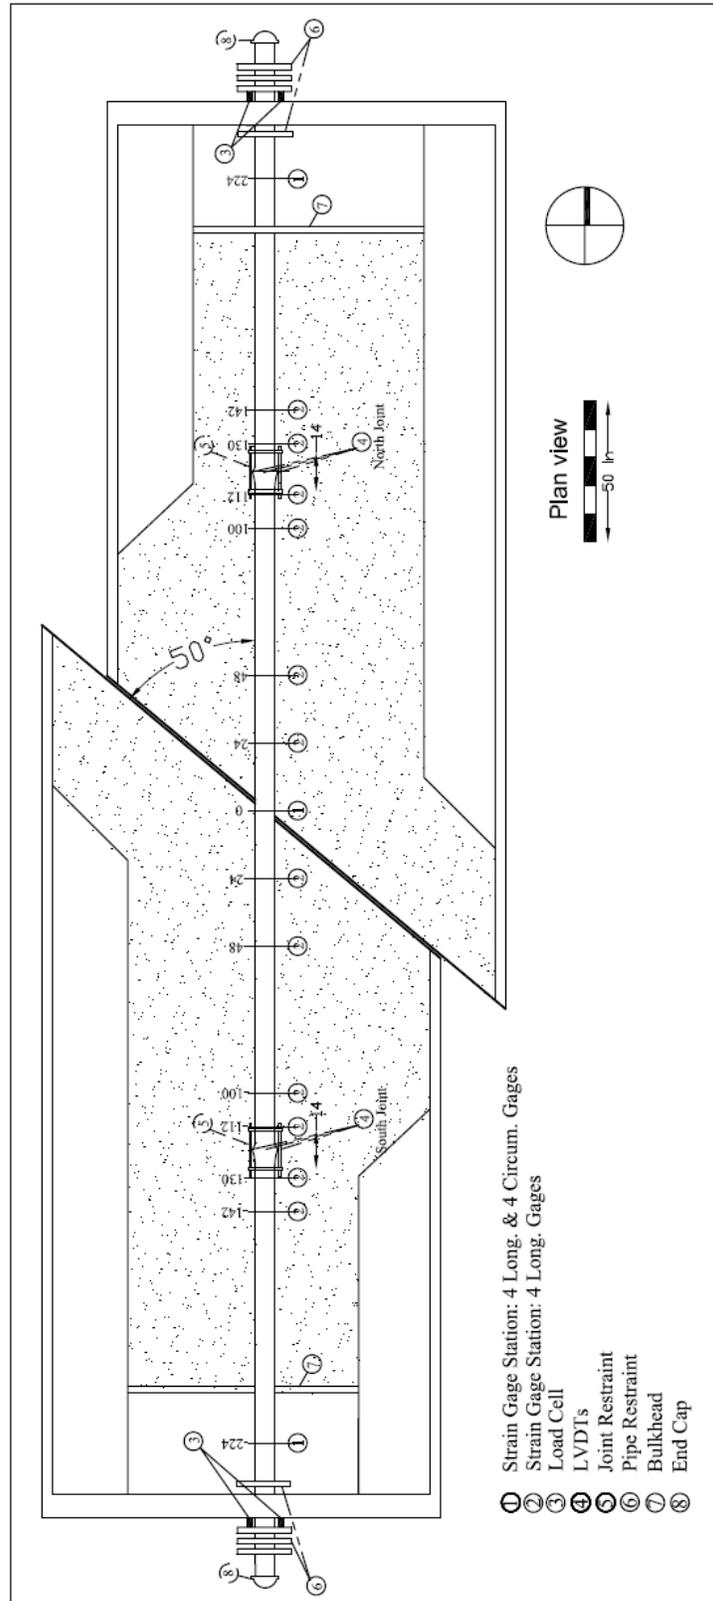
Figure A.1. Expanded Instrumentation Layout

Figure 2.1, a plan view of the test layout, shows the locations of the instruments along the test pipeline. The instrumentation consisted of strain gages at fifteen locations (gage planes) along the pipeline, load cells at the ends of the pipeline and DCDTs (Direct Current Differential Transformers) to measure joint displacements. To help correlate gage, joint, and load cell locations with the description of measurements in this report, an expanded view of Figure 2.1 is provided in Appendix A.

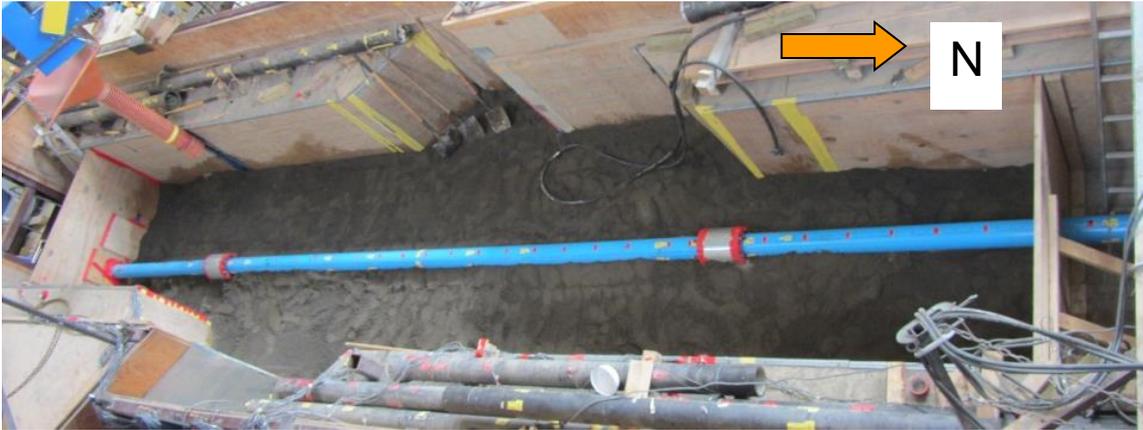
Figure B.1. Instrumented Pipe in Test Basin Prior to Backfill

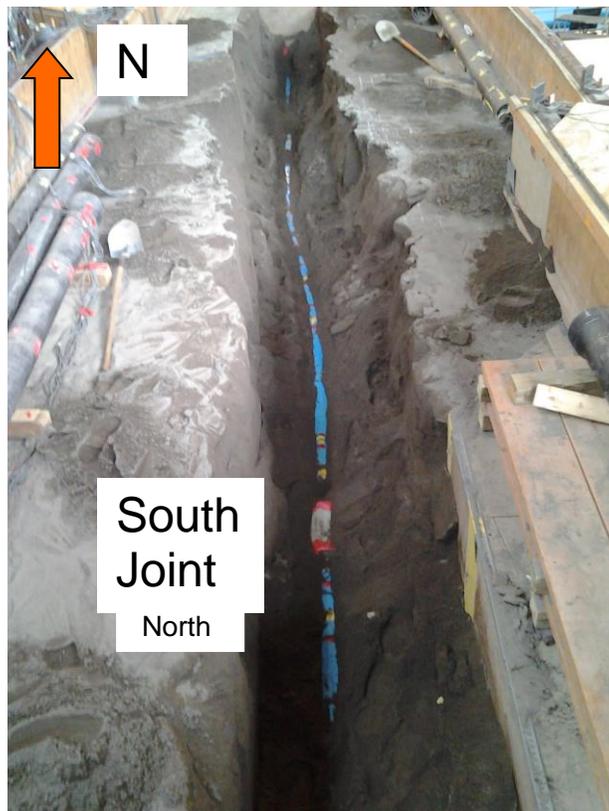
Figure B.2. Pipe after Test Showing South Joint

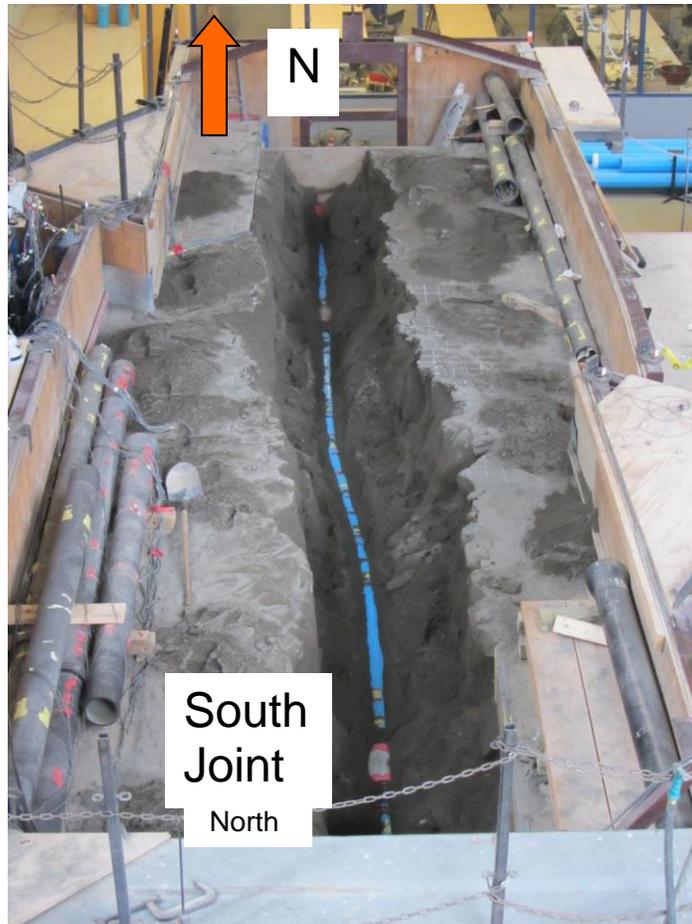
Figure B.3. Overview of Pipe in Basin after Test

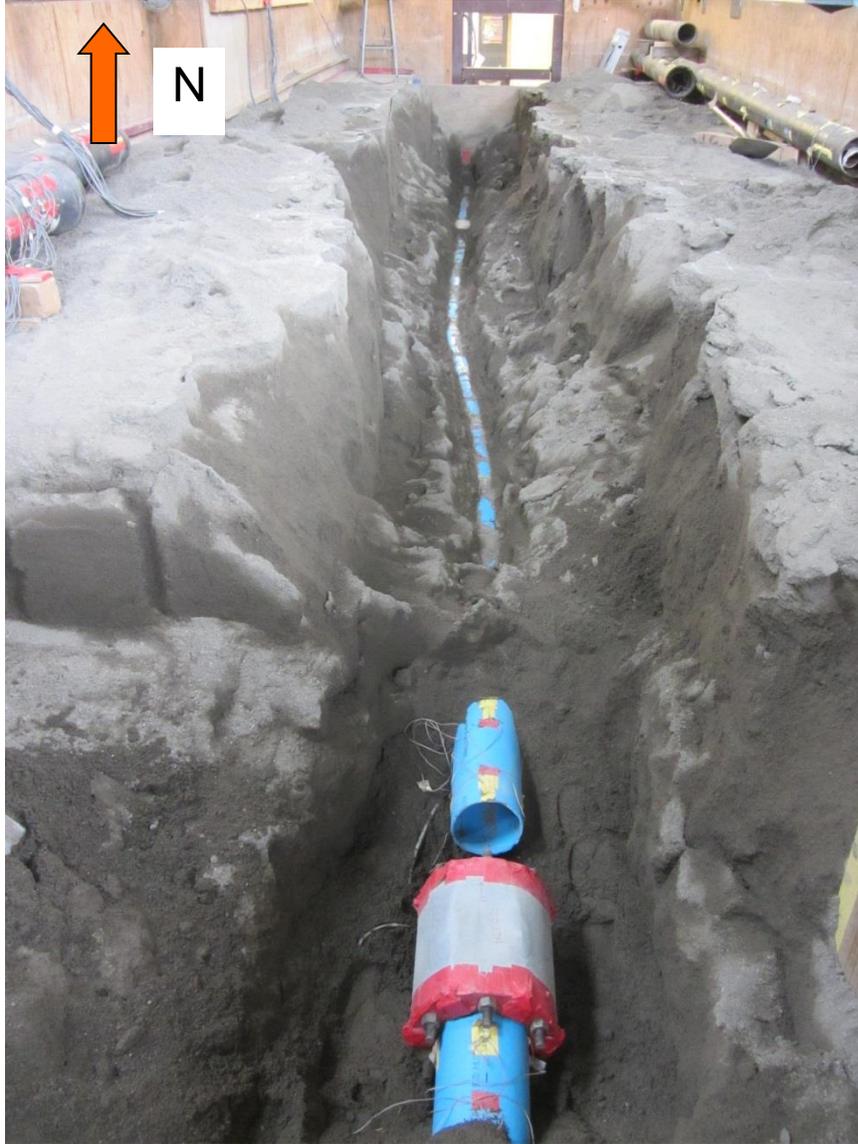
Figure B.4. South Joint after Pipe Rupture

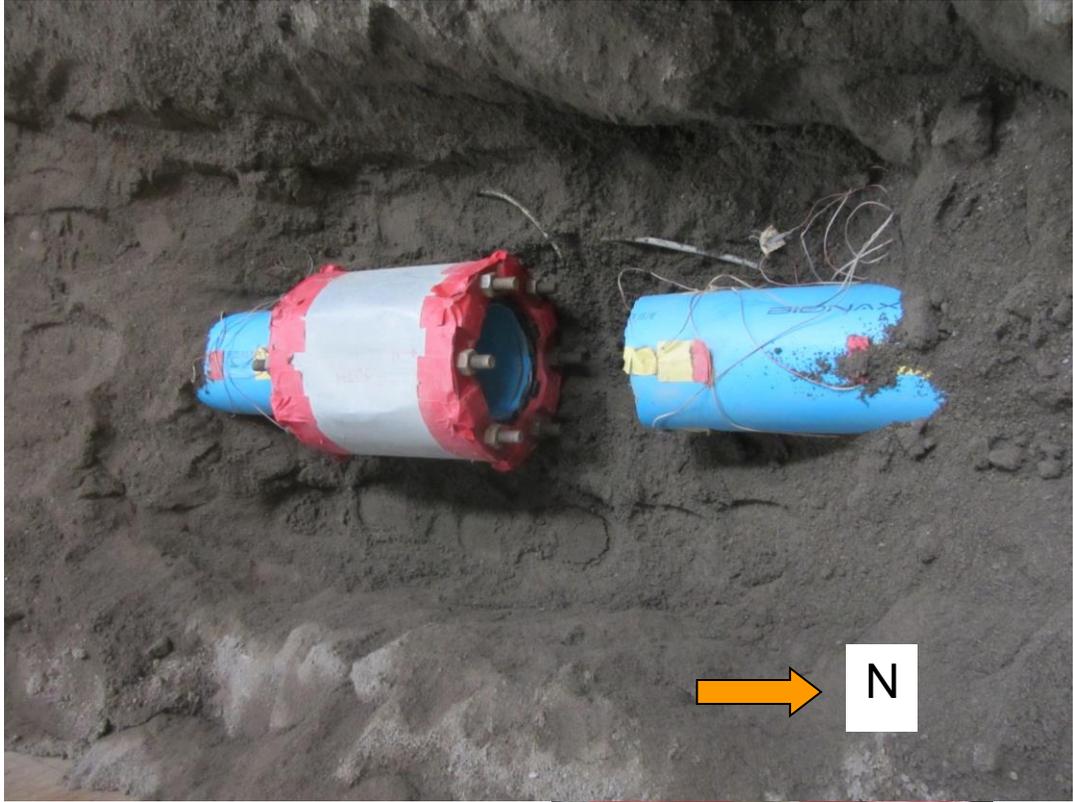
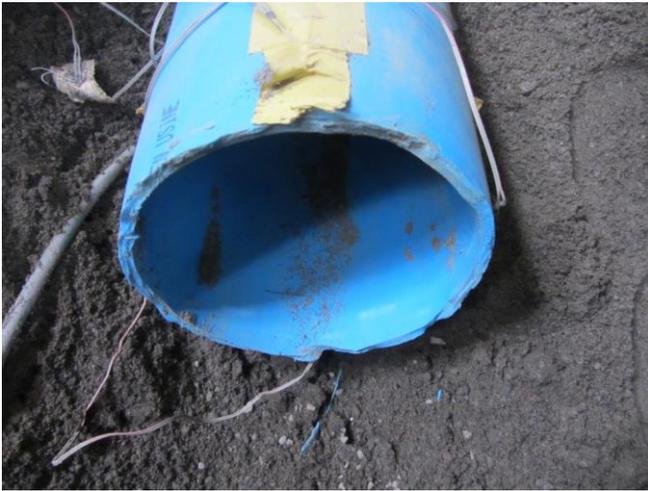
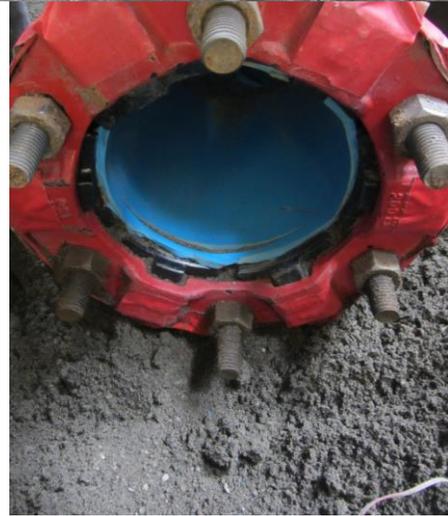
### B.6. Ruptured Pipe at South Restraint

a) Pipe Side

b) Restraint Side

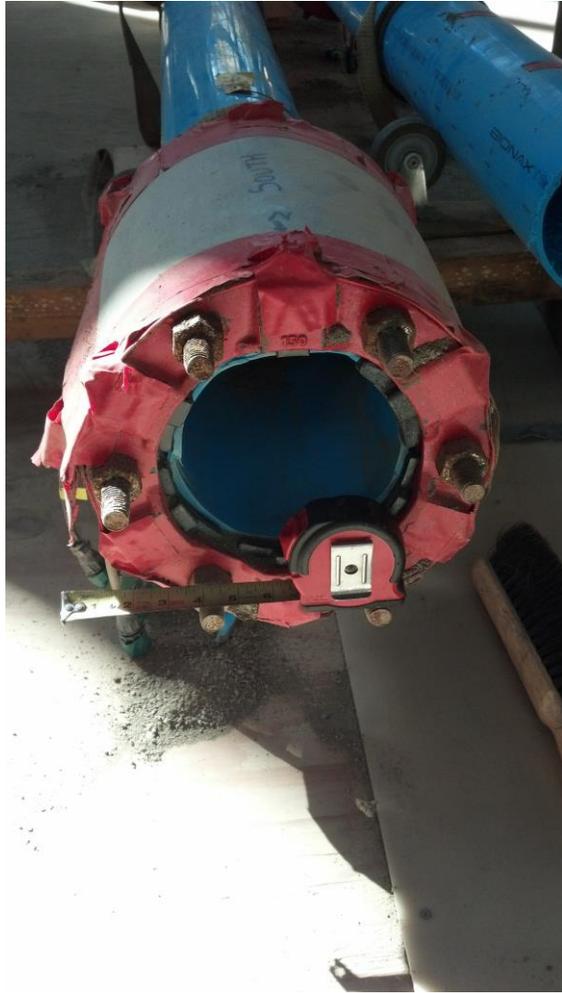
Figure B.7. South Joint Showing Ruptured Pipe and Joint Protective Enclosure

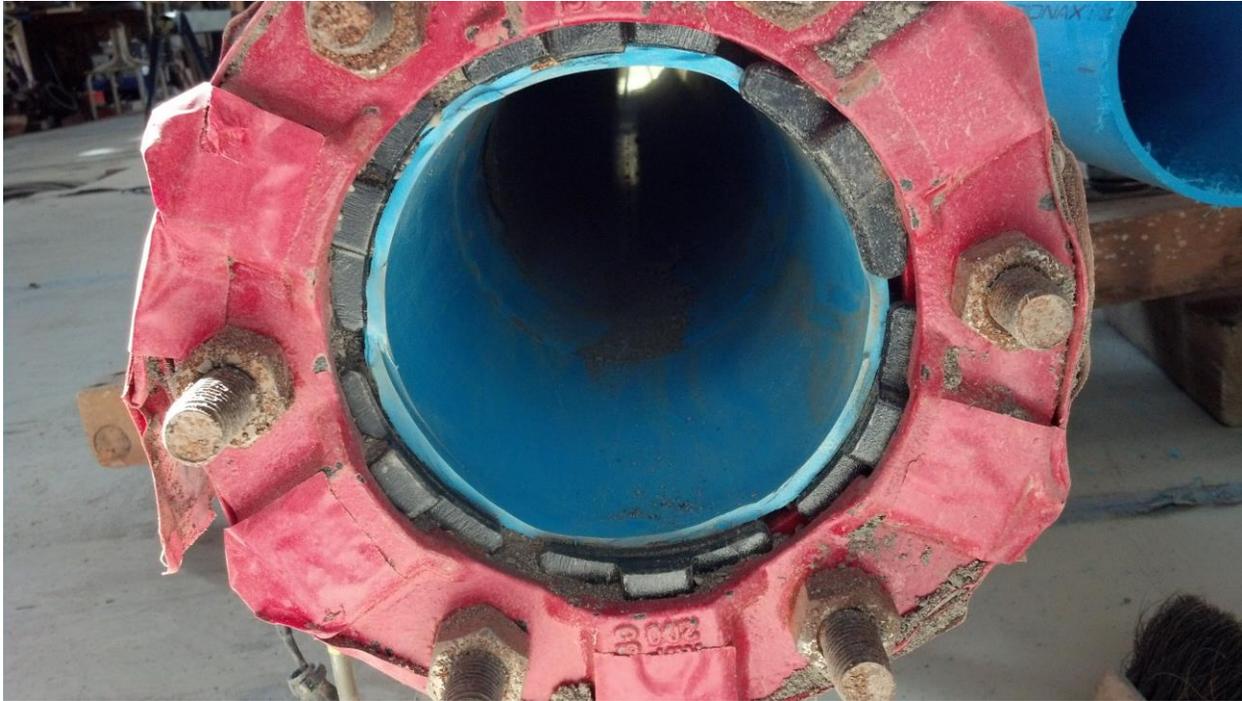
Figure B.8. South Joint Showing Ruptured Pipe

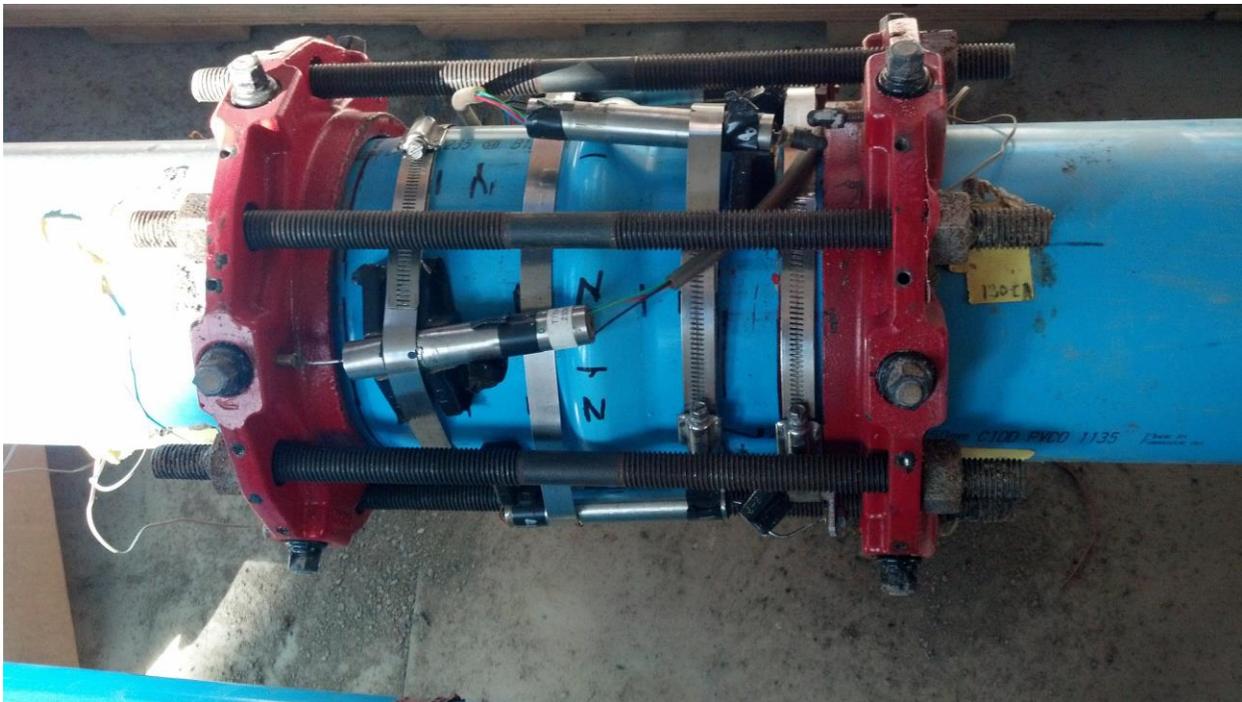
Figure B.9. North Joint after Test with Protective Enclosure Removed
