# Hazard Resilience Testing of US Pipe Ductile Iron TR-XTREME™ Pipe Joints

Russ Huggins PE  
AVP of Product Development and Quality  
US Pipe

Cornell University  
School of Civil and Environmental Engineering  
Cornell University  
Hollister Hall  
Ithaca, NY 14853

February, 2015

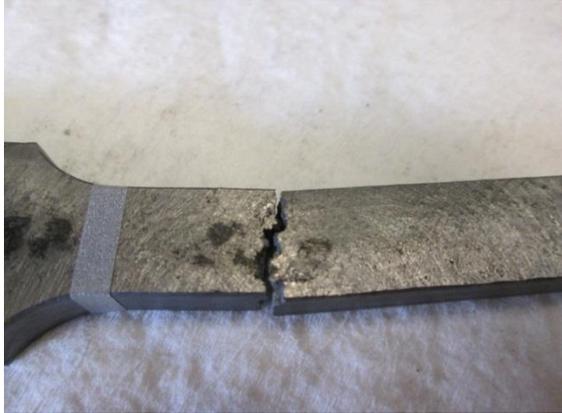
Figure 2.16. Uneven Fracture of Test Specimen 5

Two coupons, test Specimens 5 and 6, were tested with their original surface to investigate the effect of surface pitting on the material properties. Unlike the clean breaks of Test Specimens 1 – 4, the fractures of test Specimens 5 and 6 were severely uneven with a number of deep ridges stemming from the irregularities of the pitting. This can be seen in Figures 2.16 and 2.17. A closer observation yielded the discovery of a failure surface originating from a pit outside of the fracture, shown in Figure 2.18.

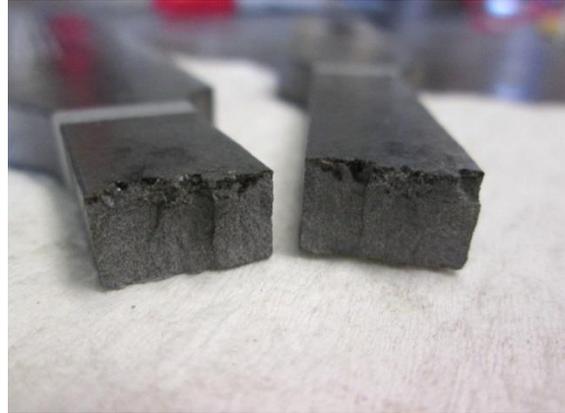
Figure 2.17. Fracture of Test Specimen 5 with Multiple Ridges

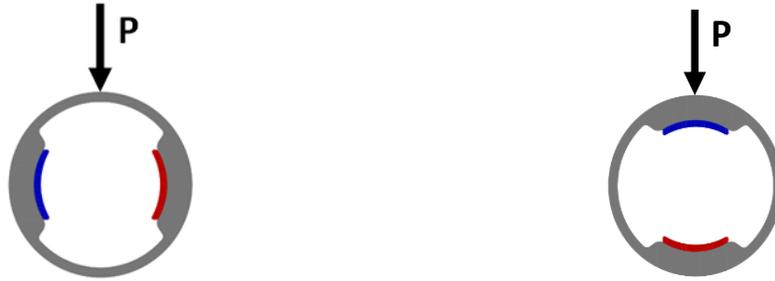
a) Clip Locations at 3 and 9 O'Clock  
(First Test, Test A)

Figure 3.2. Full-Scale Basin Test Setup with Clips at the 3 and 9 O'Clock Positions and Lateral Ground Motion

In the full-scale split basin tests, the pipeline is constructed with the slots at the top and locking clips at the 3 and 9 o’clock positions as shown in Figure 3.2. Therefore, the second 4-pt bending test (Test B) is representative of the joints’ rotational behavior in the split basin test. Before testing, rotation in this direction (with locking segments at 3 and 9 o’clock) was thought to be a worst case scenario for the pipeline due to reduced rotational capacity related to the clip positions.

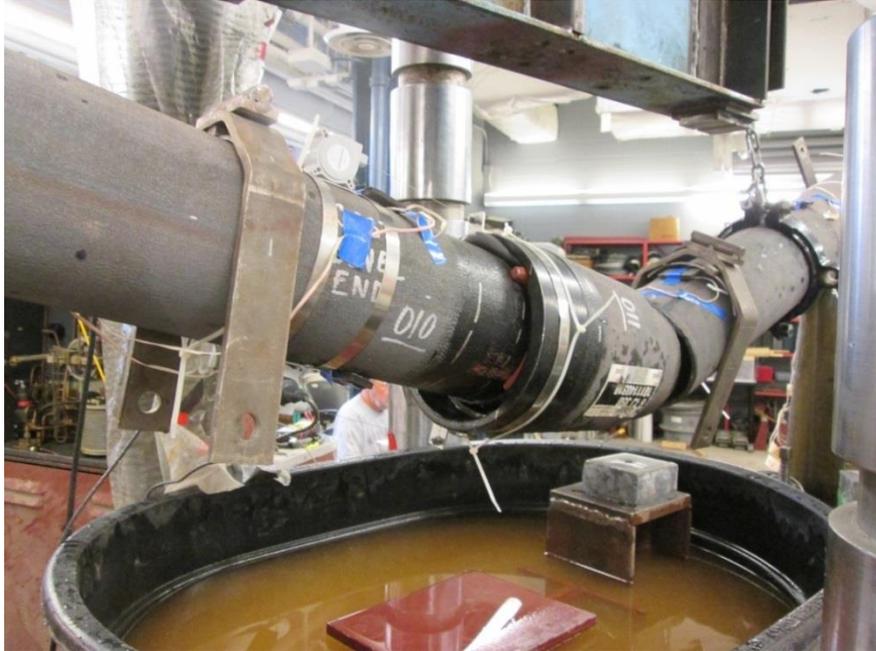
Figure 3.8. Pipe Failure in Test A

Figures 3.8 and 3.9 show the Test A specimen at pipe rupture. As previously stated, the pipe had a nearly complete circumferential crack at 13 inches away from the bell face behind the bell section. Figure 3.10 shows a feature, which was visible around the entire pipe circumference. Discussions with US Pipe personnel indicated that this is likely due to a buildup of residue from a mold release agent used during casting. It also appeared that the pipe wall was thinner in this zone than in other pipe sections.

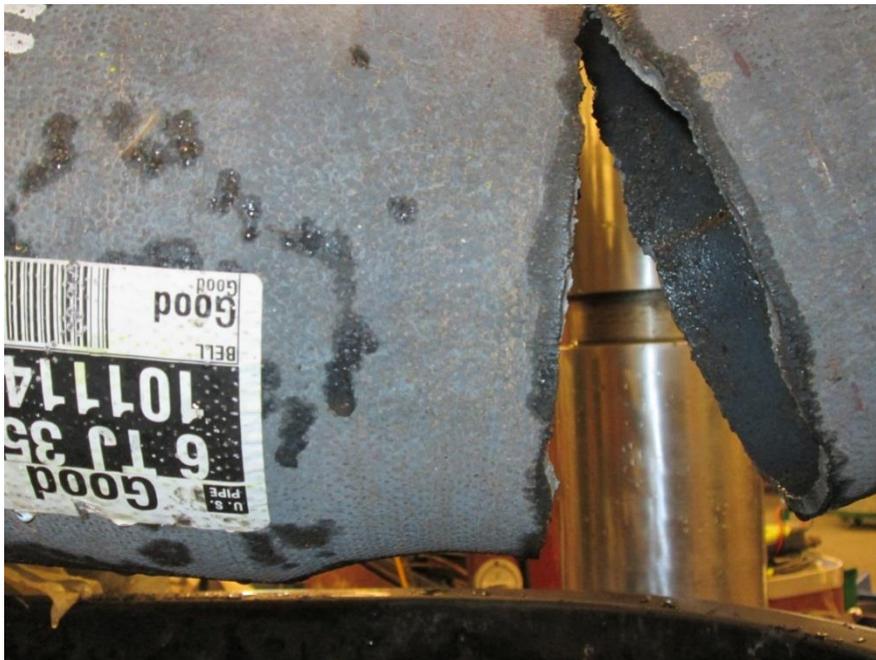
Figure 3.9. Side View of Pipe Failure in Test A

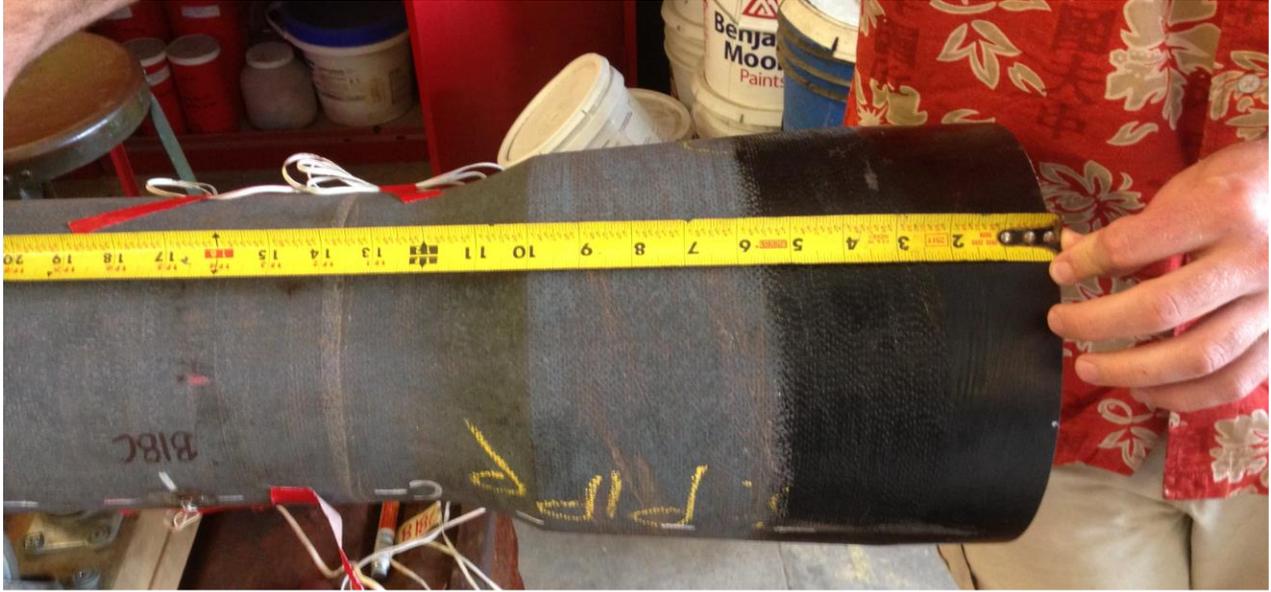
Figure 3.10. Special Feature on TR-XTREME™ Spigot

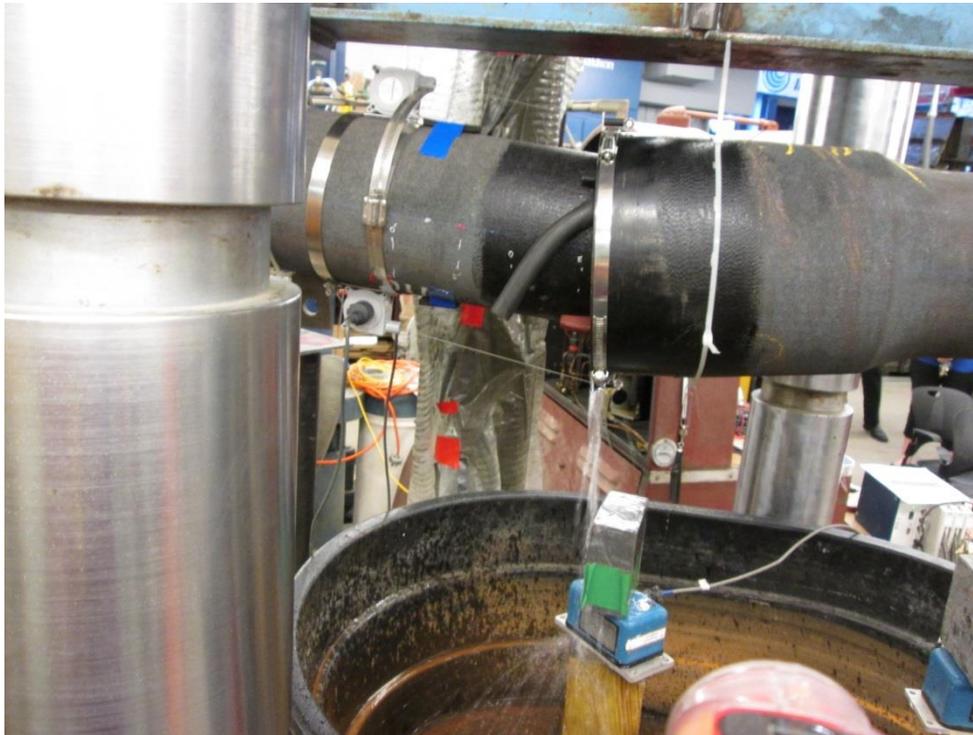
Figure 3.15. Leakage at Peak Moment in Test B

Figure 3.14 shows the joint rotation in Test B. Moment-rotations for Test B for the central portion of the bell-and spigot joint were calculated using the horizontal string pots (HSPs) at the top and bottom of the bell (Eqn. 3.3) and using the three vertical string pots (VSPs) in the central portion (Eqn. 3.4.) Figure 3.14 shows the moment-rotation data using both approaches. The moments are those in the central load pipe section. Only the rotations during the loading phase are shown. As the joint developed a slow leak, the moments (loads) were reduced. As seen in Figure 3.14, both measurement methods are in reasonable agreement. Test B failed at an applied moment of 480 kip-in. (54.2 kN-m) at a rotation of 9.1 degrees, which is the average rotation measured by the HSPs and VSPs. Figure 3.15 shows the Test B leakage.

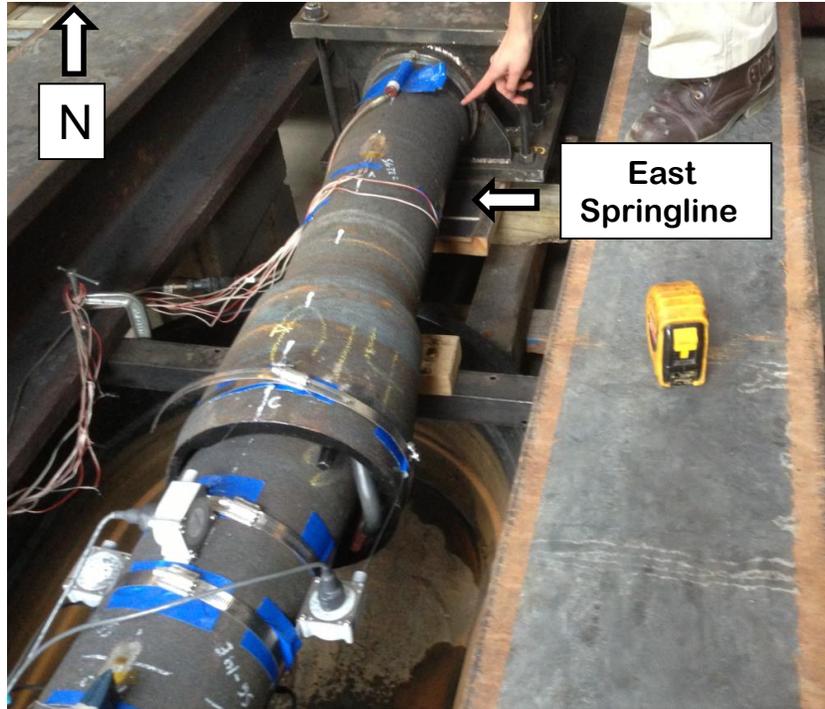
Figure 4.7. Photo of Compression Test on TR-Xtreme™ Joint

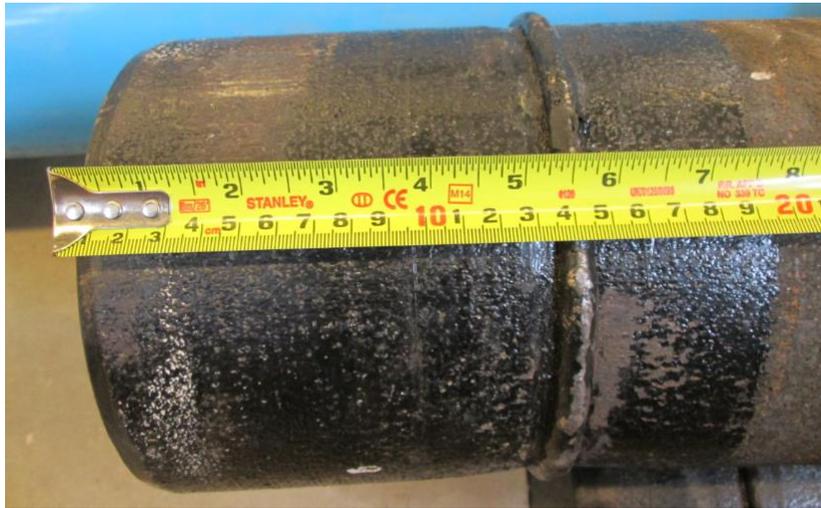
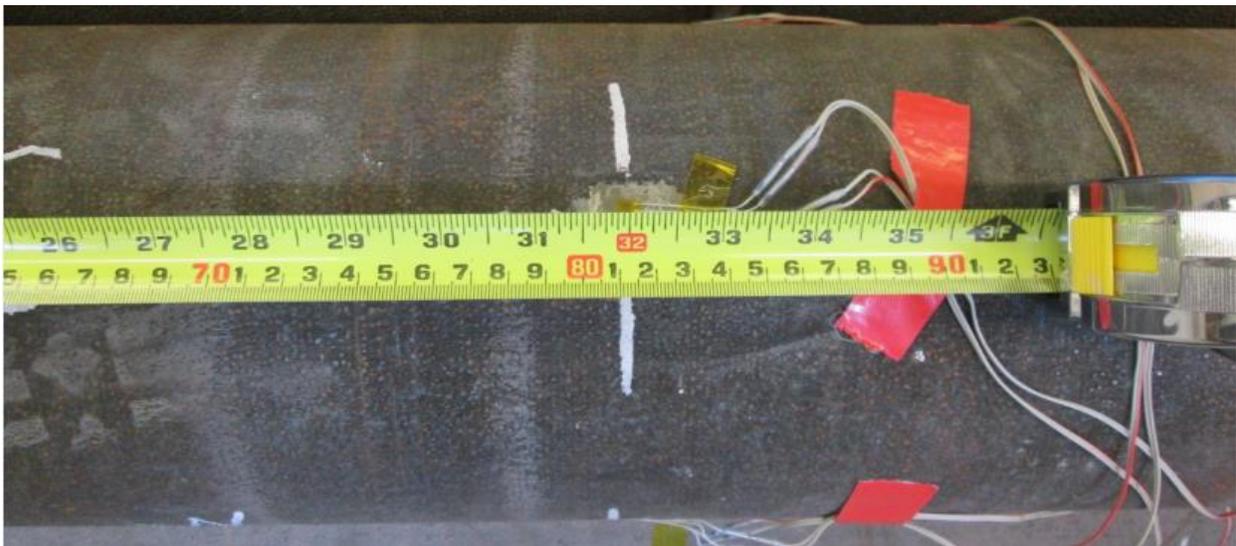
a) On Spigot Section

b) Close to Spigot End

c) 32 in. (813 mm) from Spigot End

Figure 5.6. Diameter Measurement Locations on Spigot Section

The C-I diameter measurements are larger than the E-W diameter measurements. Spigot pullout past the restraining clips caused ovaling of the spigot close to the weld bead (6 in. away from the spigot end) where the retaining clips were located.

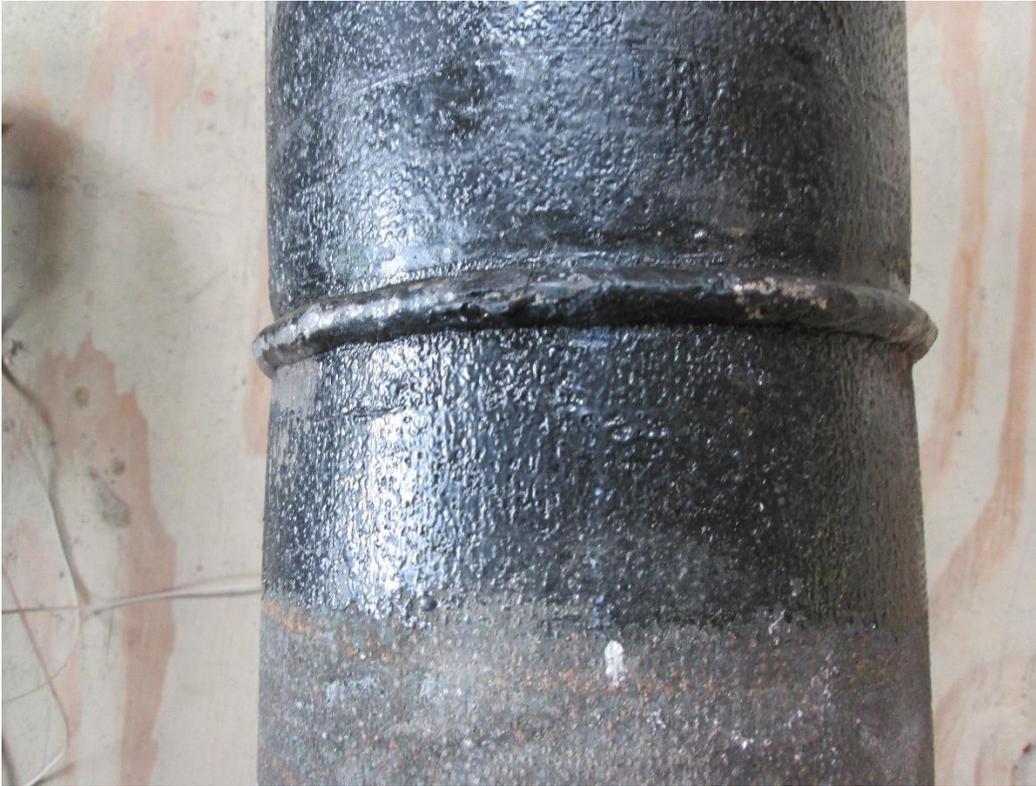
Figure 5.7. Deformed Area of the Spigot Caused by the Load Transferred from the Retaining Clips

As the spigot was pulled from the bell, the clips slid from their positions between the bell and weld bead on the spigot. At this point, the spigot end, which had deformed to a larger diameter in the vertical direction, became wedged at the landing area inside the bell. When the spigot was pulled from the bell after the test, there was some compressive deformation along the C-I direction where the spigot was wedged at a location about 2 in. away from the spigot end. Thus, the change in vertical diameter, which was measured after the spigot was pulled free of the bell, does not represent the maximum increase in diameter during the test. Figure 5.7 is a photo of the deformed area of the spigot caused by the load transferred from the retaining clips.

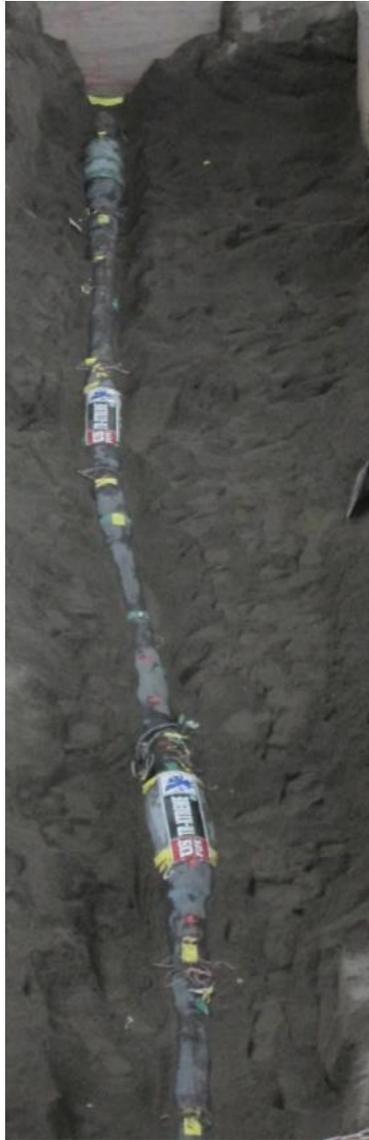
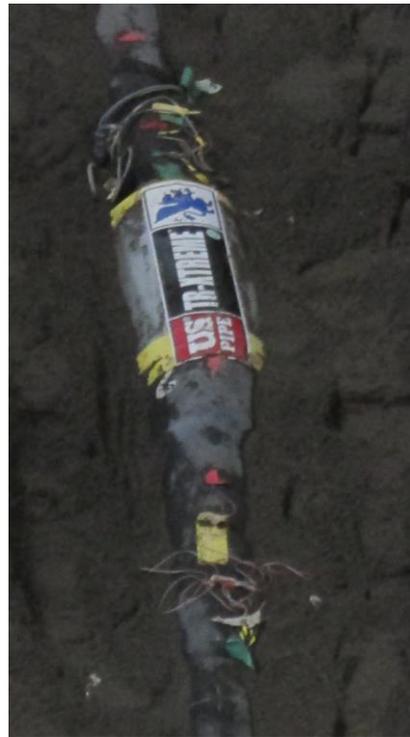
a) Deformed Pipe in Test Basin

b) Failure at South Joint

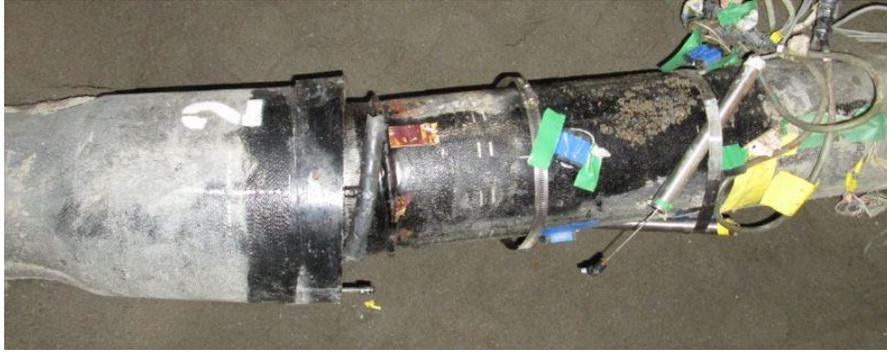
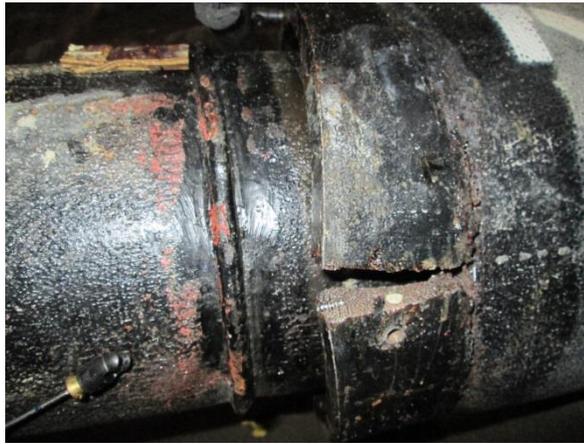
a) Plan View of the South Joint

b) Elevation View of the South Joint from the West Springline
